LEVEL MONITORING

for Subsidence Management Services

55 Gellatly Road, New Cross, SE14 5TU

Client:	Subsidence Management Services
Client Contact:	Ian Domigan
Claim Number:	700017130
Client Reference:	IFS-LBG-SUB-22-0102990
Policy Holder:	Mr Richard Hammond
Report Date:	14 December 2023
Our Ref:	M21507

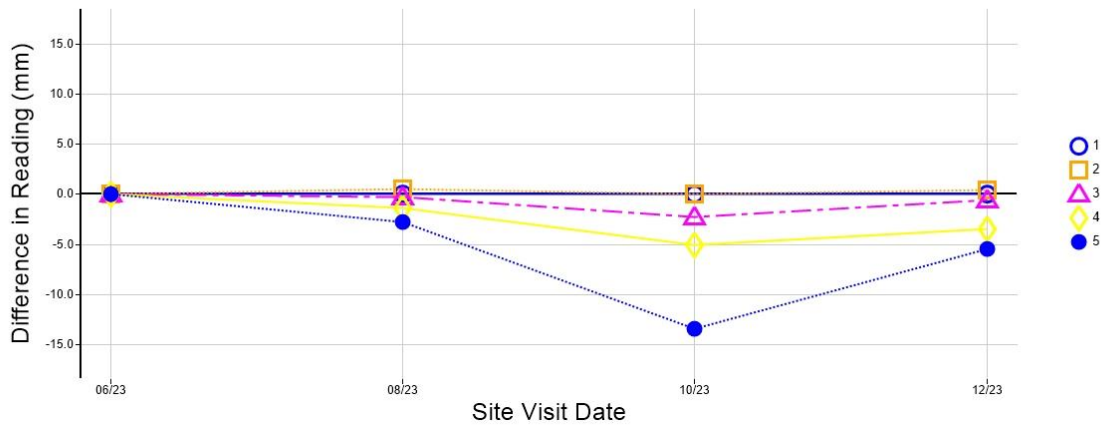
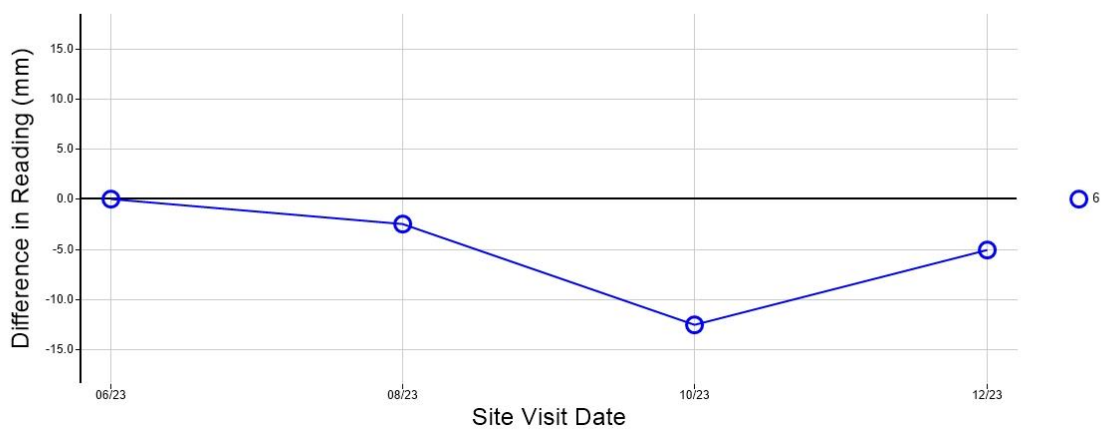
Level Monitoring Difference Graphs

The following graphs display the progressive movement that each Level Monitoring Station recorded at each separate site visit date to give an overall look at how much the property is moving.

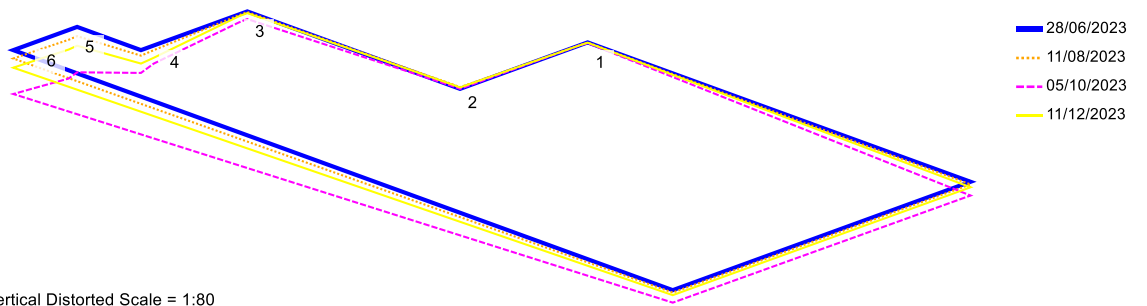
Level Monitoring Displacement Map

The following image shows an isometric representation of the movement of the property, based on the Level Monitoring Stations that were installed.

Vertical Distorted Scale = 1:80

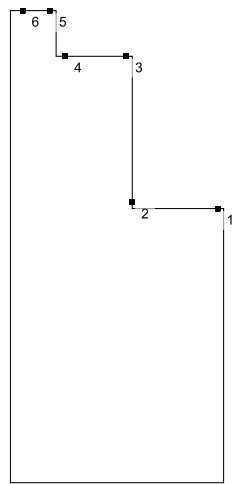
FRONT

Datum located position one on rear elevation of main building right hand side.
