# 106 Clacton Road, St Osyth

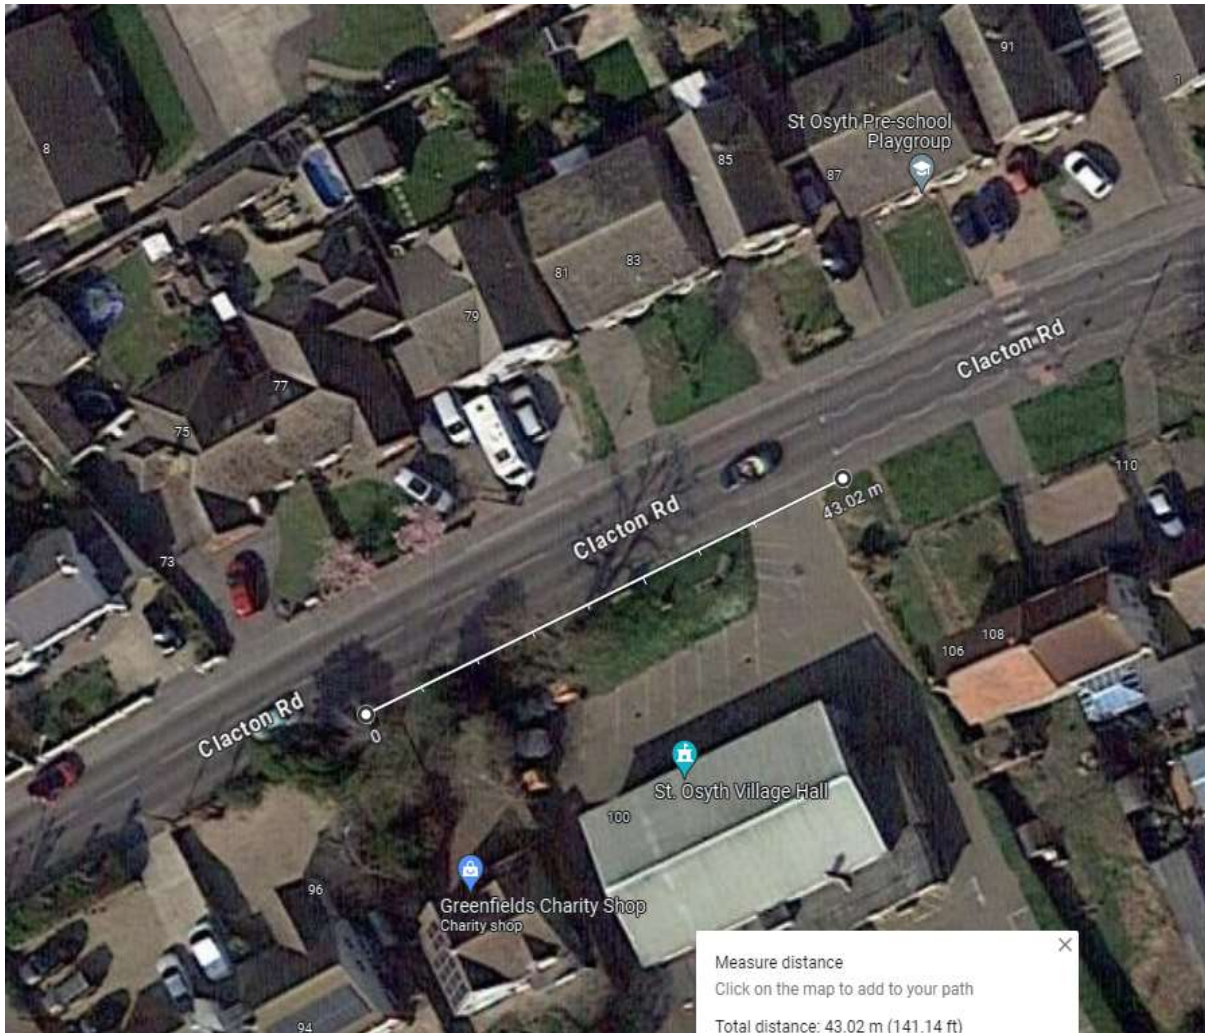
Fig. 1– 30mph, 43m visibility splay distance looking south west

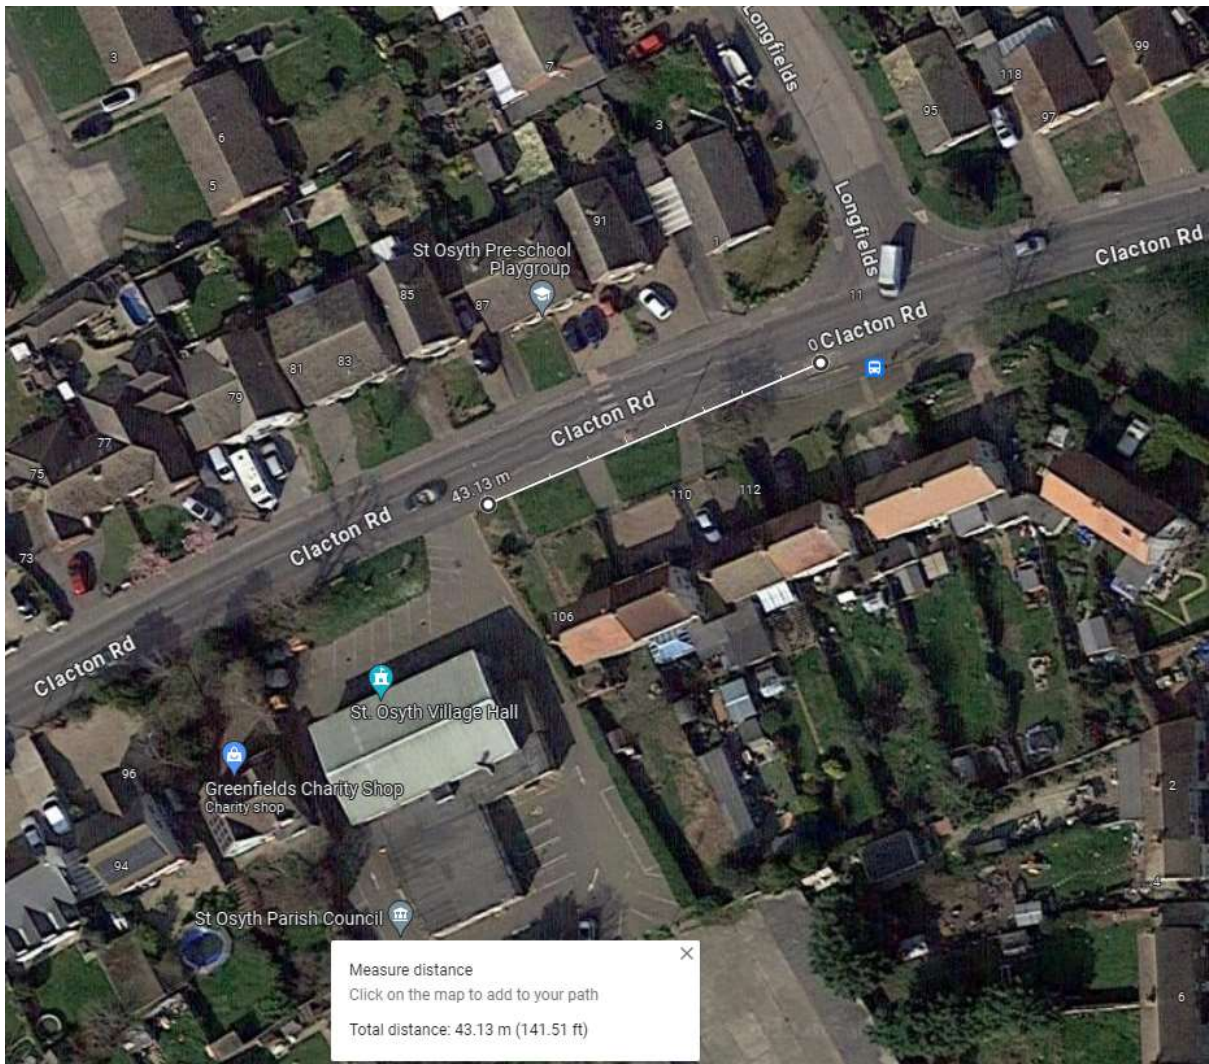
**Fig. 2**– 30mph, 43m visibility splay distance looking north east

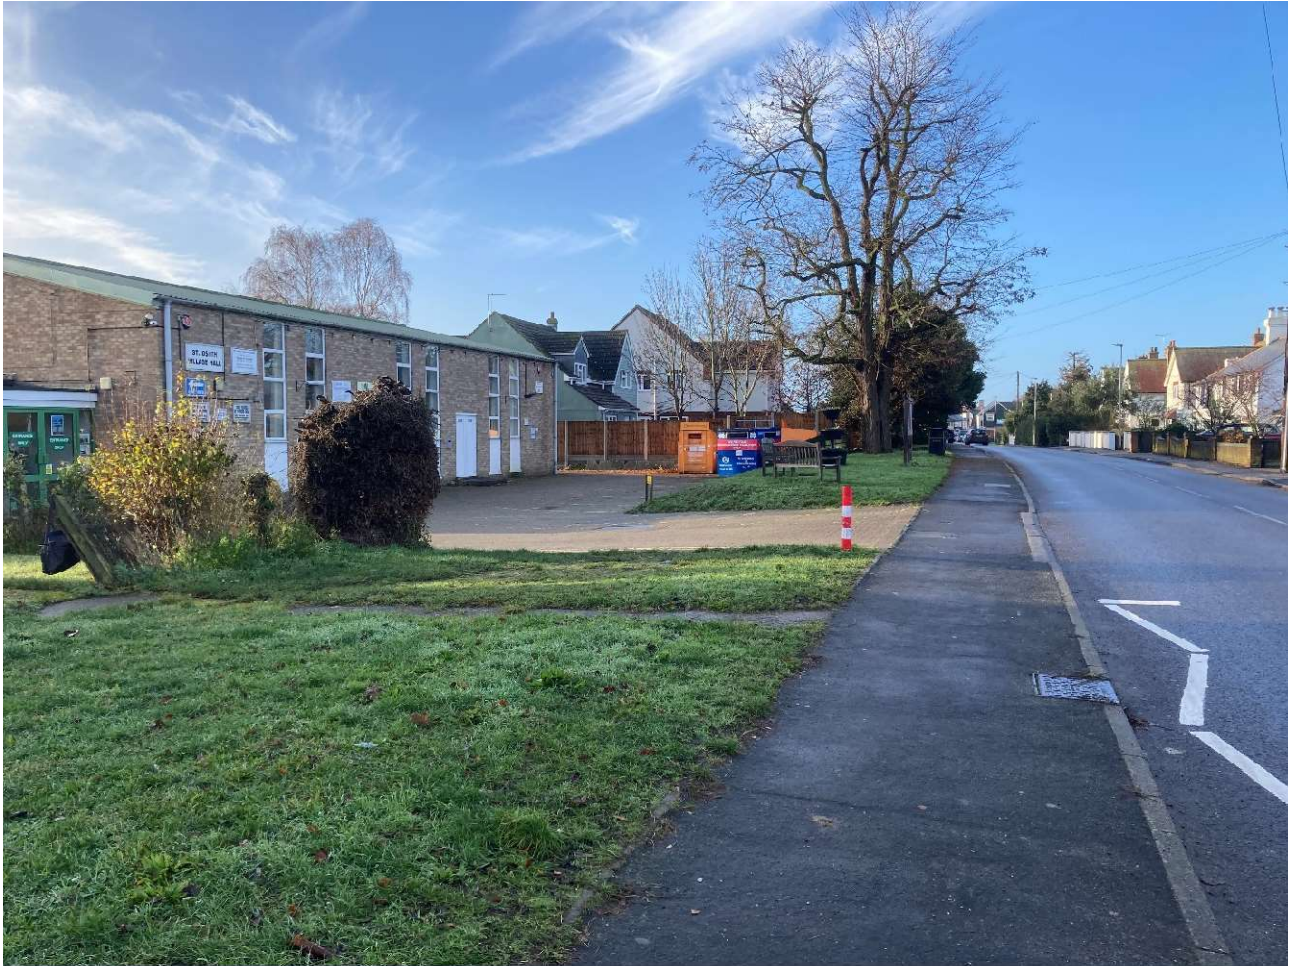
**Fig. 3**– Clacton Road looking south west, note grass verge & concrete path in front #106

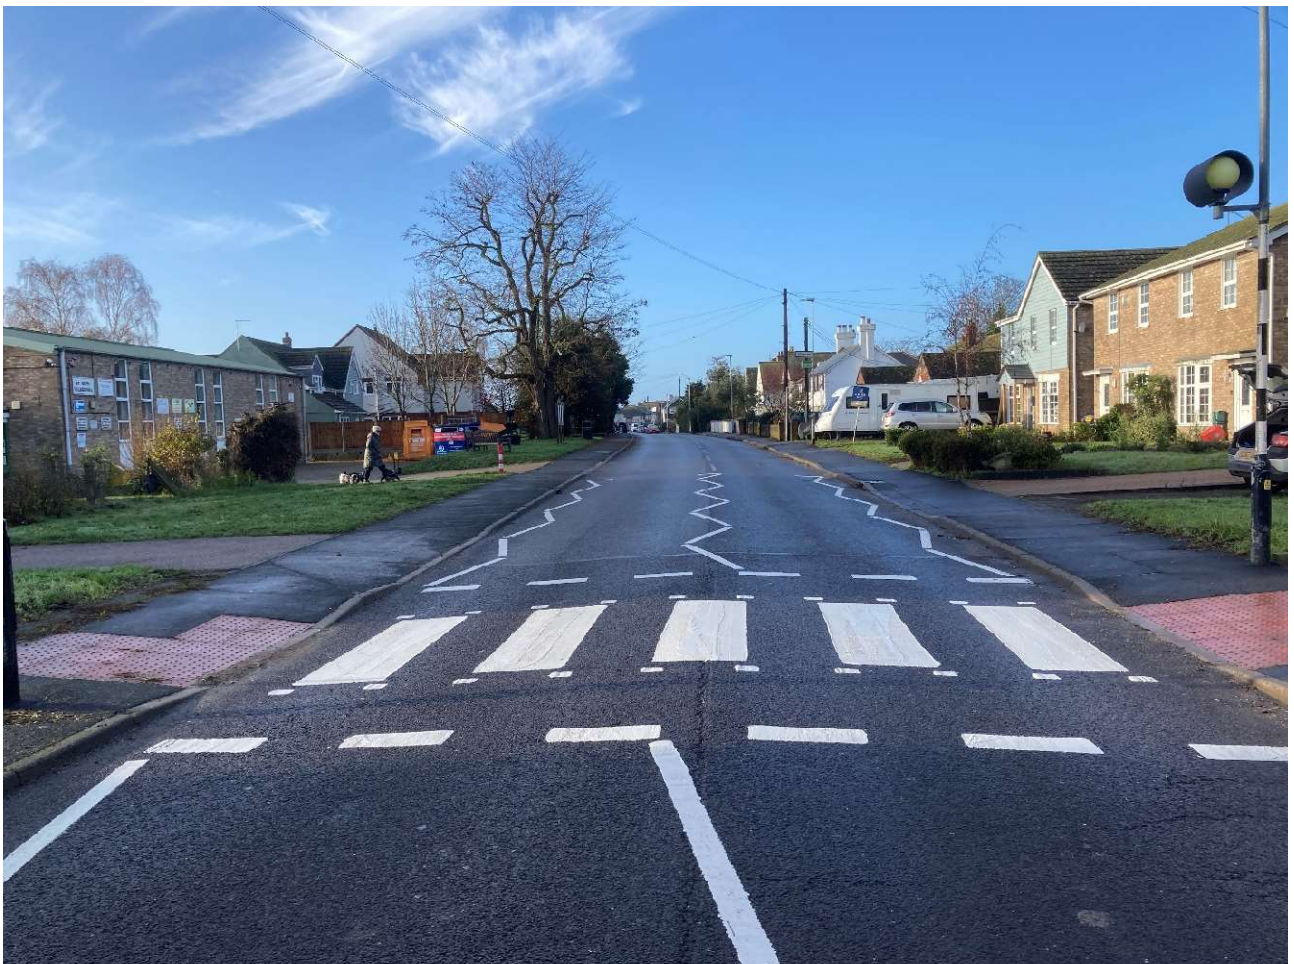
**Fig.4**– Clacton Road looking south west, entrance to Village Hall can be seen in front of building itself.

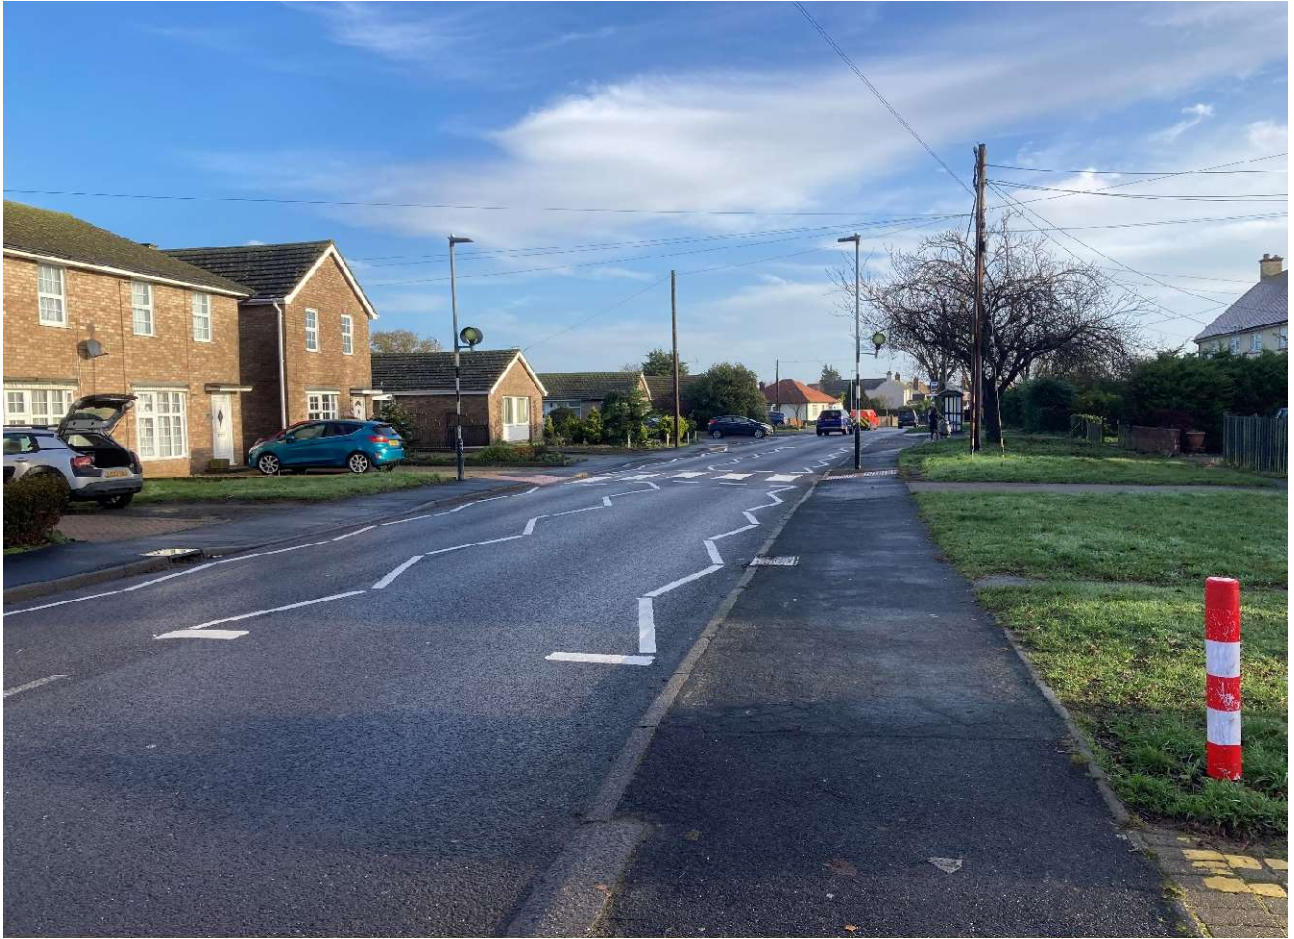
**Fig.5**– Clacton Road looking north east, grass verge in front of #106 & entrance to Village Hall can be seen to RHS in foreground.

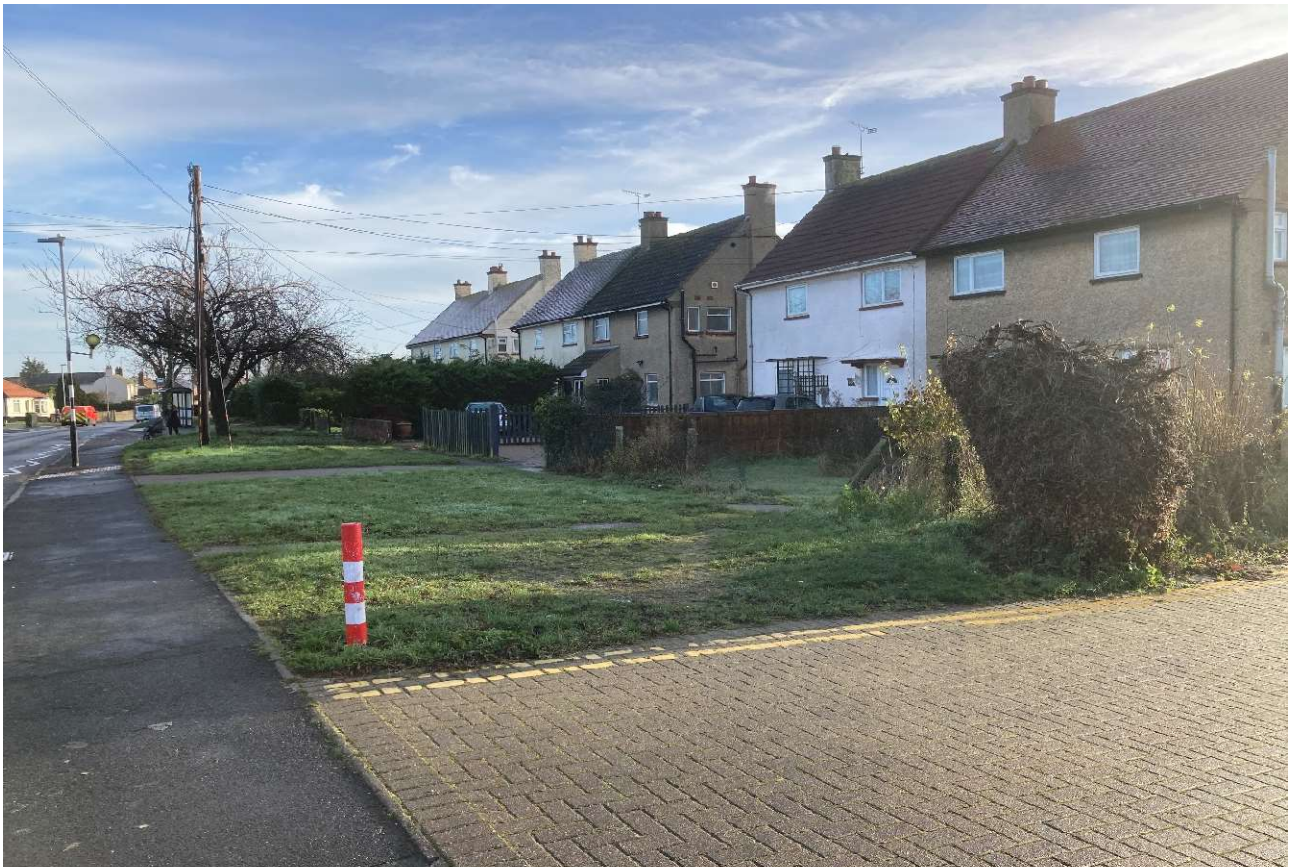
**Fig.6**– Looking north east, with #106 to RHS. Entrance to Village Hall can be seen in foreground
