Surveyed for
Annie Martin Architect
 Little Thorne
 Cheriton Bishop
 Exeter
 EX6 6HP

Survey at
PENNYLAND FARM
 YEOFORD
 EX17 5EU

Scale 1:200 @ A1 Contours at 0.5m

DRWG. NO. ANN123_LS Rev 0

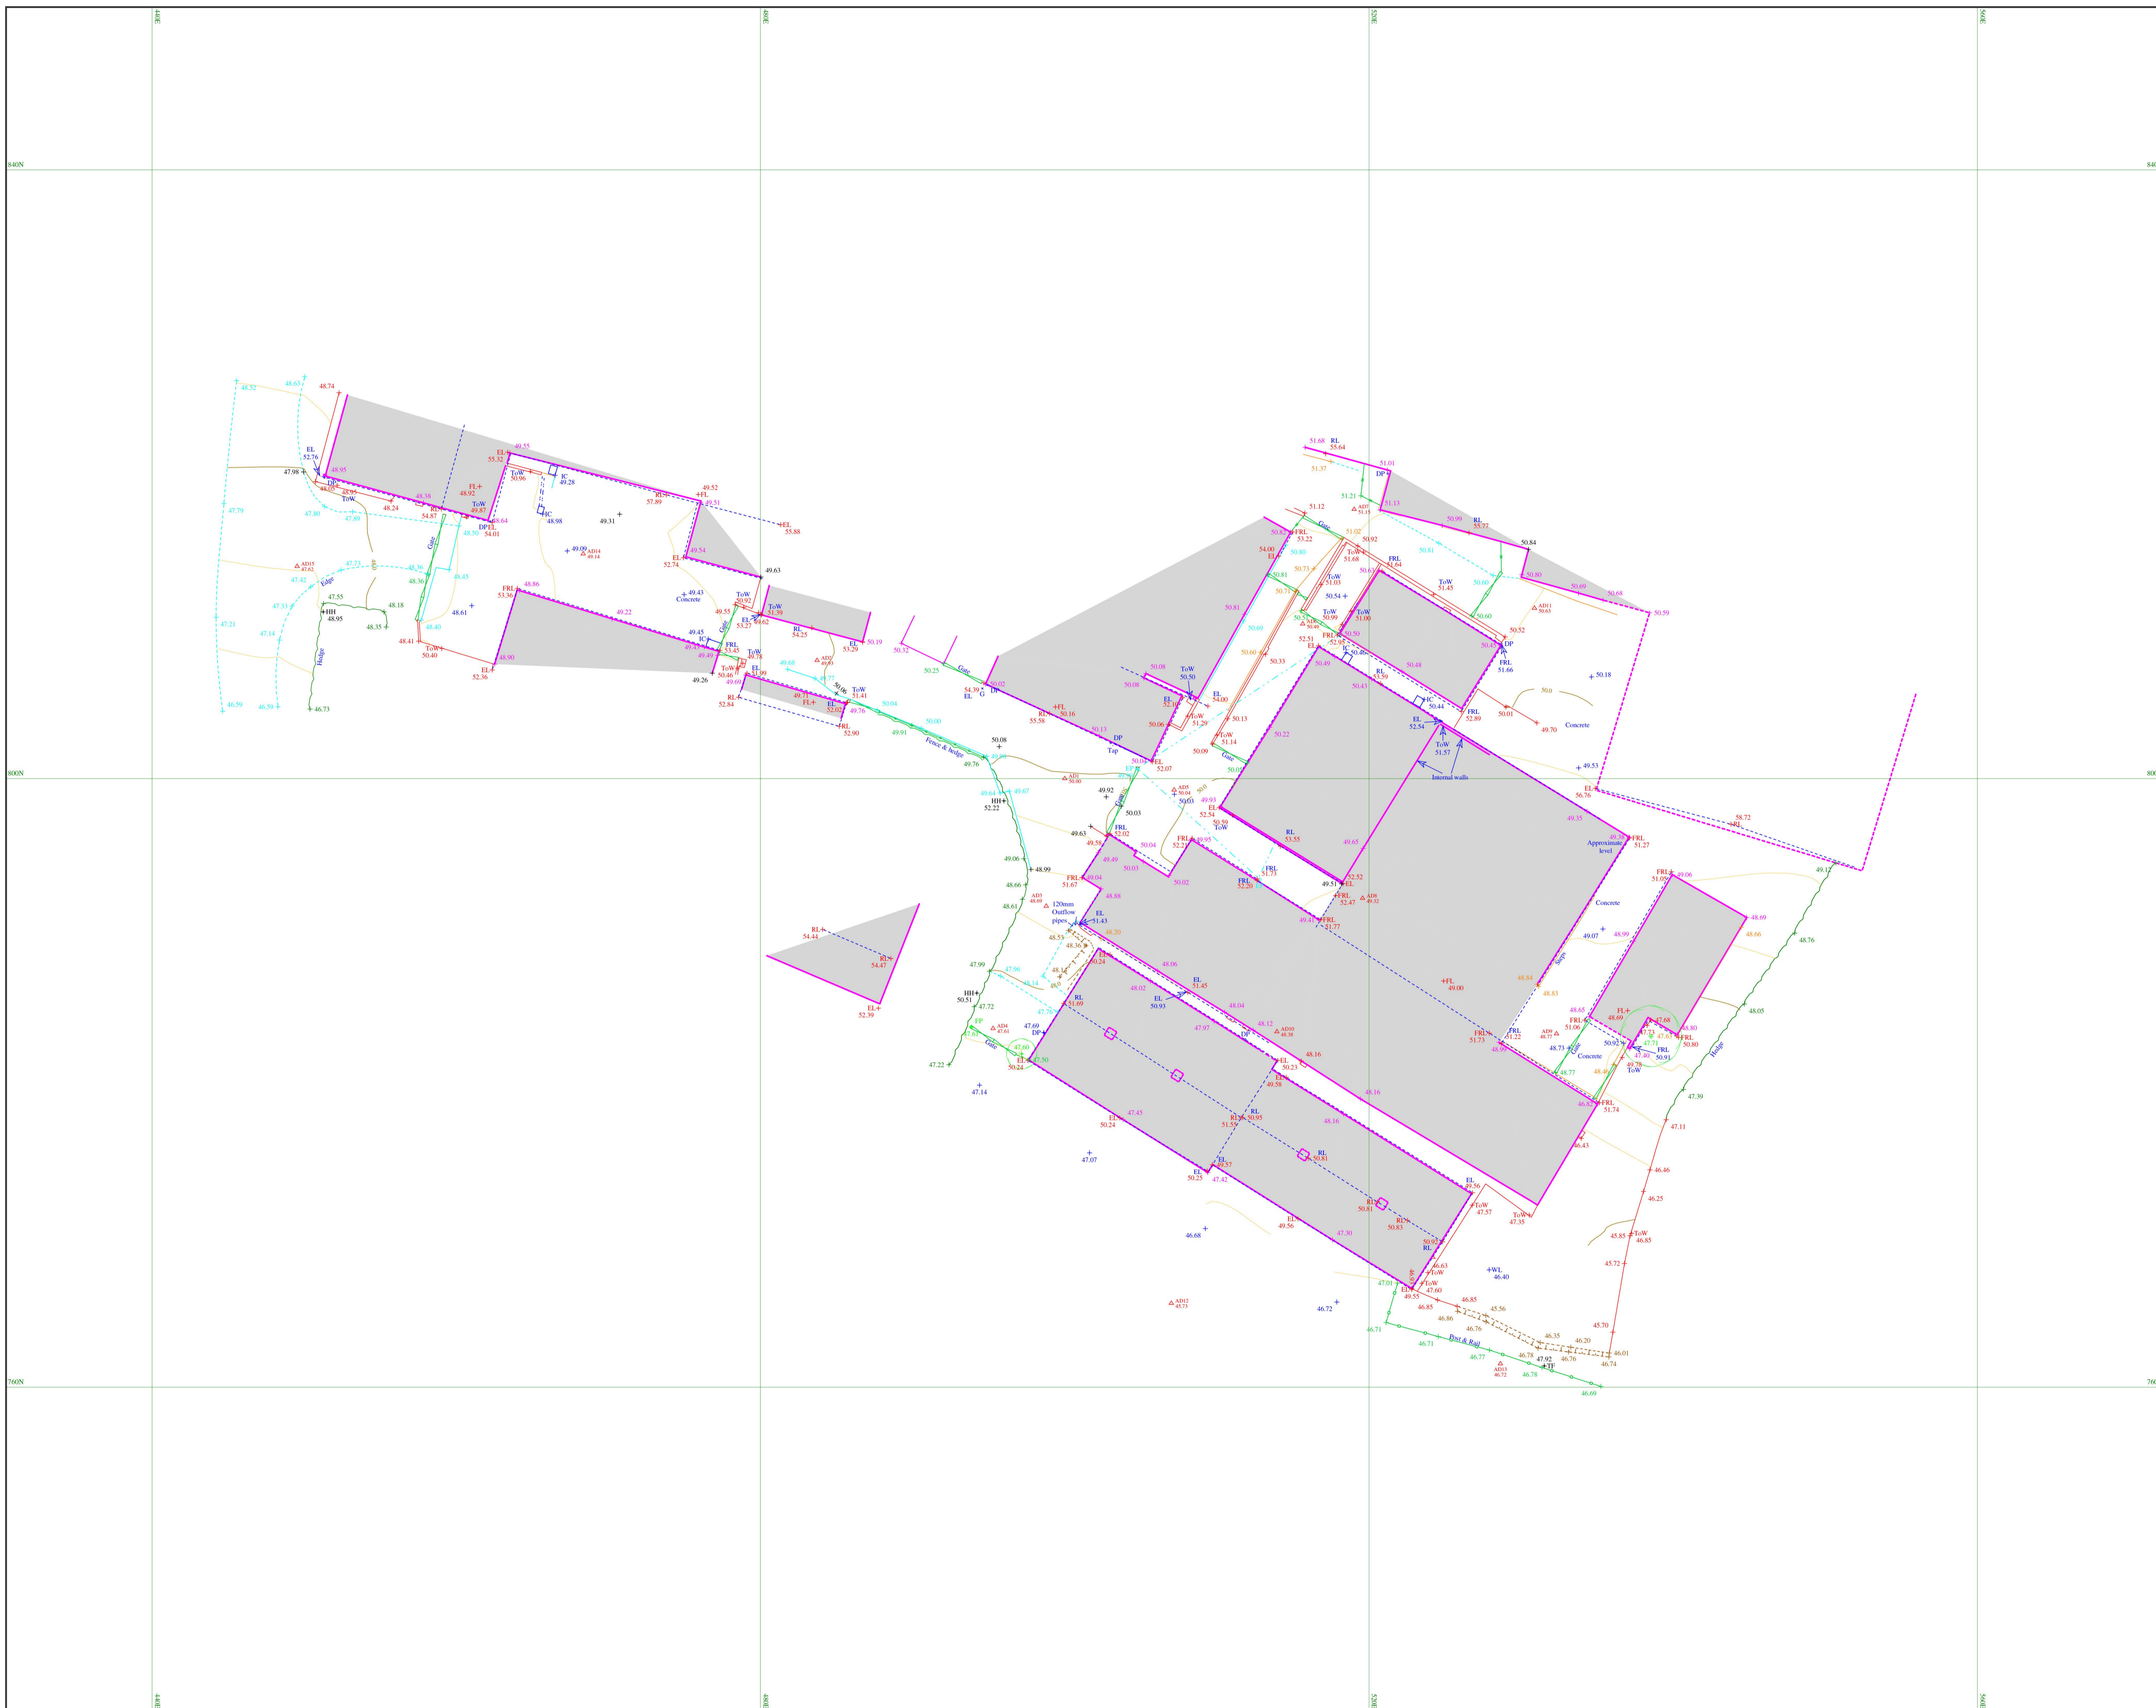
- 1) Survey based on a local coordinate system, oriented on magnetic north.
- 2) Levels based on an arbitrary TBM (Station AD1, level 50.00).
- 3) Kerb levels are taken in channel.
- 4) Features shown on this plan may not delineate legal boundaries.
