Existing South West Elevation

Proposed South West Elevation

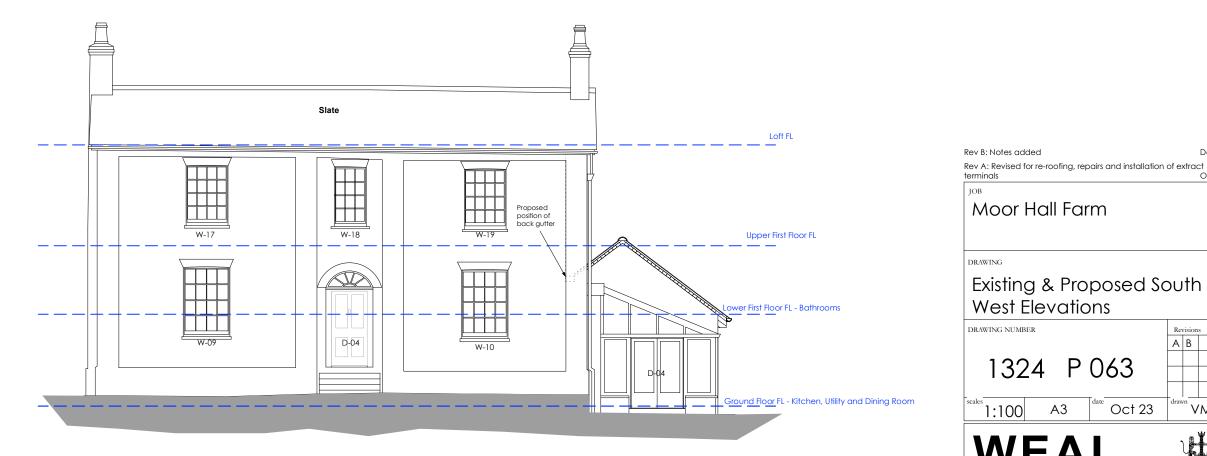
5m Replace rotten fascias and soffits as necessary in species and profile to match existing. NOTE: Maintain bat access into the roof space as identified by the Ecologist if the relevant soffit needs replacing.
