ARBORICULTURAL IMPACT ASSESSMENT AT CHURCH BARN, WASH LANE, WORTHAM

Prepared for Scott Timber Buildings

By A.T. Coombes Associates Ltd.

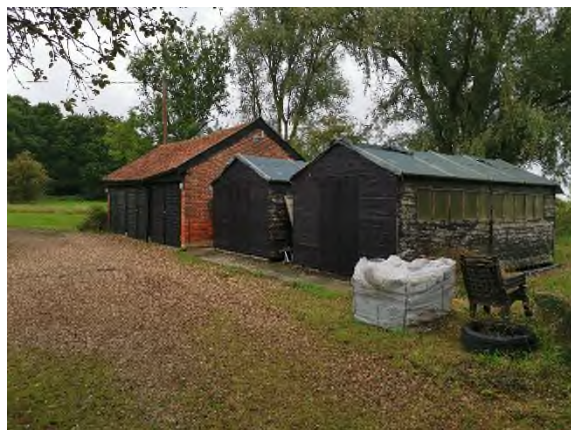
Fig 1: Timber sheds and concrete base

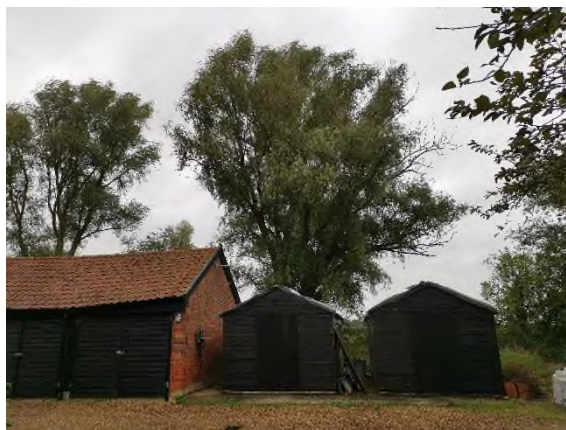
Fig 2: Site, looking north with mature willow

Timber buildings and foundations	<p>The structure's foundations will encroach slightly into the RPA of the category B tree T3 - crack willow, amounting to approximately 10% of the overall RPA of the tree. Therefore, pre-emptive root pruning will be carried out to minimise the damage caused to roots, should they be present. This involves carefully excavating a trench outside the line of the foundations using hand tools or compressed air soil displacement, severing any roots found with a sharp handsaw or secateurs and installing a root barrier. Full details of this work are found in Appendix 5 – Arboricultural Method Statement.</p> <p>Temporary ground protection will be used to minimise soil degradation and compaction where traffic is likely to require access during the</p>

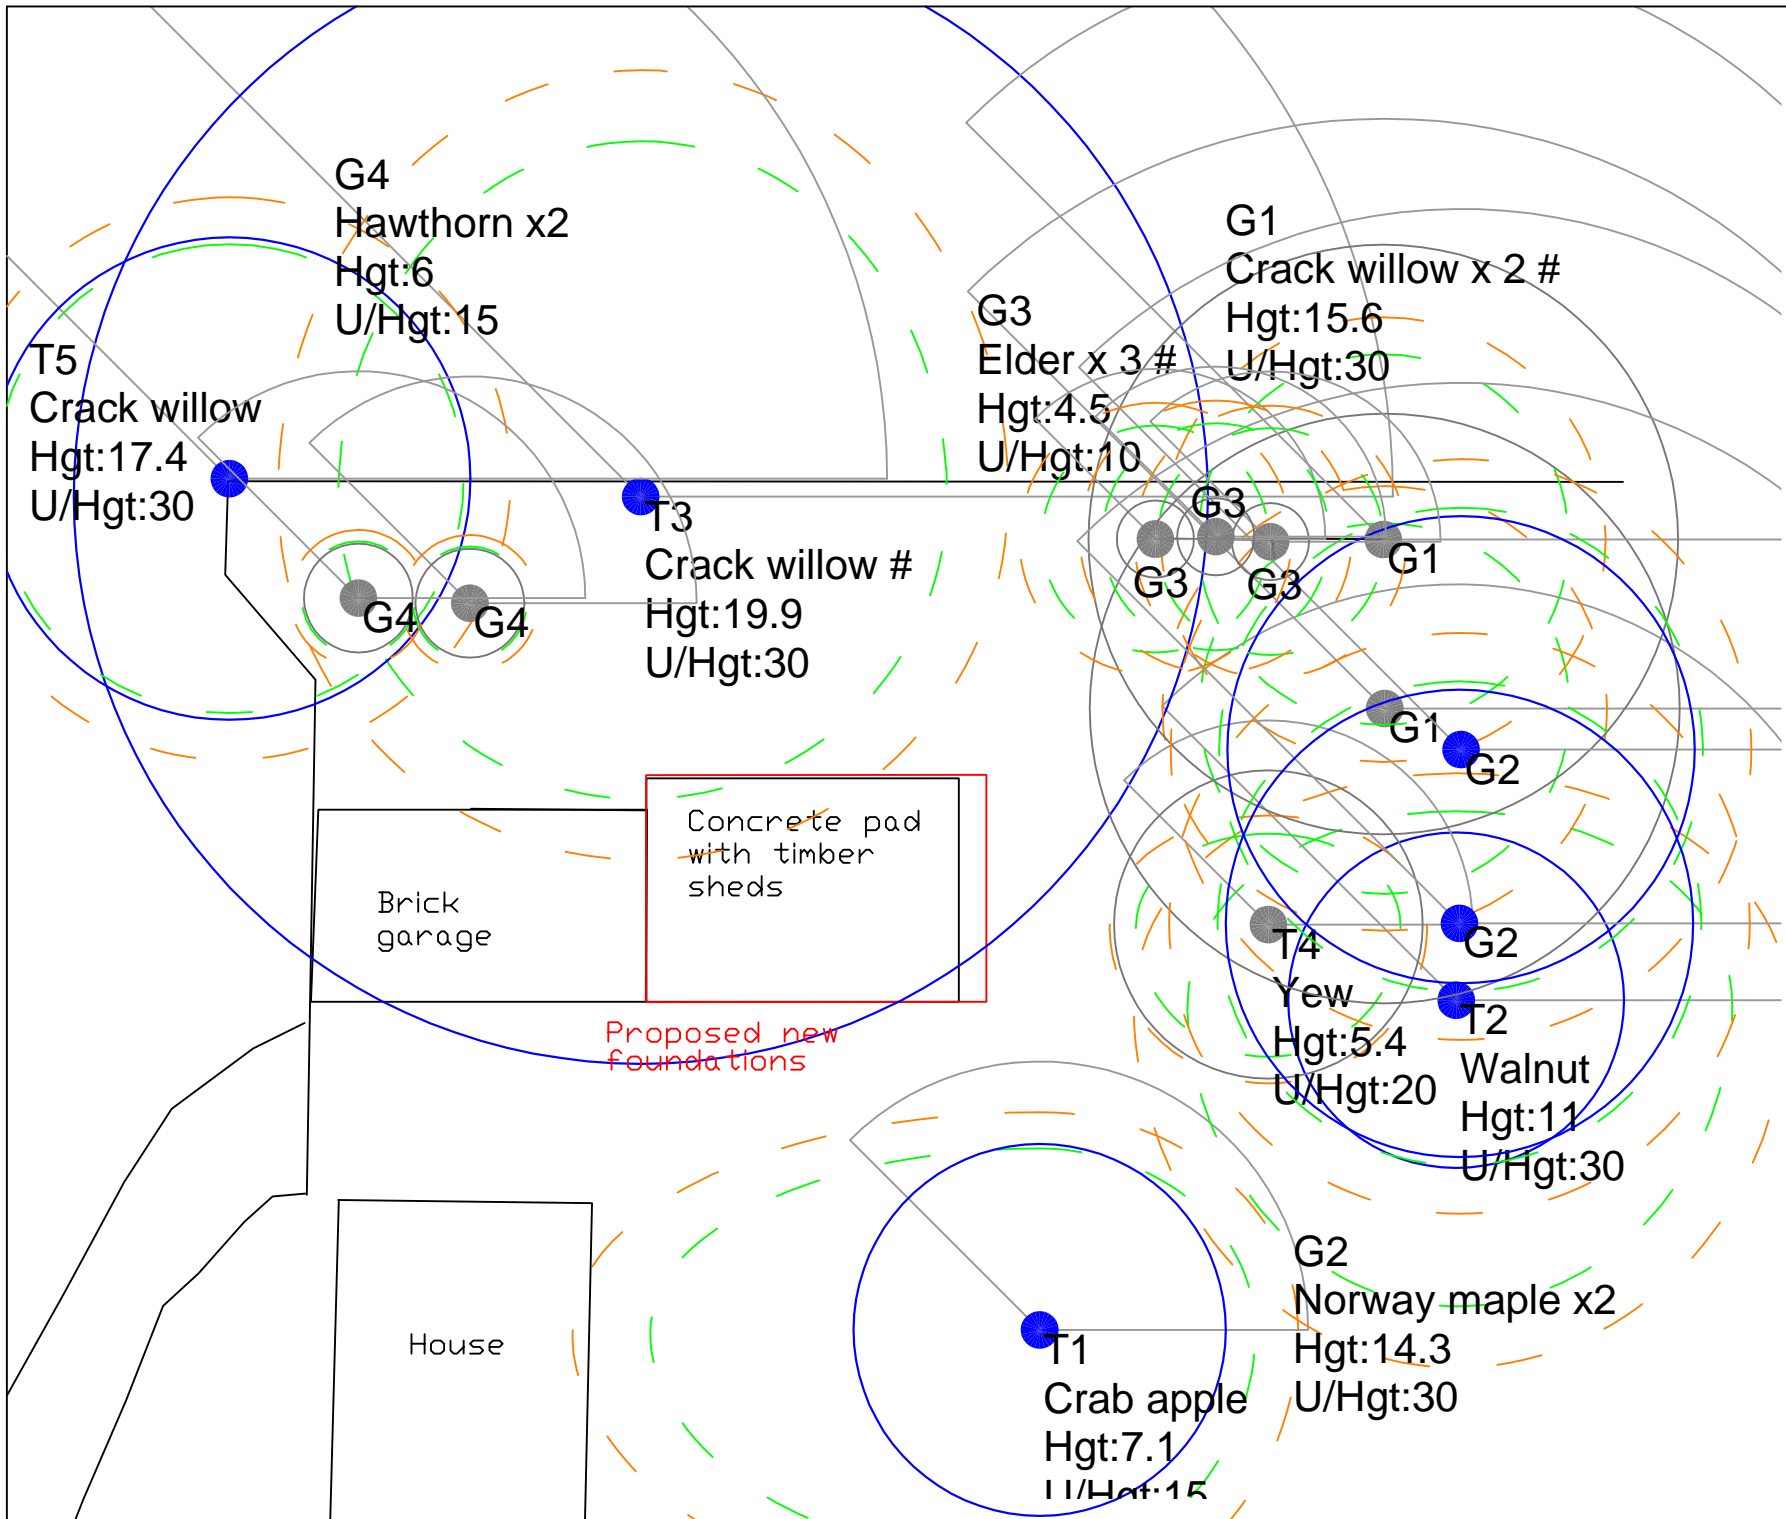
Drawing Title:
 Appendix 3 - Tree Constraints Plan

- 4.1 To facilitate the proper assessment of tree constraints, a Tree Constraints Plan (TCP) has been prepared and forms Appendix 3. The plan has been produced as a basis for the assessment of the constraints imposed by existing trees on the proposed design.
- 4.2 Appendix 3 shows the position of trees marked by a coloured dot matching the retention category status and a reference number (as listed in Appendix 1). Heights (Ht) are marked in metres for each tree, together with the predicted ultimate heights (U/Hgt).
- 4.3 The plan deals with constraints that the trees may place on the development in two areas as follows:

- 4.4 The Root Protection Areas (RPA) for the trees are shown as a coloured circle to match the retention category colour. The RPA will be used to help inform the closest positions of any future buildings. The RPA will be protected during any development work with temporary barriers as prescribed by the British Standard.

- 4.5 The branch spreads were measured at the four cardinal compass points, with a shape drawn around these points to indicate approximate branch spread, represented by green broken lines on the plan. The ultimate crown spread has been shown with an orange dashed line. This is a predicted distance based on personal experience of how far it is likely the crown will grow.
- 4.6 A shade pattern has been shown for each tree forming an arc from northwest to due east. This gives an indication of the patterns of shadows created by the trees around mid-day in the summer. This is as recommended in BS5837:2012 (Section 5.2.2) but actual shade patterns throughout the year will vary widely. If shading is likely to be a serious constraint a more detailed analysis of shade pattern using proprietary software may be deemed necessary.

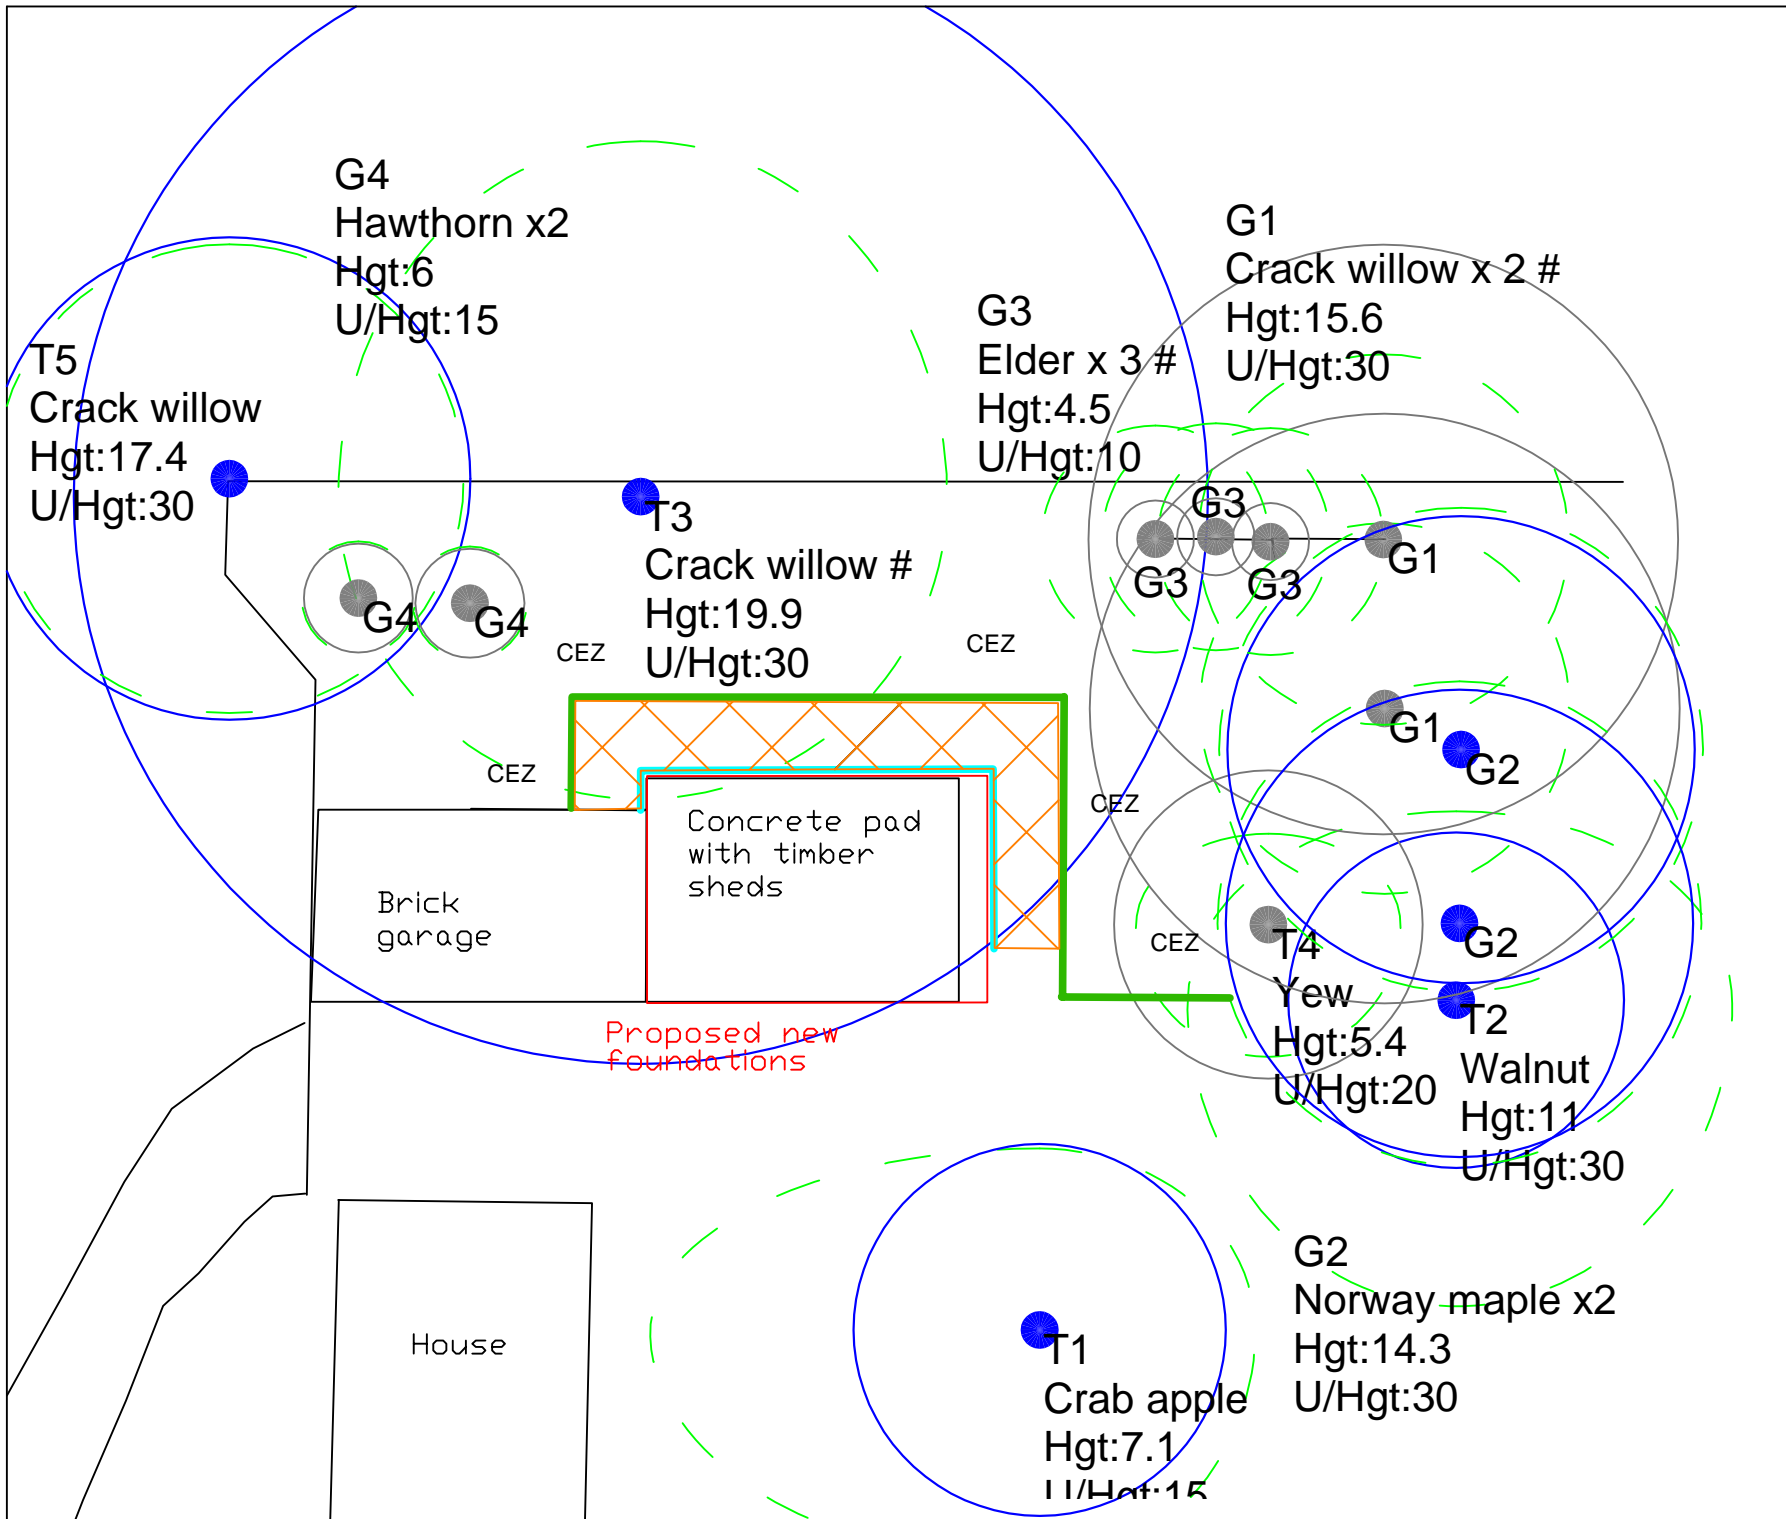
Appendix 4 - Tree Protection Plan

- 3.1 Remaining trees will be protected by forming Construction Exclusion Zones (CEZ) as shown on Appendix 4 the Tree Protection Plan (TPP).
- 3.2 Temporary barriers will be erected as shown by the thick green lines on the TPP to form the Construction Exclusion Zone (CEZ). The barriers will consist of 2m tall welded mesh panels (Heras) supported on rubber or concrete feet. The fence panels should be joined together using a minimum of two anti-tamper couplers installed so they can be removed from the inside of the fence. The distance between couplers should be at least 1m and be uniform throughout the fence.

- 5.1 Temporary ground protection will be required as shown on the TPP with orange crosshatching. The ground protection should be constructed as follows depending on the type of traffic that will use it:

- 6.1 Pre-emptive root pruning will take place just outside foundations of the new <Insert more text> to minimise injurious damage to the root system of the neighbouring trees whilst excavating. The position of this work has been shown as a thick light blue line on Appendix 4 – TPP.

Element	Detail
<p>Timber buildings and foundations</p> <p>cont.</p>	<p>construction process. This is shown on Appendix 4 – TPP as orange crosshatch and detailed further in Appendix 5 – AMS.</p> <p>The timber structure will be close to the current branch spread of T3, which will need facilitative crown pruning to provide clearance between the outer branches and the new building and provide sufficient clearance for construction works. The amount of pruning will be agreed with the consulting arboriculturist and carried out prior to the commencement of construction works.</p>
<p>Services and soakaways</p>	<p>No details of any new service runs have been provided. They should be routed to avoid the RPAs of trees. If this is not possible, special techniques must be employed to place the services within the RPA of the trees. The British Standard suggests a range of trenchless methods suitable for various applications including microtunnelling, surface launched directional drilling, pipe ramming and impact moleing/thrust boring. It is important common ducts should be used where it is not possible to avoid the RPA. Further guidance on installing underground services adjacent to trees can be found in the NJUG Guidelines for the Planning, Installation and Maintenance of Utility Apparatus in Proximity to Trees (Volume 4 Issue 2). This document outlines a number of techniques that may be used for trenching near trees, including trenchless techniques, discontinuous trenching and hand digging.</p> <p>It will be necessary to prepare detailed plans for any services that run through the RPA of retained trees. This should be produced in conjunction with an arboriculturist and include allowance for the space needed for access for the installations, and the levels across the proposed area.</p> <p>Any above-ground apparatus including CCTV cameras and lighting should also be positioned to avoid the need for any regular or detrimental pruning to the trees. Minor facilitative pruning is acceptable. However, positions that require repetitive and significant tree work must be avoided.</p>

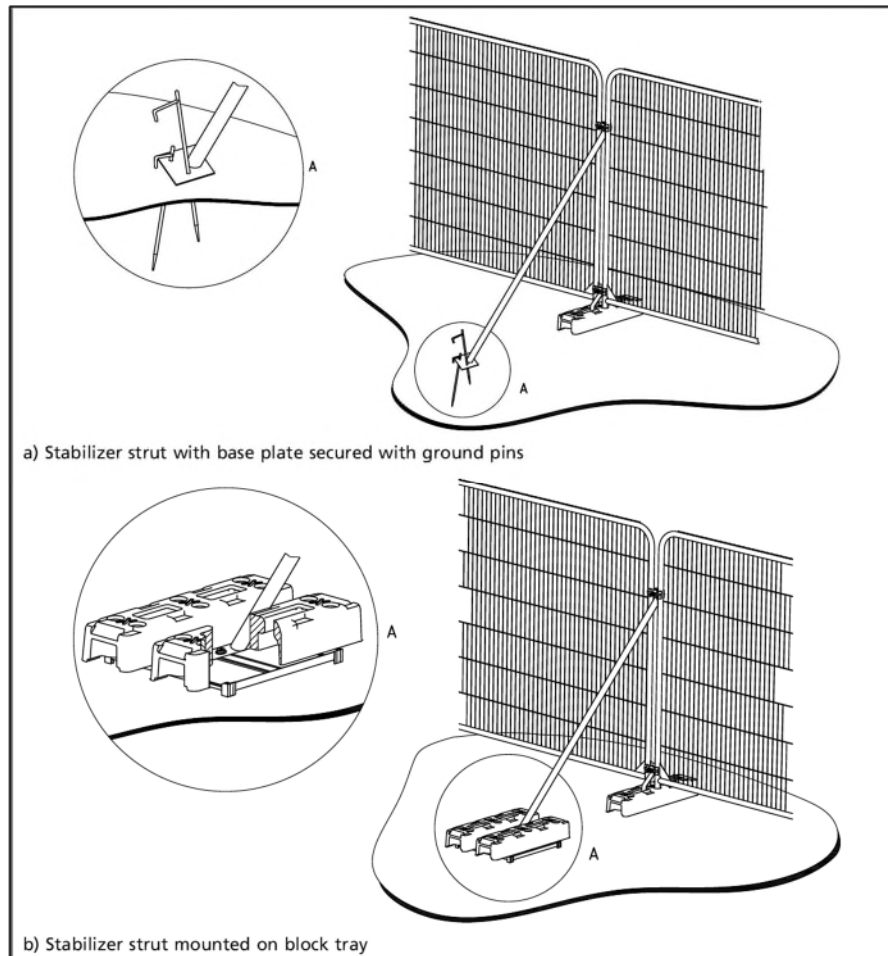
Fig 1: Temporary protective fencing as recommended by the British Standards (2012).

- 3.4 Figure 1 is an extract from BS5837:2012 showing the method of supporting the panels with ground pins and a block mounted tray for use on hard surfaces. Stabiliser struts should be fitted at each panel junction.
- 3.5 At least FOUR all-weather notices should be erected on the barriers forming each CEZ stating “Construction Exclusion Zone – No Access “. These should face outwards towards the work area. Signs must be maintained in good condition and remain in place until completion of the works.
- 3.6 Barriers will be maintained throughout the duration of the works, ensuring that access is denied to the CEZ throughout the process.

- 3.3 Panels should be supported on the inner side by stabilizer struts which should normally be attached to a base plate and secured with ground pins. Where the fence will be erected on hard surfacing, or it is otherwise unfeasible to use ground pins the struts should be mounted on a block tray.
