Alterations to Shop at 3 High Street, Clare

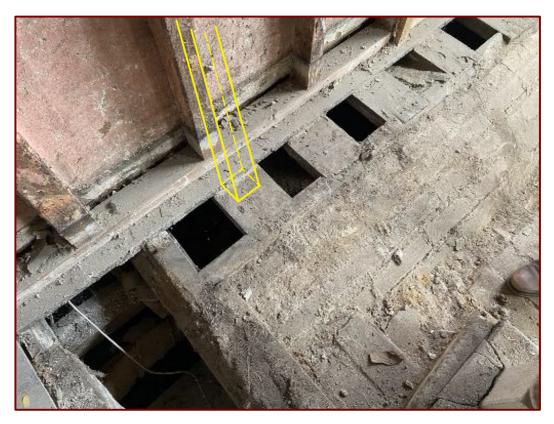
Exposed floor over edge of Cellar indicating position of new 80×80 SHS post conflicting with existing floor joist - steel post is to continue down to pad foundation at Cellar floor level.

The proposal is to sever the joist end from the floor trimmer flush with the adjacent partition soleplate and to resuppoort the joist end on a steel plate welded to the post or a steel angle bolted to the post to provide min. 75mm end bearing to the joist.

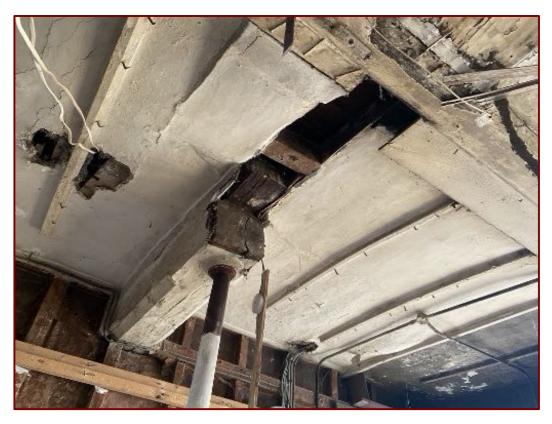
False boxing to beam end now removed indicating historic cut to beam. Original beam above can now be seen - this has also been cut short of the original beam bearing and the floor structure infilled.
