# ARBORICULTURAL SURVEY, IMPACT ASSESSMENT AND PROTECTION PLAN

NEW RESIDENTIAL DEVELOPMENT AND  
ASSOCIATED ACCESS

LAND OFF FIRS CLOSE, BLEDDINGTON

DMD GROUP

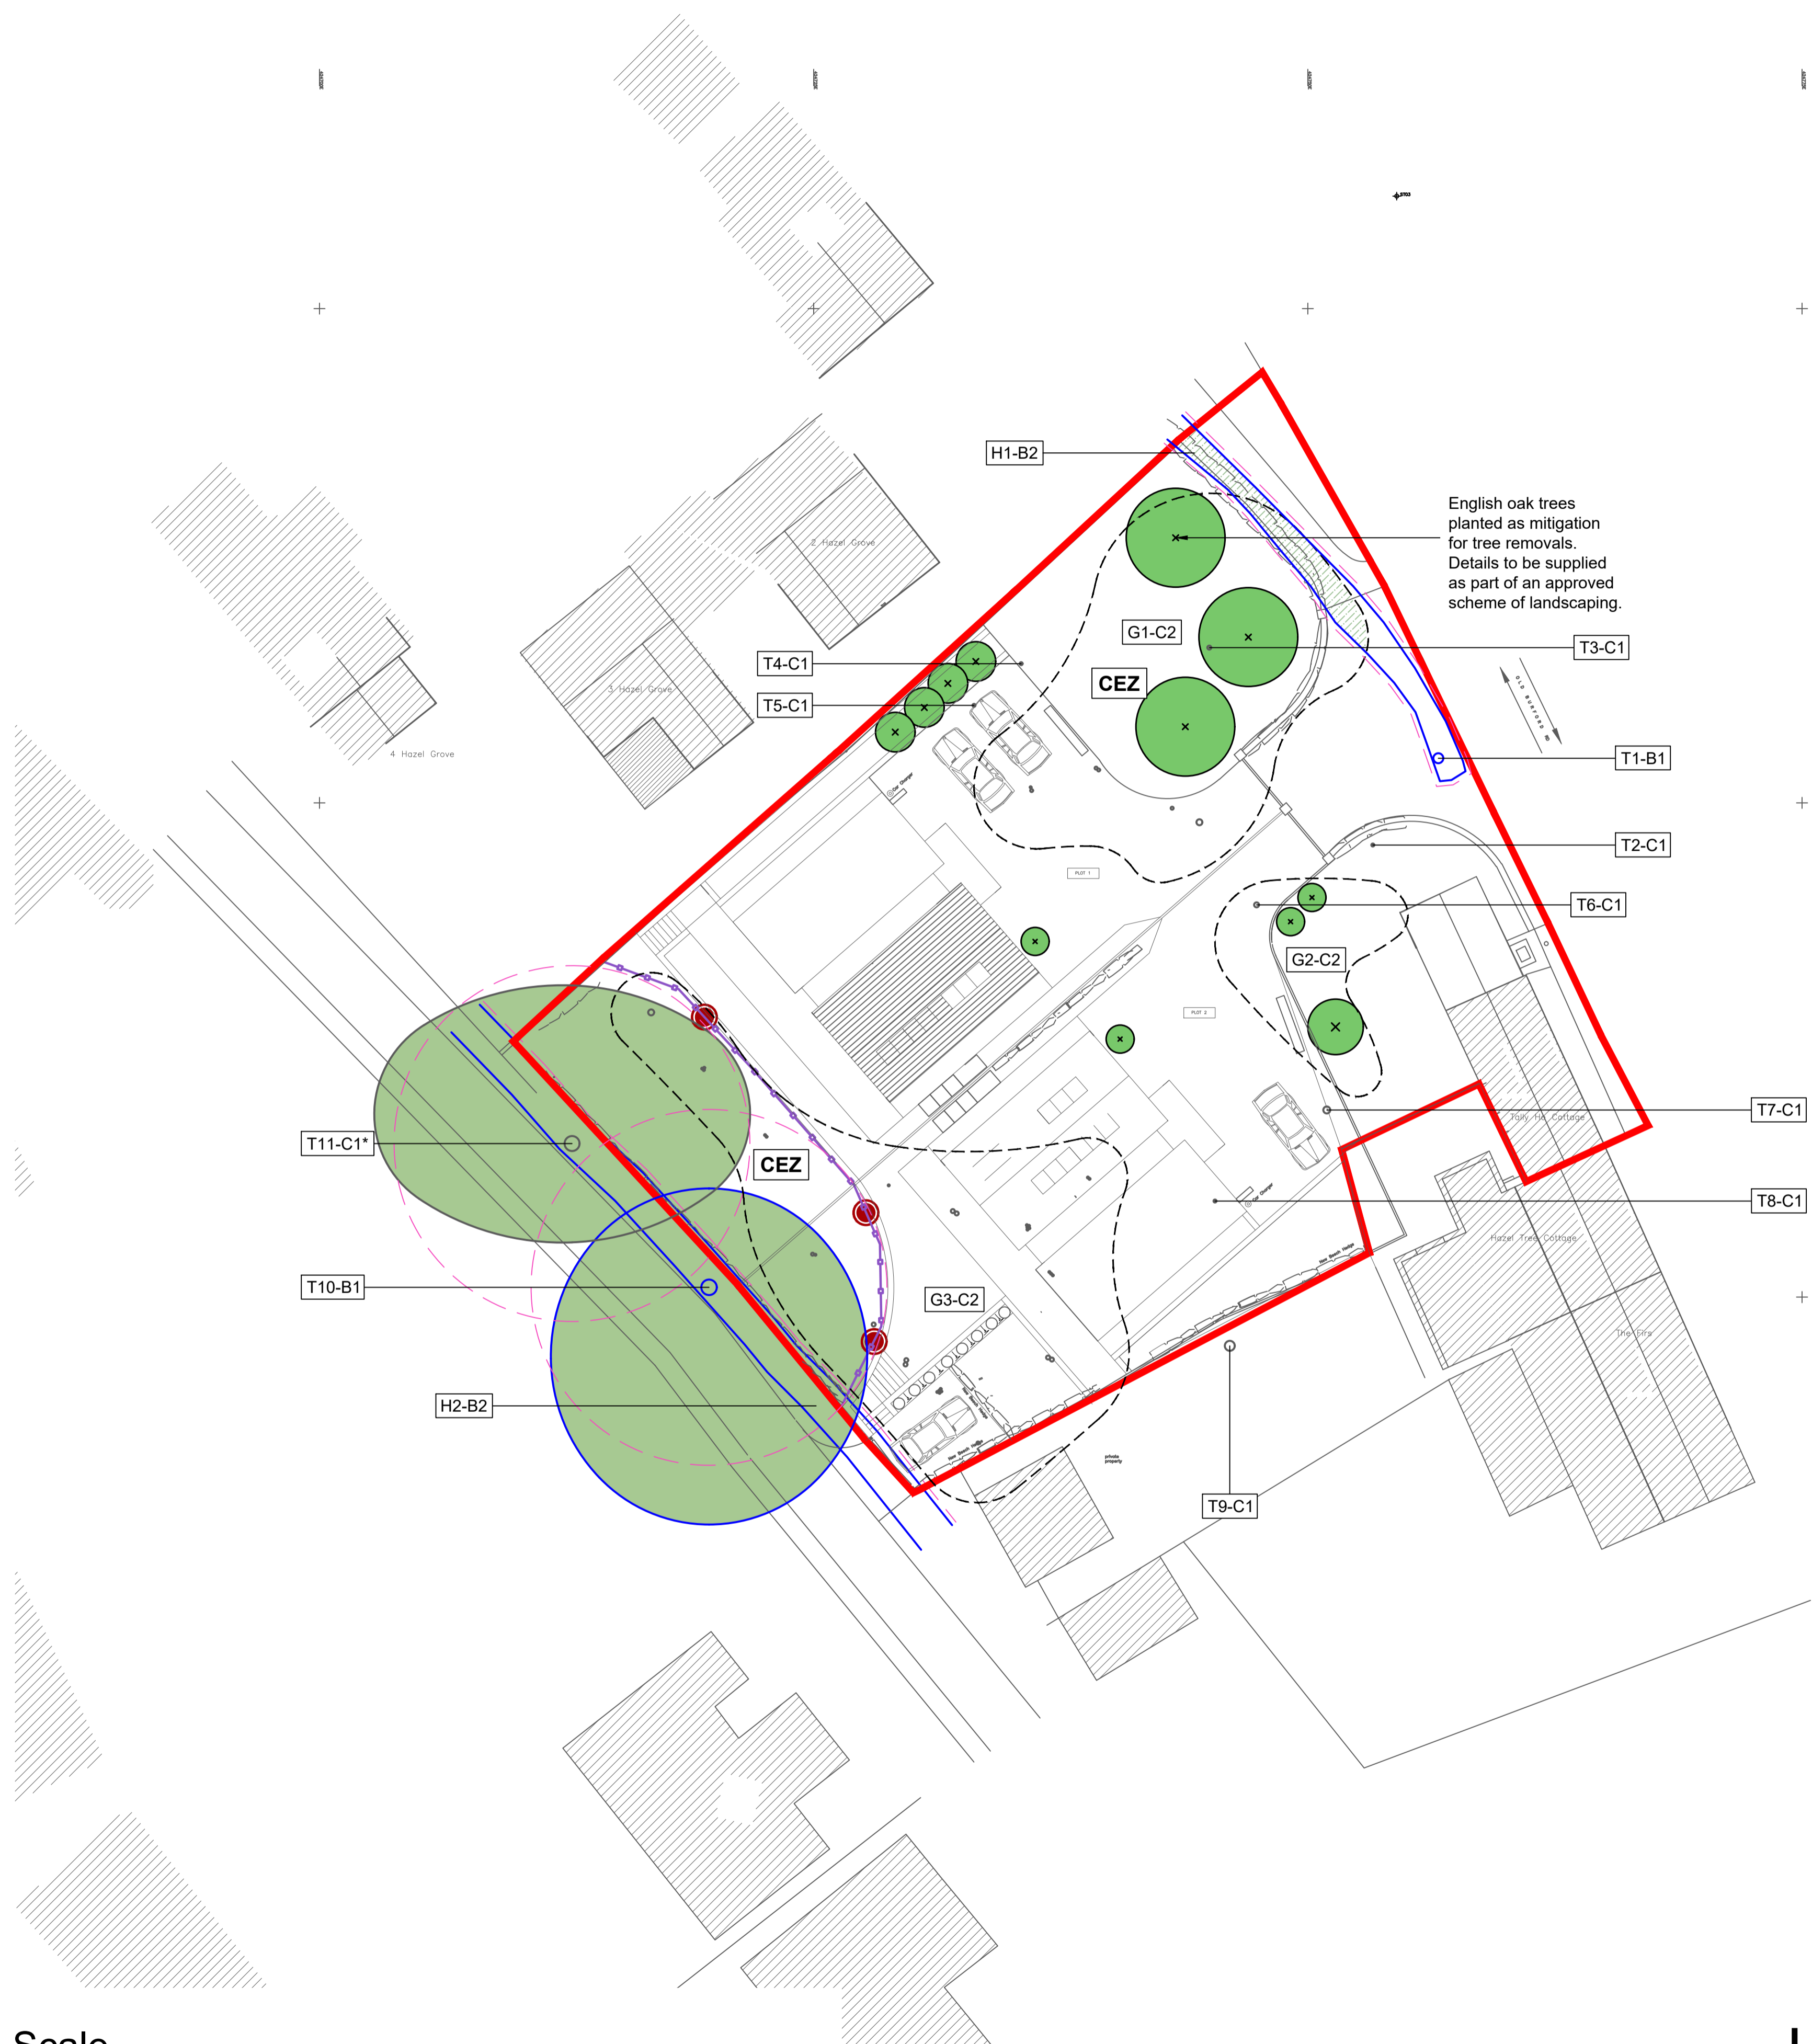
Drawing number: 23189.502 Rev: C

- 5.1.1 A combined AIA and TPP is included at **Appendix 2**.
- 5.1.2 The plan shows the tree survey and constraints information in relation to the proposed layout and confirms that several existing trees must be removed.

- 5.2.1 The Tree Protection element of the plan demonstrates how retained trees can be effectively retained as part of the construction of the proposals.
- 5.2.2 Locations and specifications of tree protection barriers are provided.
- 5.2.3 Tree protection barriers must be put in place before any other work is carried out on site and remain in place for the duration of construction works.

- 5.1.3 Most of the trees to be removed are low quality specimens within the site interior that do not enhance public visual amenity. In my opinion, the removal of these trees will not be detrimental to the character of the area.

- 5.1.4 T1 sycamore must also be removed. This is a larger tree that is situated next to the road and which makes a positive contribution to the local street scene and visual amenity.

- 5.1.5 Although in this sense, the removal of the tree will have a noticeable adverse visual impact, I think that it is important to consider the tree's removal 'in the round.' In my view, in the longer term the tree is likely to become a substantial management liability due to its potentially very large size and risk management in relation to the users of the road. The multi-stemmed nature of the tree means that there is long-term potential for weakness at the unions between the trunks as they become longer and heavier with increased 'lever arm' effect. In this sense, the tree is arguably unsuitable for long-term retention and its removal and replacement with a more sustainable specimen is a legitimate management option.

- 5.1.6 In a wider 'planning mix' context the need for local housing may need to be weighed against the value and long-term viability of this tree.
- 5.1.7 I have indicated new tree planting on the plan and anticipate that full details can be covered off as part of an approved scheme of landscaping.

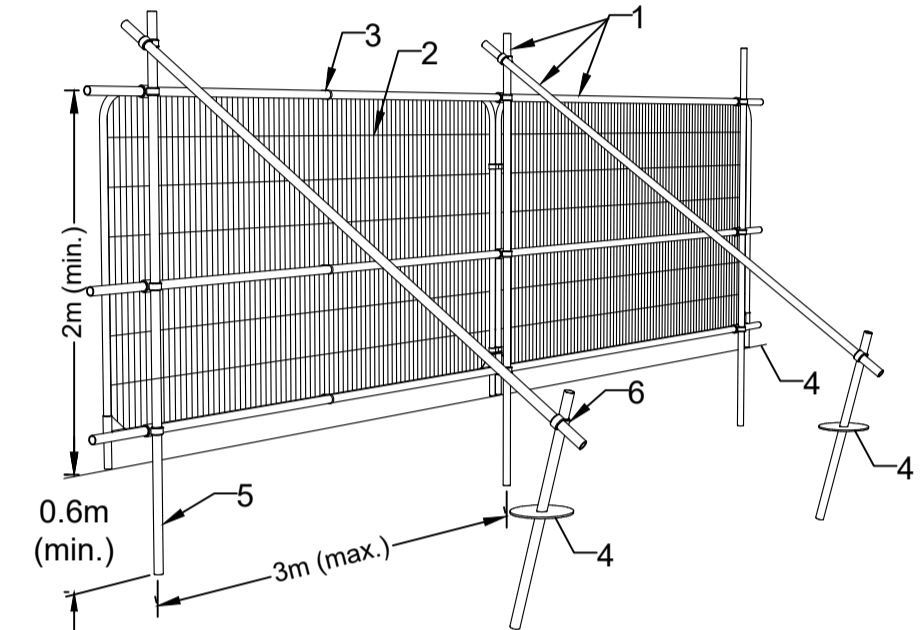
**Protective Barrier**

- Key**
1. Standard scaffold poles
  2. Heavy gauge 2m tall galvanised tube and welded mesh infill panels
  3. Panels secured to uprights and cross-members with wire ties
  4. Ground level
  5. Uprights driven into the ground until secure (minimum depth 0.6m)
  6. Standard scaffold clamps
