Re: Development at Laneside Farm, Morley

Further to your request we have attended the above site to undertake an inspection of the gas membrane to confirm that the quality of the installation is satisfactory in Blocks 2-4 at the above site.

Inspection Checklist

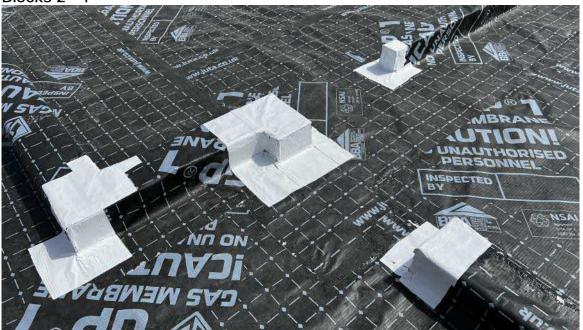
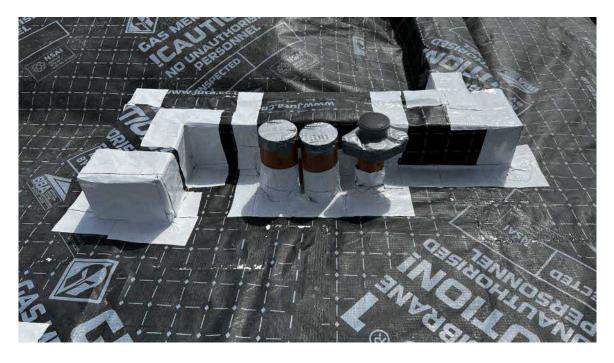
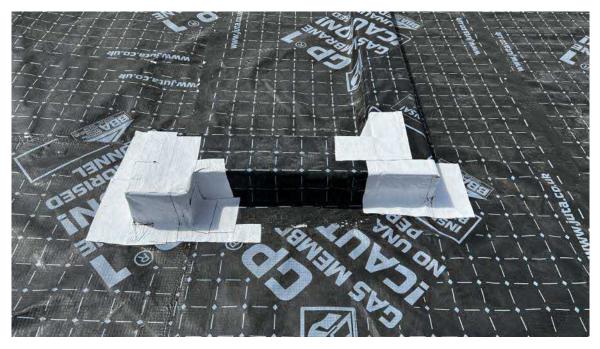
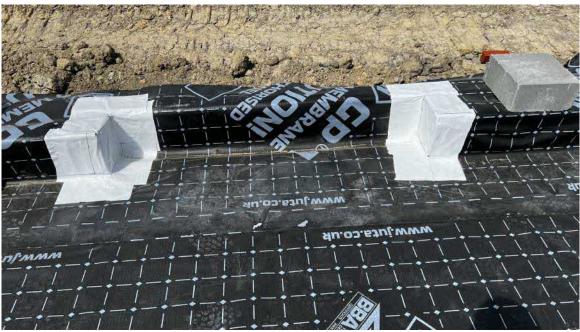
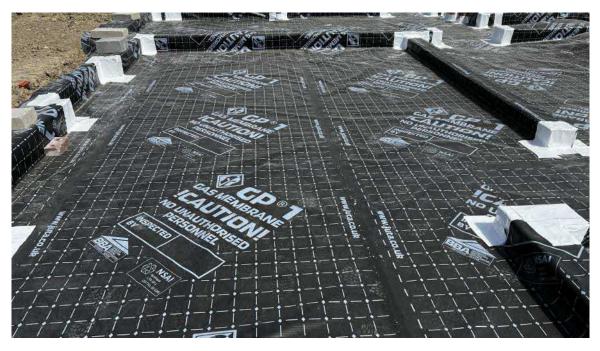
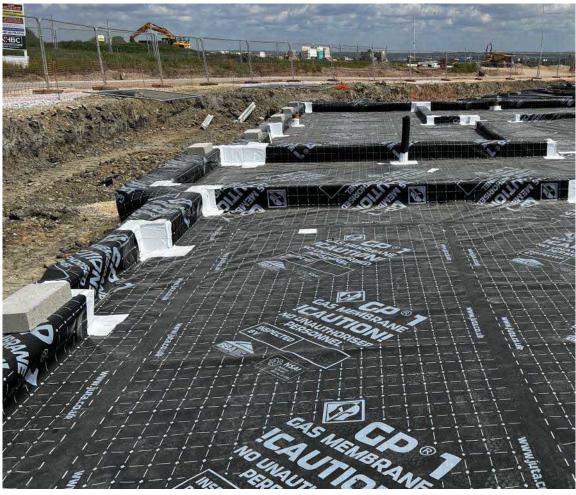
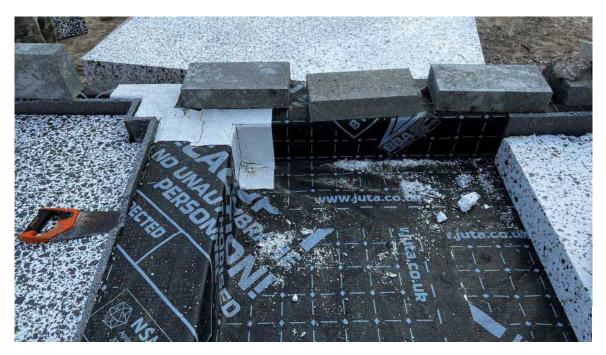
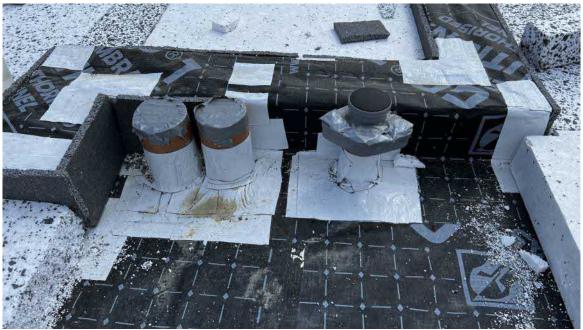
Blocks 2-4

Blocks 2 –4 at the above development have been inspected in accordance with the above procedure. Initial inspections on site found the membrane installation to be satisfactory, with no repair works being required on these plots.
