**23/01937/HOUSE - PROPOSED TWO STOREY EXTENSION FOLLOWING  
DEMOLITION OF SINGLE STOREY LEAN TO AND GARAGE**

**24 ST GEORGES VIEW, CULLOMPTON, EX15 1BA.**

Wildlife Trigger Table Statement

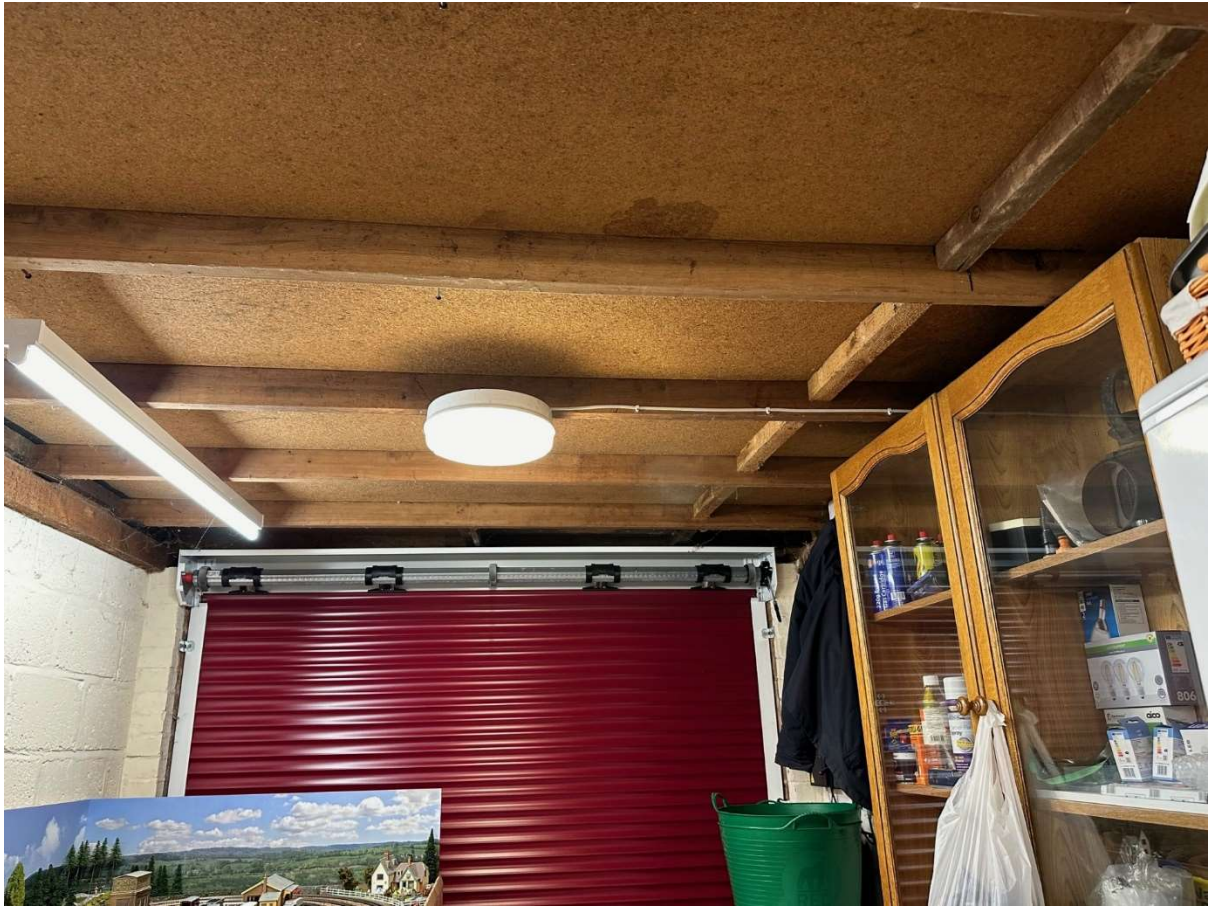
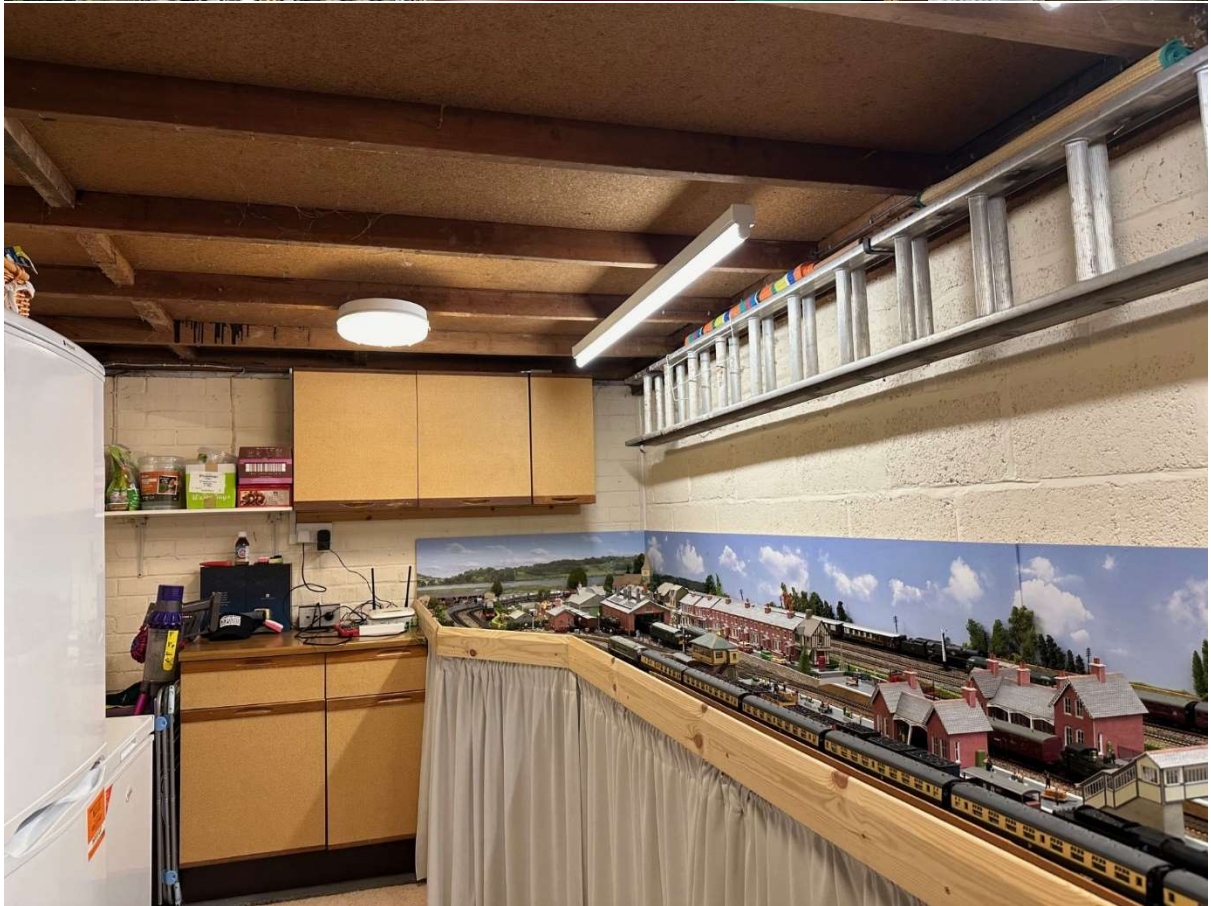
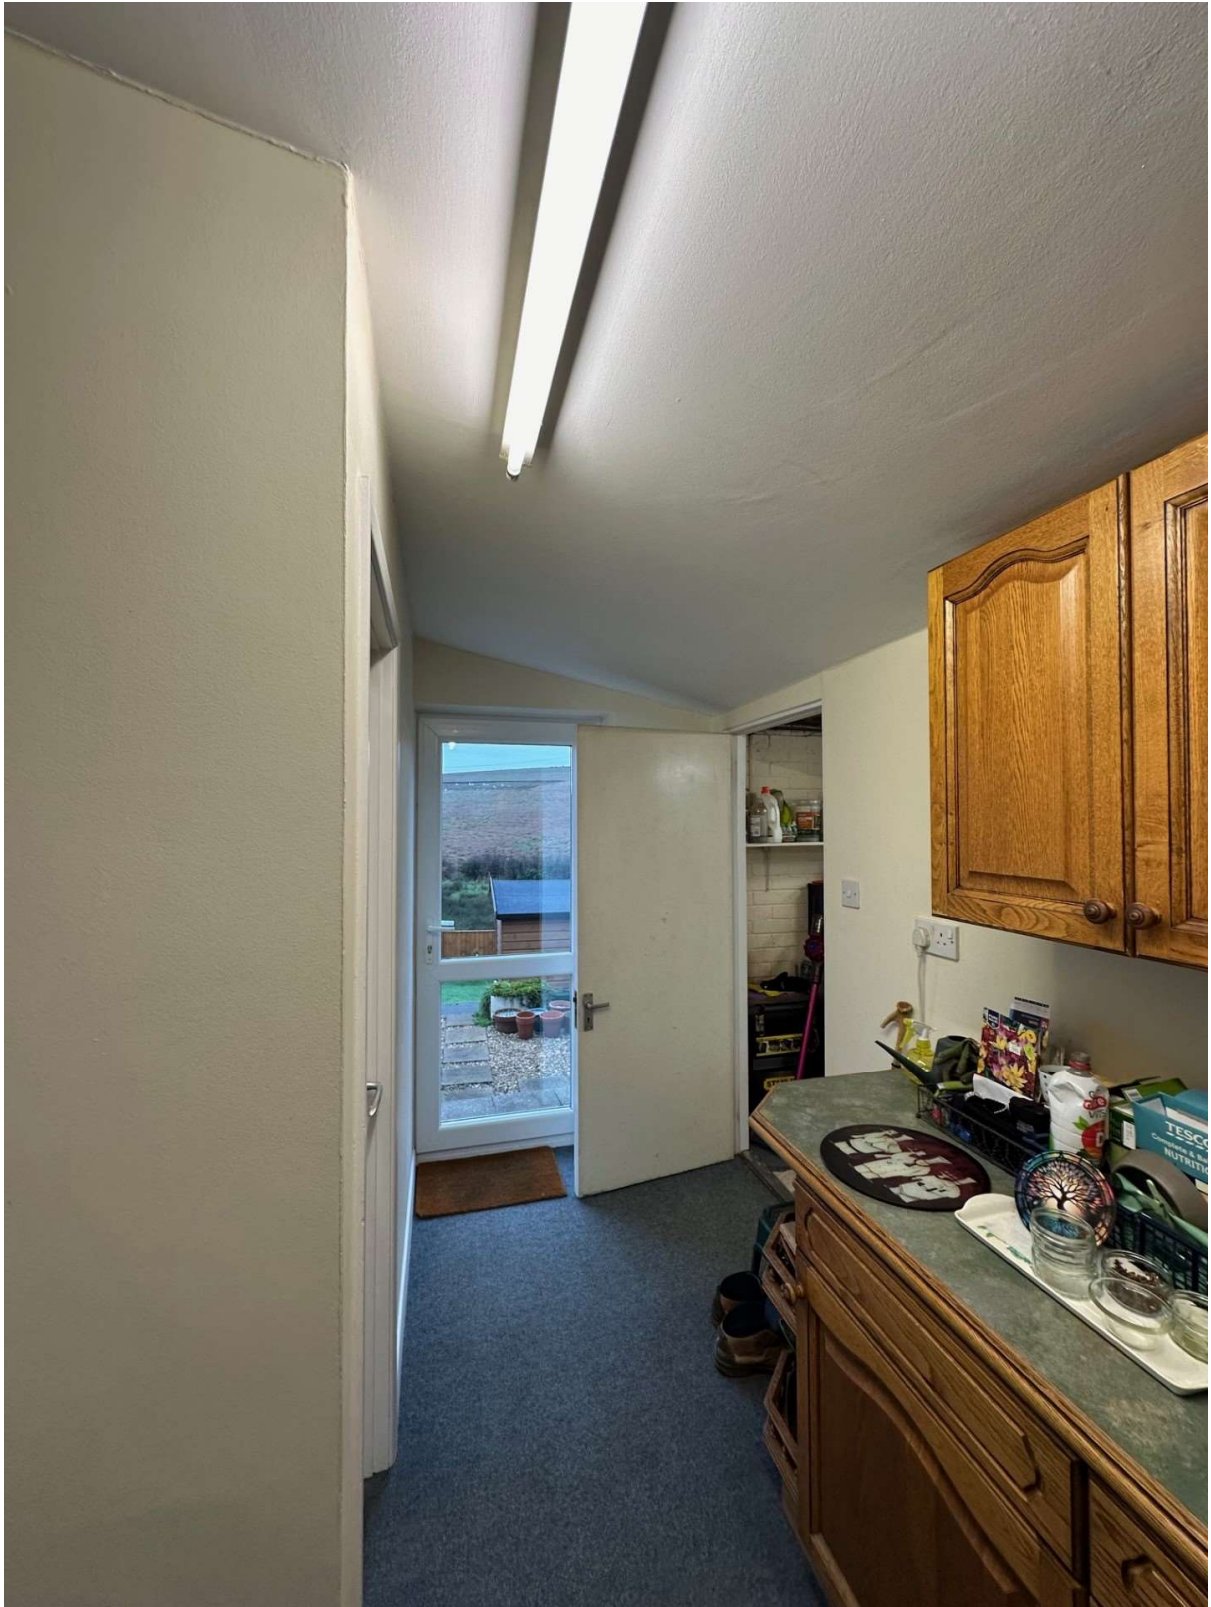
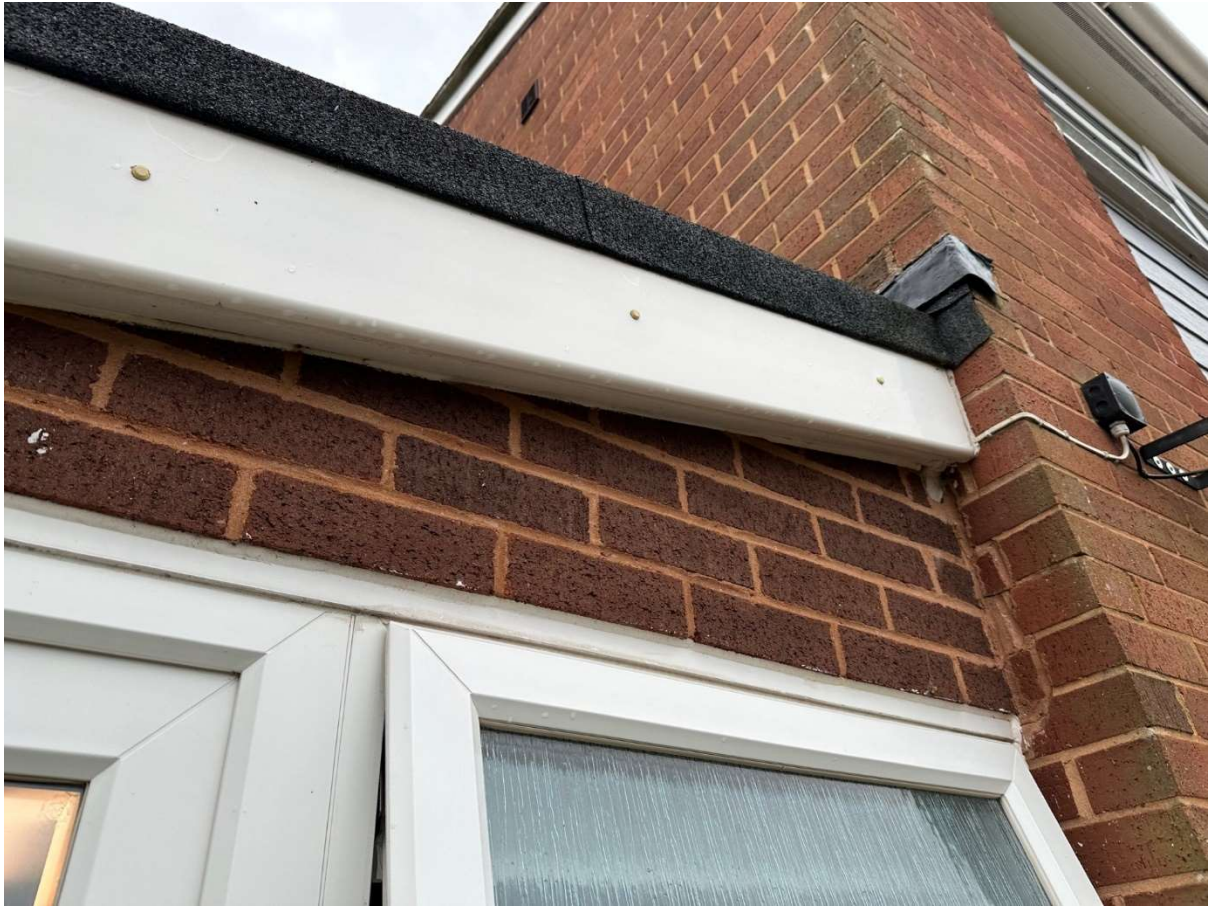
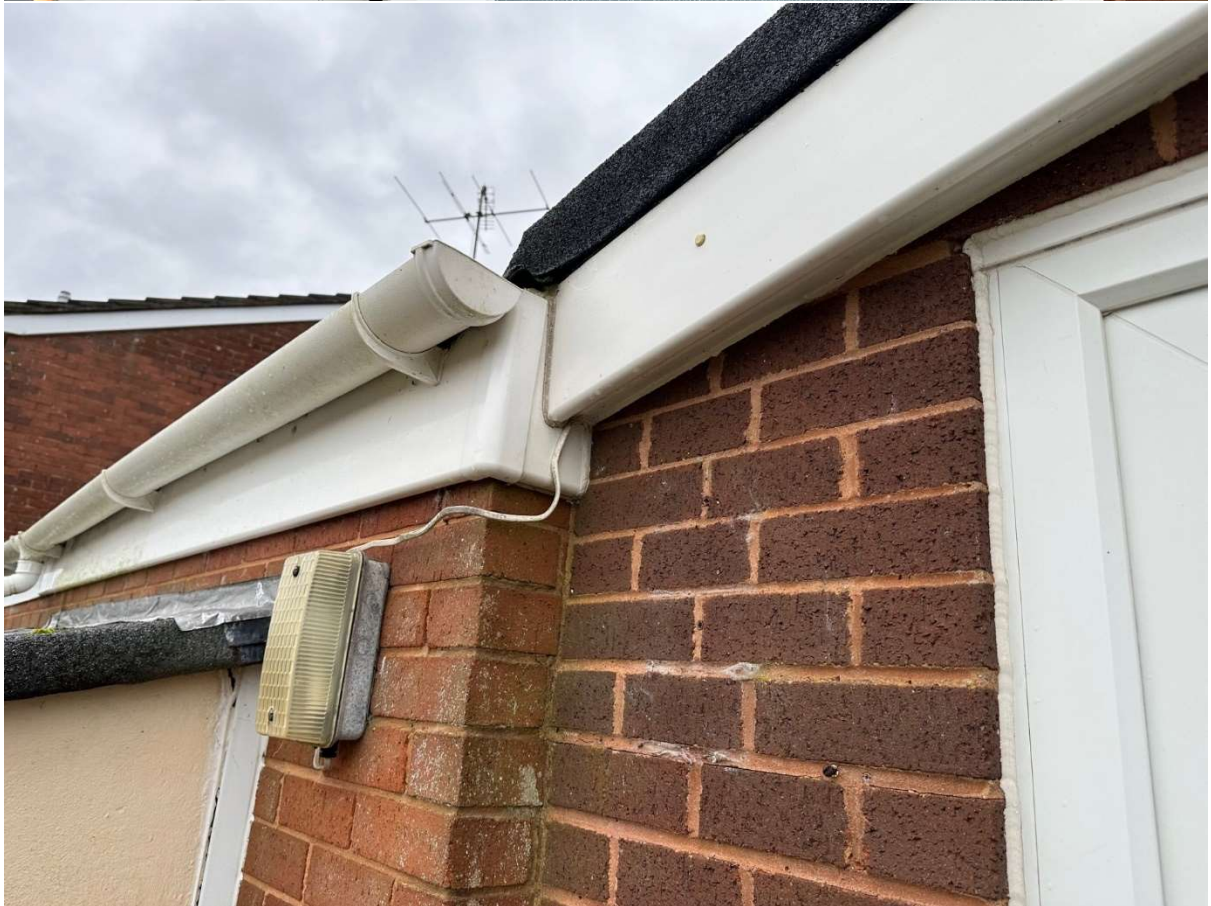
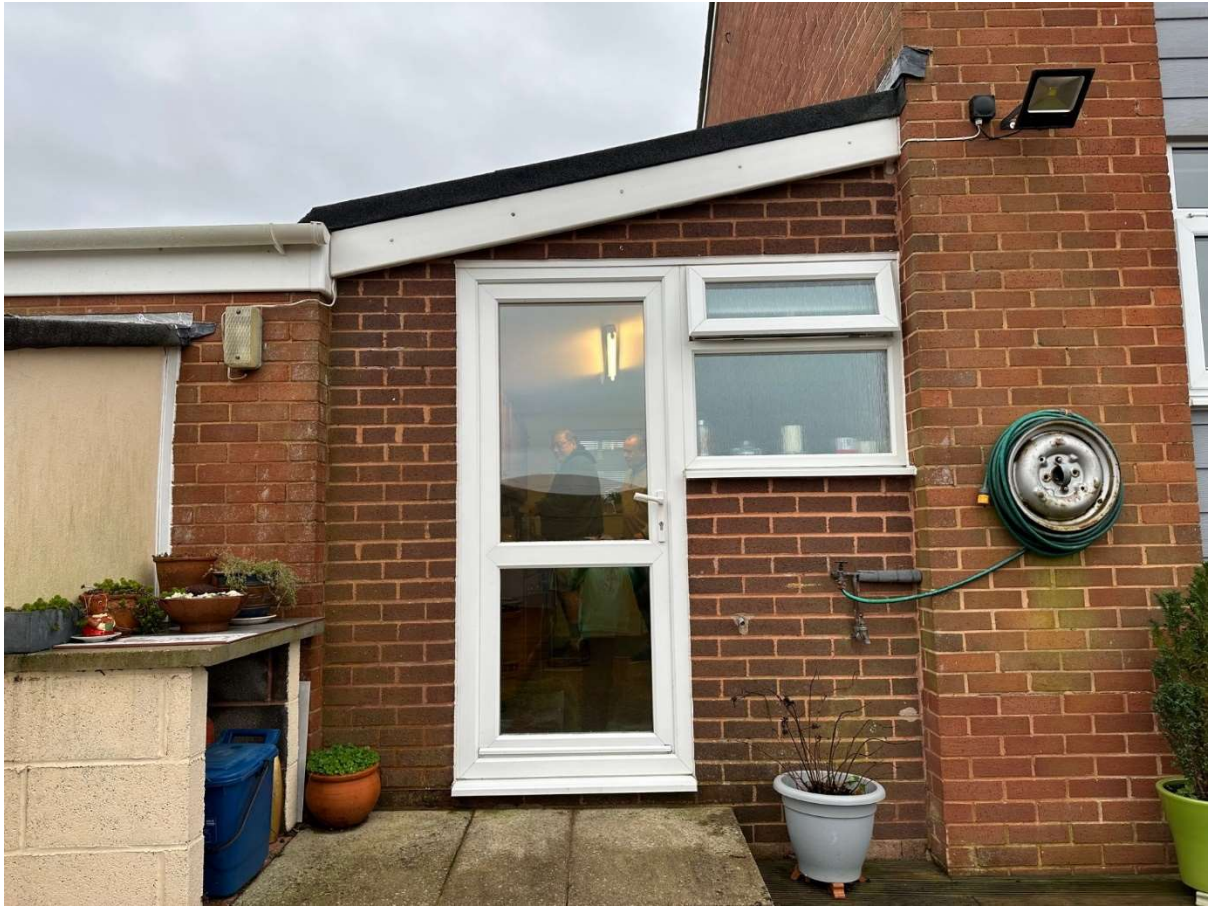
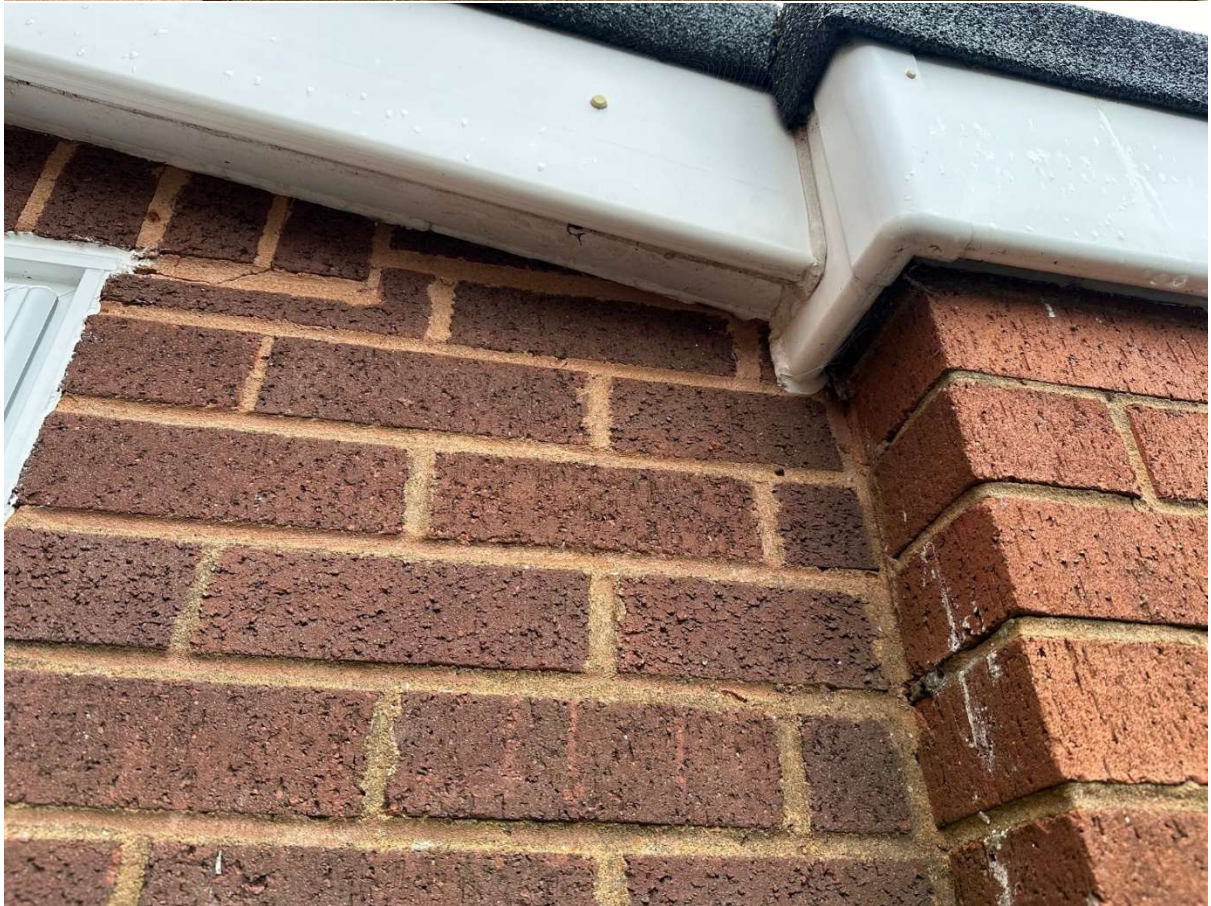
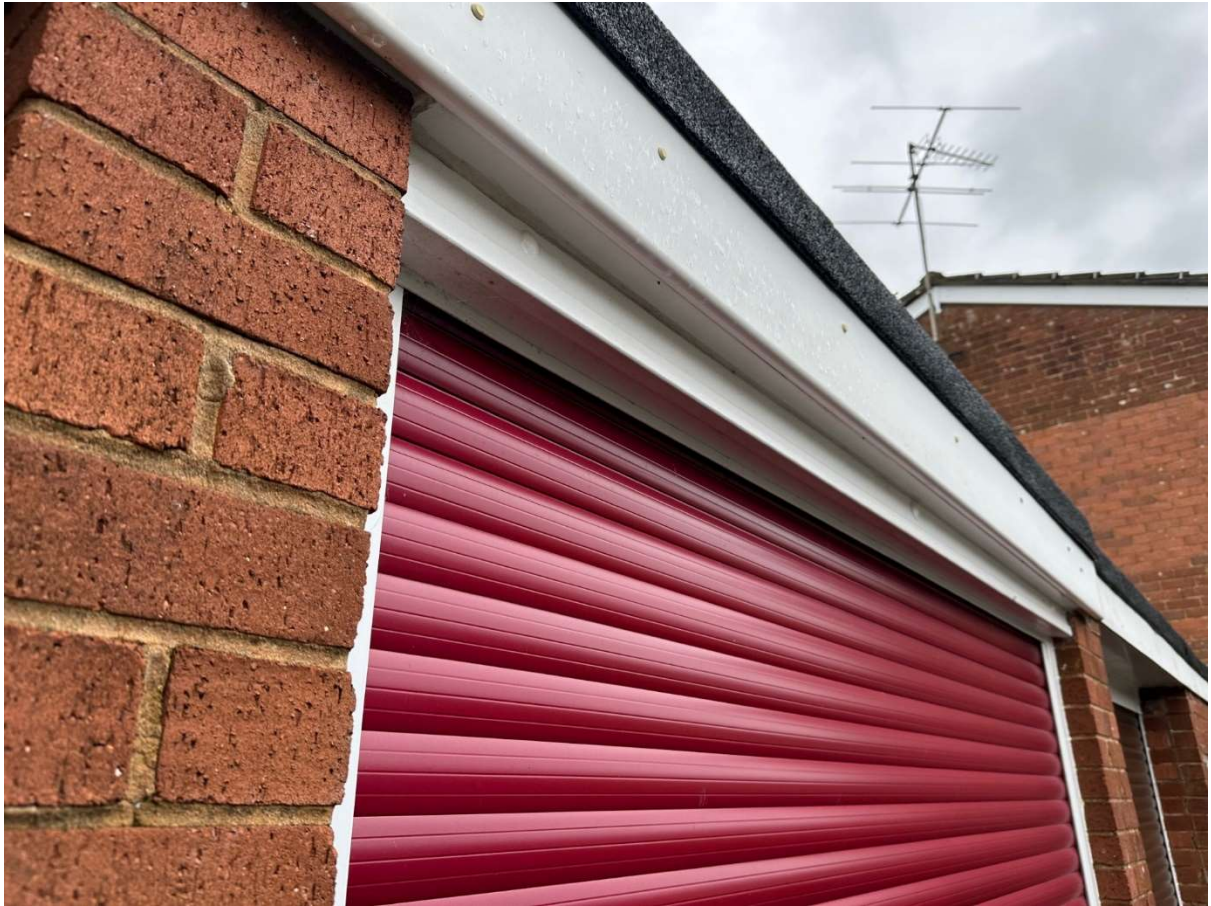
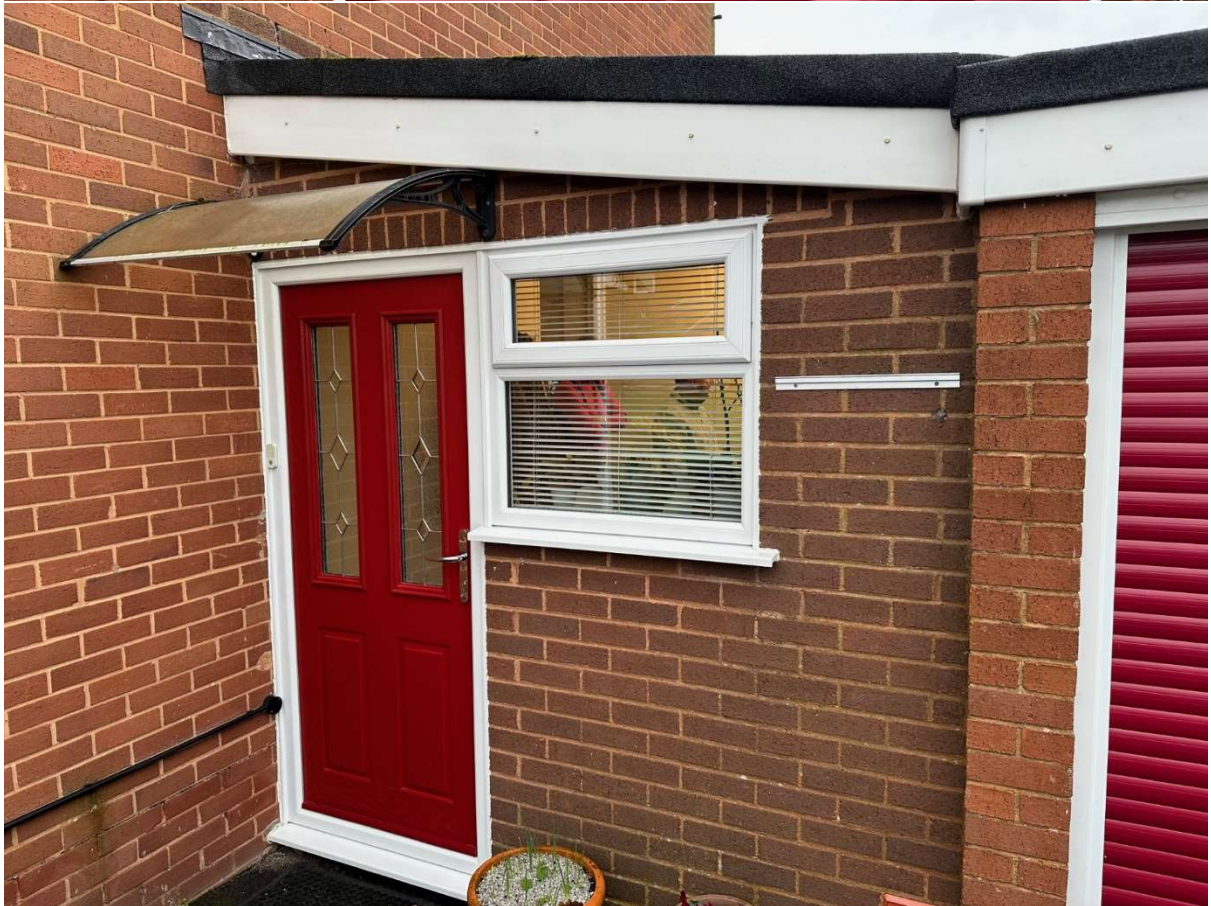
Both the lean to and the garage roofs are flat roof construction with mineral felt finish. The fascia's and soffits are PVCu with mastic seals to the existing face brickwork. The garage roof has exposed structure internally with no voids. The ceiling to the lean to is sloped internally with voids filled with insulation. You will see from the photos attached that there are no gaps at eaves as PVC fillers are mastic sealed. The existing face brickwork including pointing is in good condition.

Please see photos of both the internal and external structures.

Considering the above and having spoken to Kestrel Wildlife Consultants Ltd who have also visited site on 04/01/24 it is highly unlikely that there is a bat roost therefore we would be grateful if you could confirm that a survey/report will not be required in this instance.
