Requirements as detailed in the Preliminary Bat Roost and Barn Owl assessment (Greenlight Environmental Consultancy , August 2022.

Biodiversity enhancement layout plan

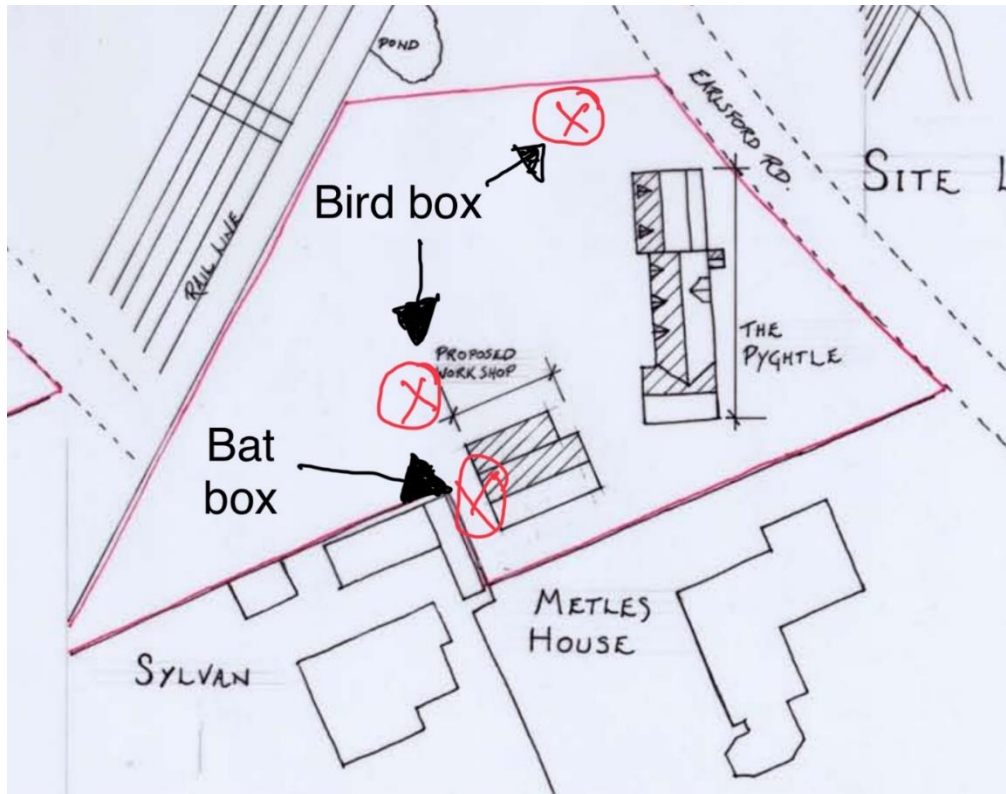
- Installation of one integrated bat box on the new garage building
- Installation of two small bird boxes onsite

Protected habitats/species	Status	Potential effect	Recommended mitigation and enhancements	Response
Protected sites	No statutory protected sites within 2km.	No significant impacts on protected sites and their qualifying features.	None required.	N/A
Bats	Negligible bat roosting potential in buildings on site. Low-moderate value commuting and foraging habitat on site.	Low scale loss and potential light disturbance of commuting and foraging habitats on site.	<i>Precautionary mitigation</i> A soft roof strip around the chimneys will be undertaken with special care. If any bats are found, work will cease immediately and a licenced bat worker contacted to remove any bats to safety and advise on the appropriate mitigation. Any lighting schemes will follow guidance from the Bat Conservation Trust and CIE 150:2003. <i>Enhancement</i> Installation of one integrated bat box on the new garage building.	Chimneys removed with due care and attention, no evidence of bats found. See proposed layout below for location of integrated bat box on gable end of workshop/garage.
