## Barker-Mills Conservation

### Heritage Statement and Impact Assessment

37 Melville Street Ryde, Isle of Wight

Internal alterations to ground floor including removal of stair and installation of a floating floor (*Application 1*)

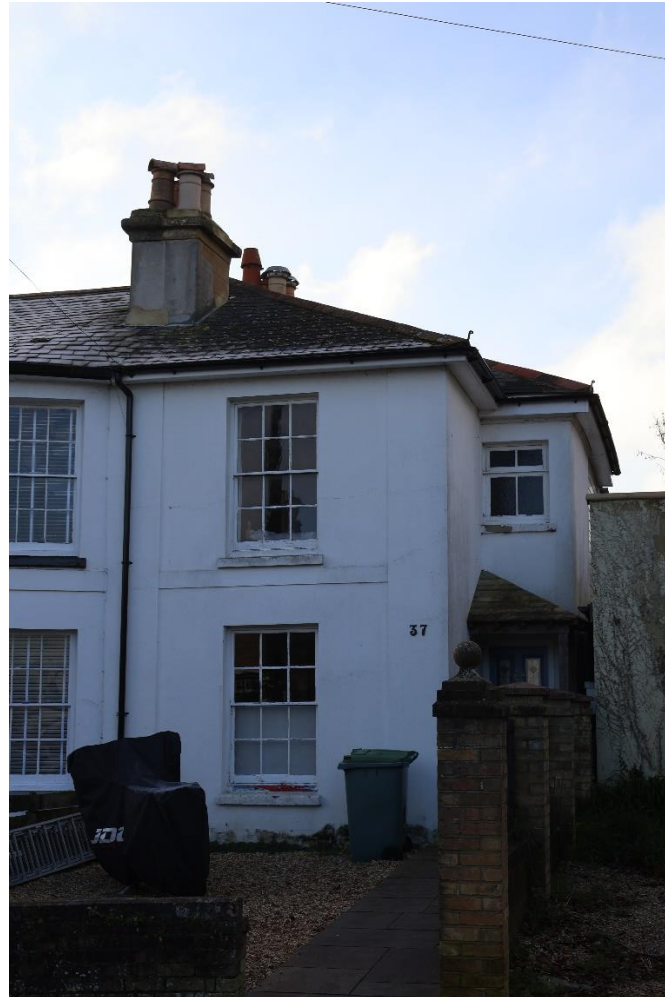
*37 Melville Street Photograph taken by the author December 2023*

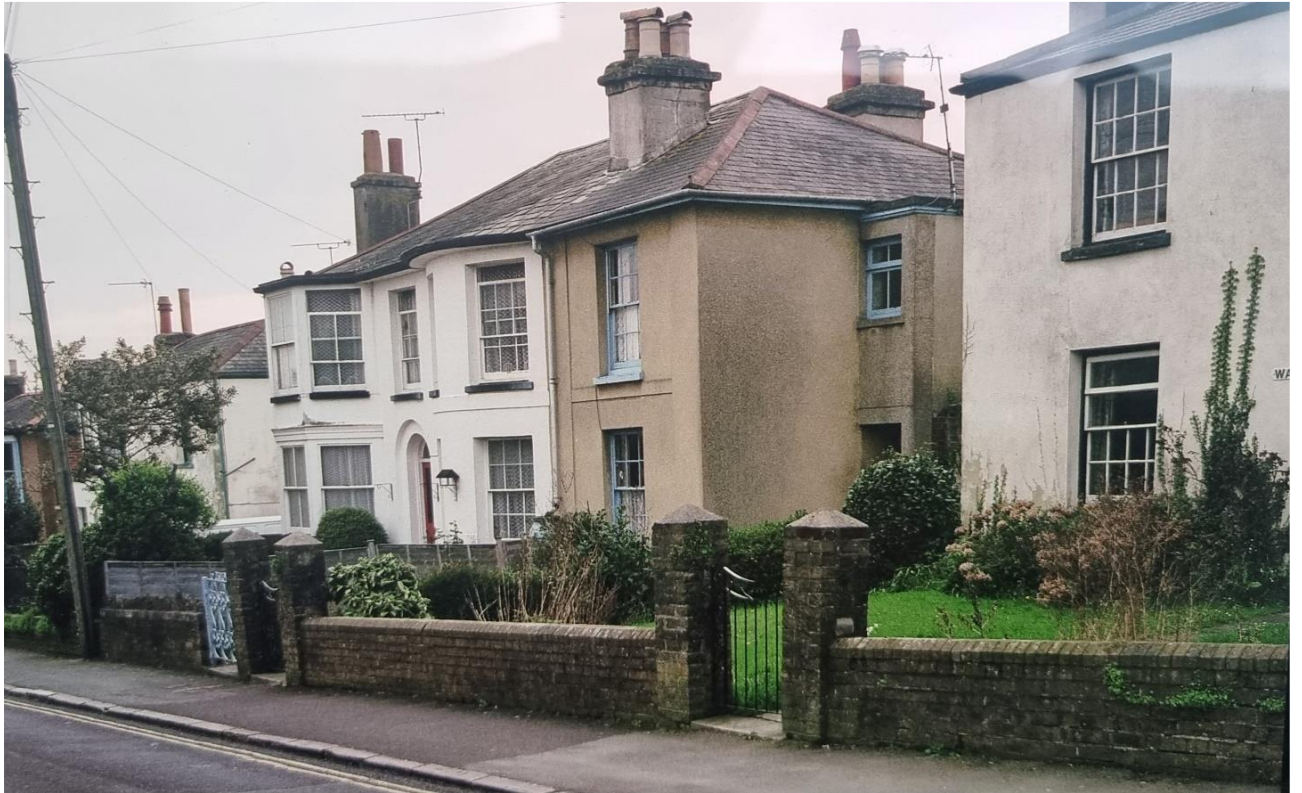
Photograph 1: 37 Melville Road in the 1960's-70's. The exterior finish is relatively new although has signs of weathering. Note the different roof tiles and the consistent render finish of the stacks

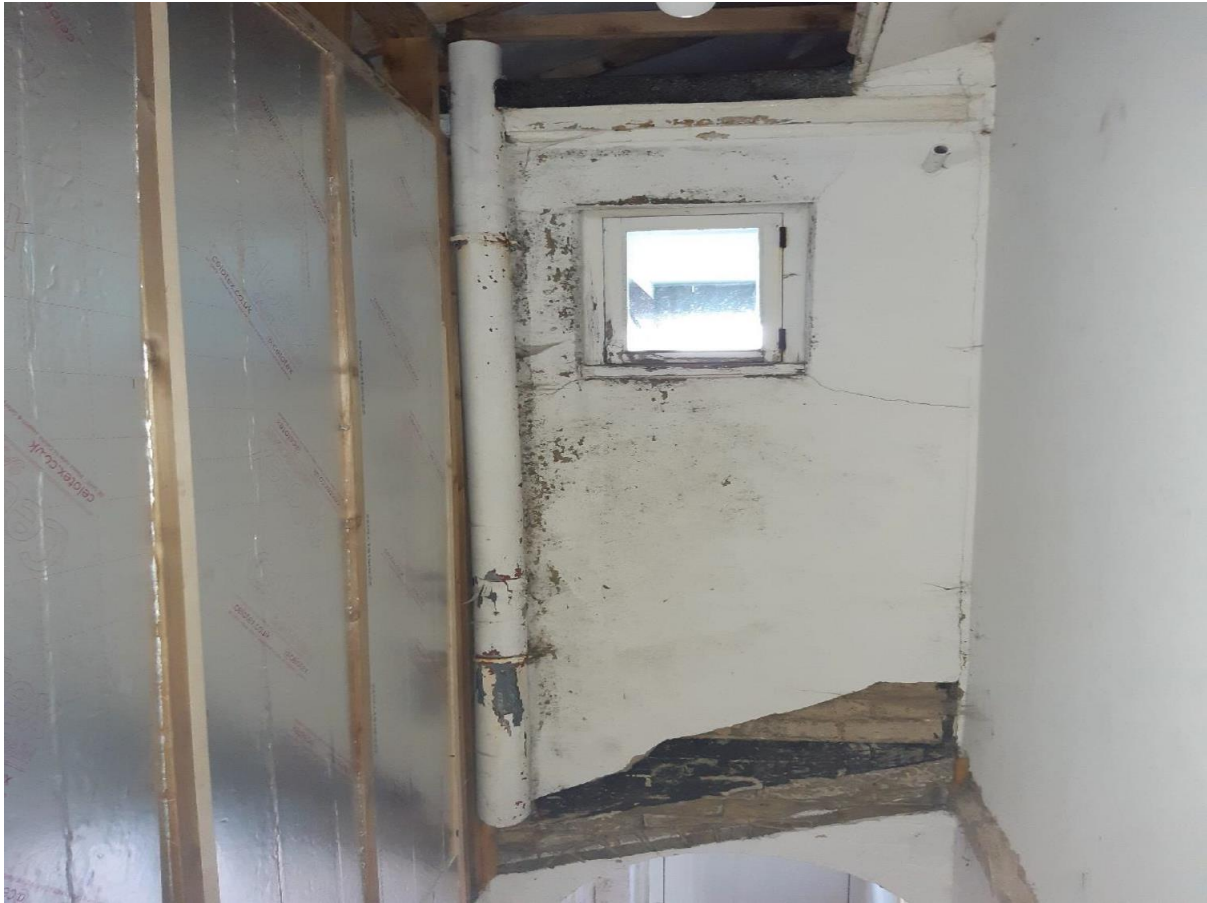
**Photograph 2:** Interior rear (south) wall of the first floor added storey above the west entrance bay. Note the line of the original single storey roof above the arched entrance and the black bitumen coating to what was the rear of the parapet. The old external downpipe to the added floor is now encased within the building

- 2.10 The entrance wing itself contains yellow stock brick at ground floor level floor (*Appendix NPBM 3 Photographs 2 and 3*) which includes an entrance arch and it was clearly originally single storey. The original roof appears to have been mono-pitch with a parapet to the front and was almost certainly covered in slate. This fabric is later 19th Century and therefore the evidence suggests that the entrance into the ground floor of number 37 was formed at that time, if not later. There does not appear to be any evidence for an alternative earlier entrance into 37 which would suggest that it was constructed at the same time as 36, or shortly afterwards, as an independent or separate house.

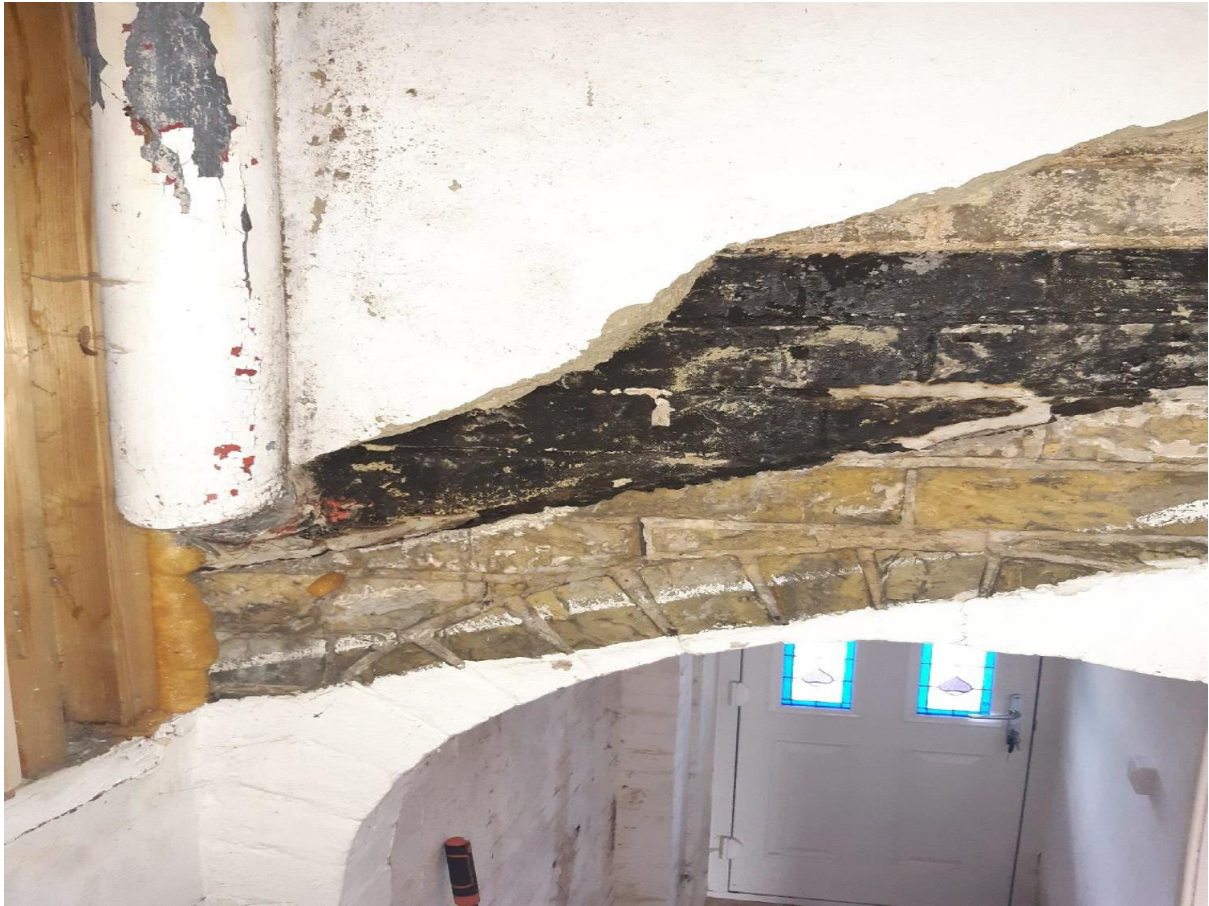
**Photograph 3:** Detail of the former pitch roof detail over the entrance bay and the rear of the parapet with the later downpipe diverted through the wall above the former roof. Note the thick cement render over the brickwork added to cover up the junction between the different storeys.

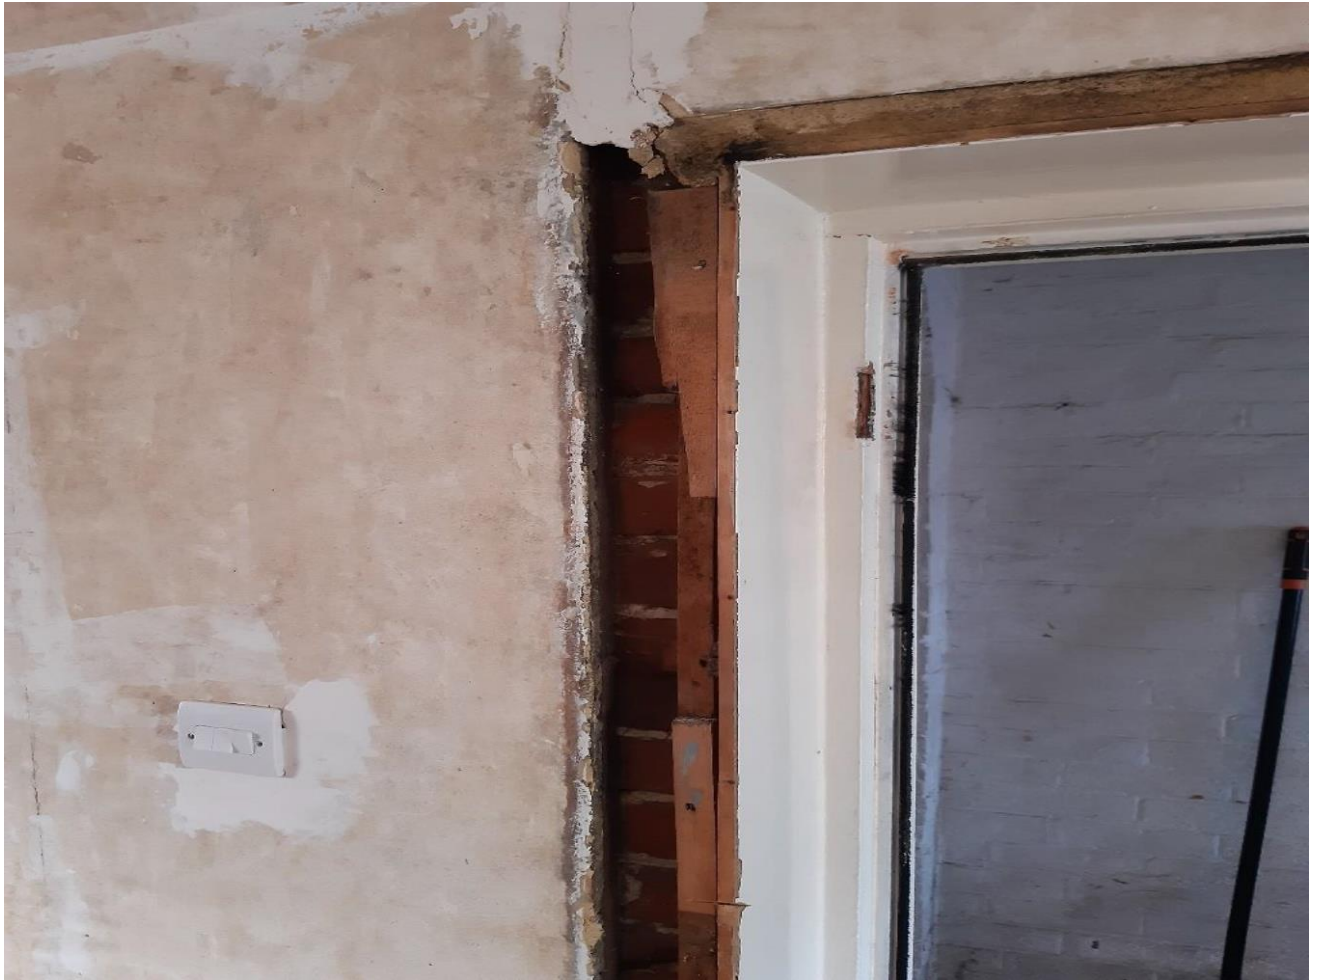
**Photograph 4:** Interior Ground Floor west entrance south jamb showing line of former stair partition and the modern nature of the door linings. Note also the red brick wall fabric which is distinct from the yellow stock brick of the added entrance bay beyond (painted over).

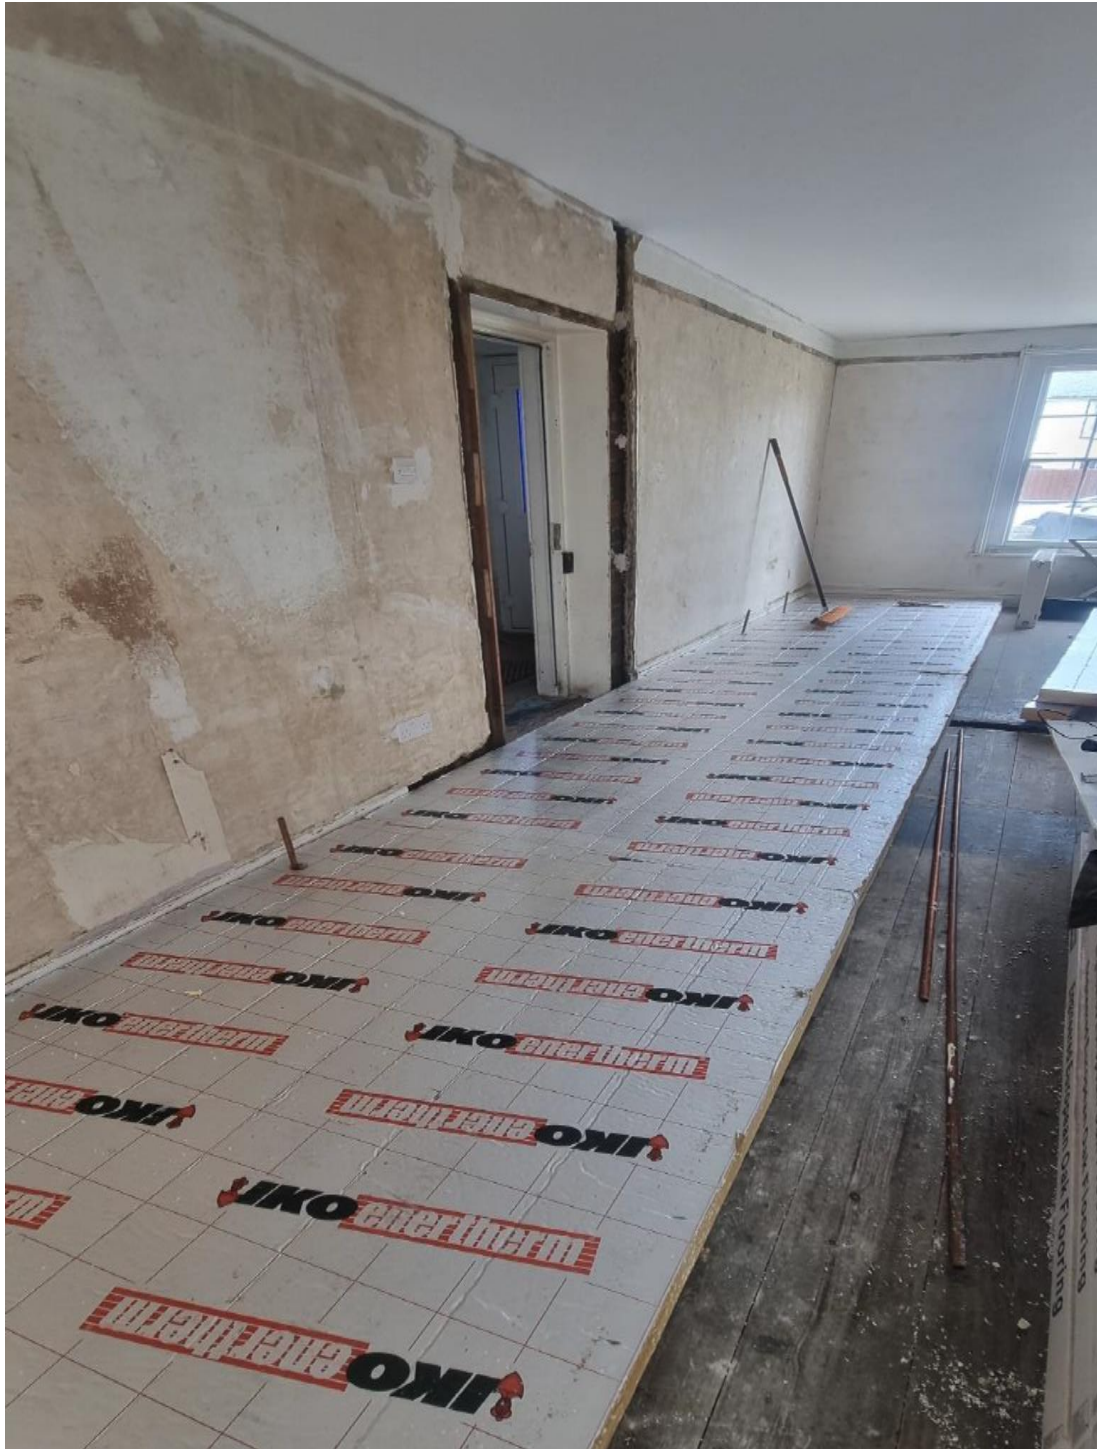
Photograph 5: Interior Ground Floor looking north. Note the line of what was the historic partition to the north of the inserted side entrance. Note also lack of the line of a picture rail above the entrance door and the different line of the vanished picture rail in the rear room. The laminate floor is being laid over the earlier stained floorboards and encasing the existing skirting.

The evidence for the picture rail in the “front” ground floor room (*Appendix NPBM 3 Photograph 5*) indicates that it was almost certainly part of the 1930’s refurbishment of the property. The proportions of the rear of the rail which can be seen on the surface of the wall and the small nail holes where it was fixed are important indicators of its likely date. The owners report that the profile of the rail was simple and this is shown in the photograph. That profile is replicated in surviving joinery upstairs and that joinery is clearly 20<sup>th</sup> Century in date. The ground floor rooms of number 37 were always modest in terms of architectural character and scale and there is no evidence for dado rails or significant architraves and skirtings. The position of the picture rail relative to the window indicates that it was a later addition and the contrasting profiles of the window architrave with the that of the picture rail also add weight to this interpretation. Permanent removal of the rail will not harm the special interest of the building; that is the reason why it has been listed, so it is unlikely to have required consent.

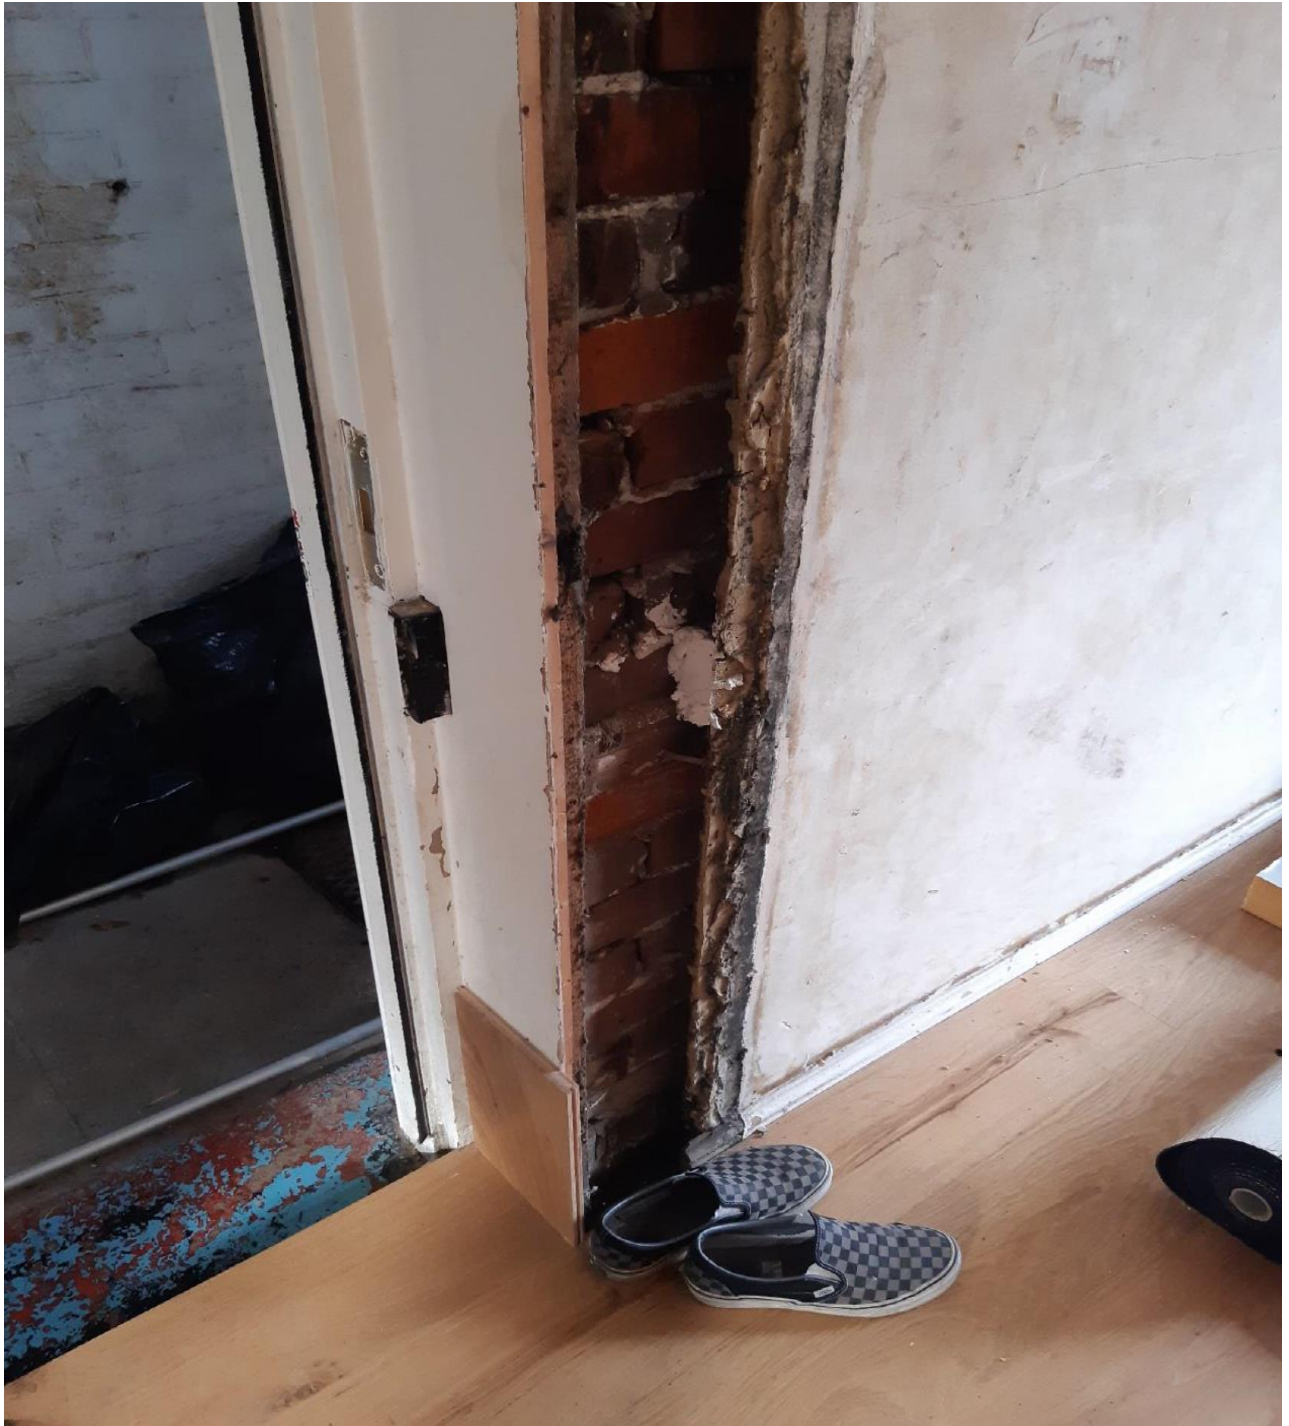
Photograph 6: Ground floor interior north of the side entrance. Note the line of the architrave removed from the door- the original partition did not extend this far- and other evidence shows this was where the door into the north room was sited. Note also the regularity of the exposed lathe ends and the nature of the finishing coat of plaster. Also note the profile of the small section of the skirting above the laminate floor which is not typical mid-19<sup>th</sup> form but rather that used from the later 19<sup>th</sup> century right up until the mid-20<sup>th</sup> and evidence that the room has been refurbished

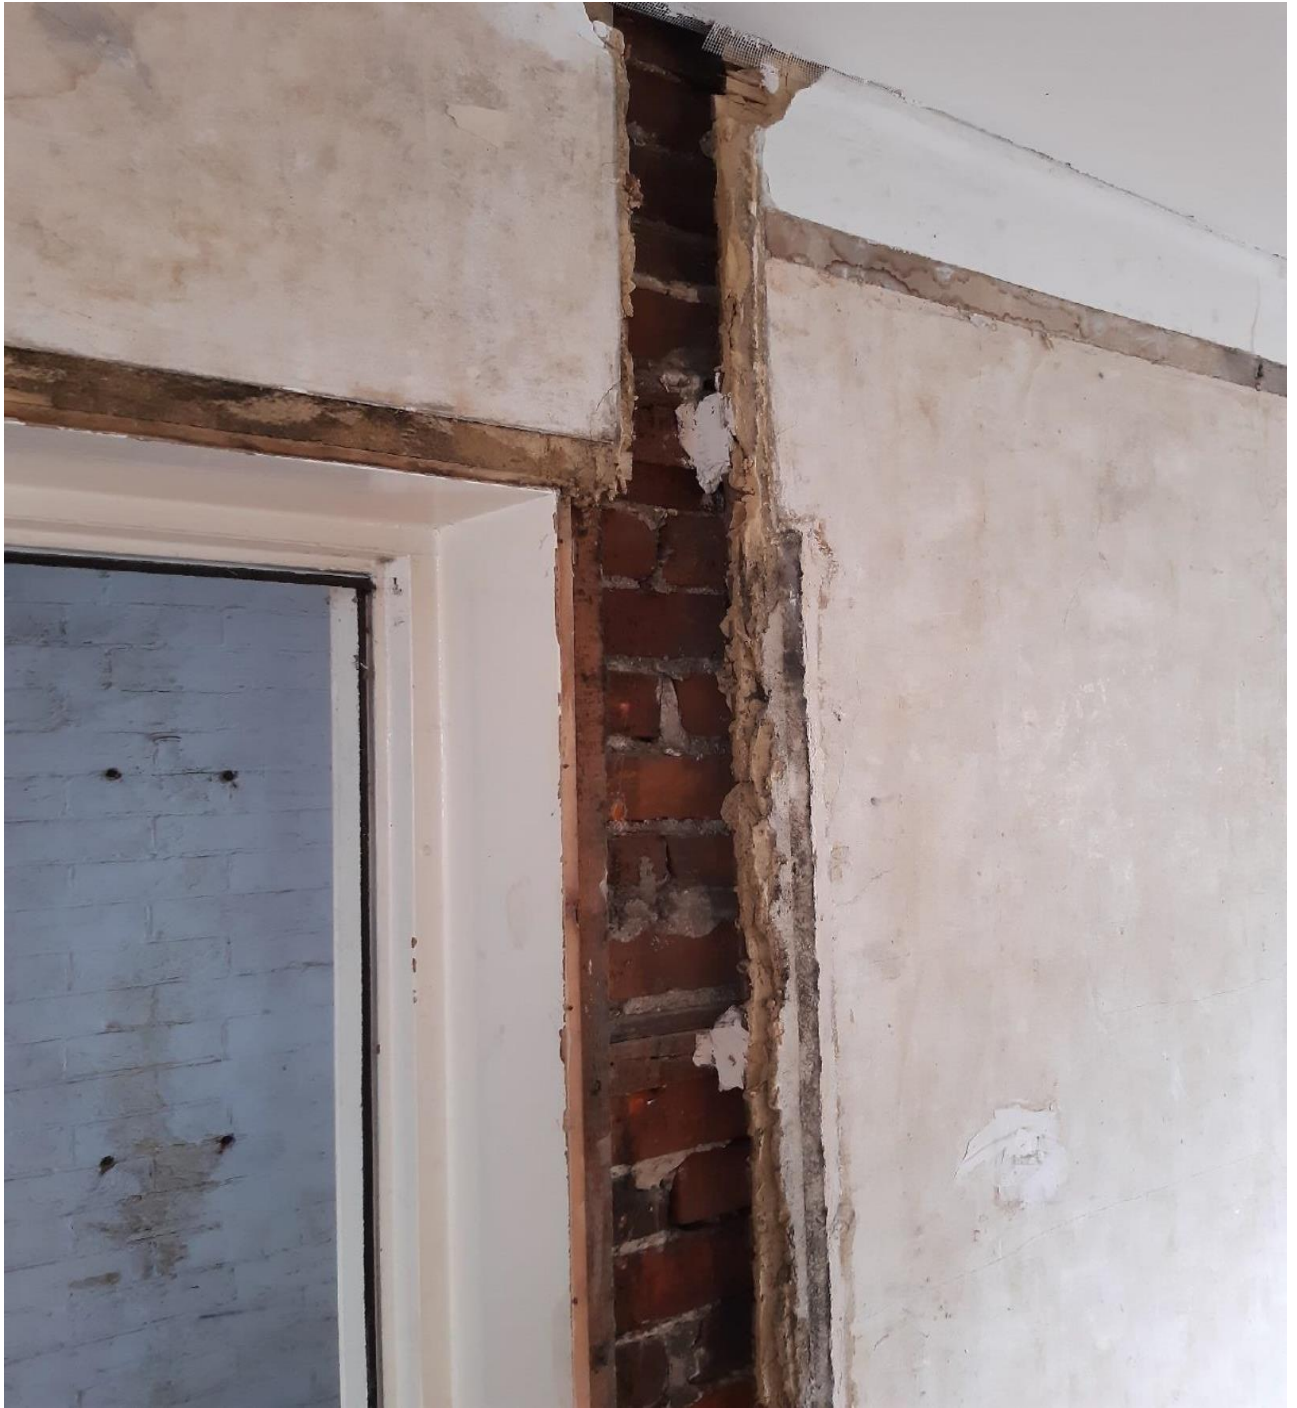
**Photograph 7:** Ground floor interior north side of the entrance upper section. Note exposed ends of lathes at the very top- clearly modern. Note also the reduced width of the exposed fabric representing the extent of the partition structure above the former doorway itself that has been removed and the line of the rear surface of the plaster formerly abutting the architrave of that door into the living room.

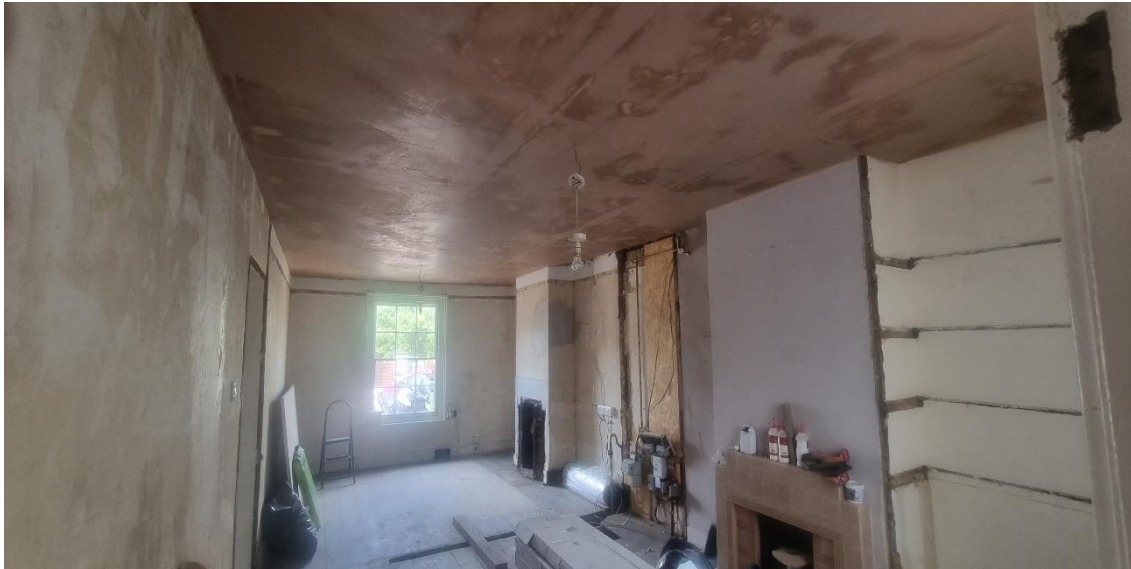
**Photograph 8:** Interior ground floor looking north. Note the slot in the floorboards marking the line of the former partition and where it terminates. The existing flooring extends continuously to the west indicating the position of the former doorway. Note also the cement rich render exposed to the south of the chimney breast in the rear (dining) room following the removal of shelving. Both chimney breasts were obviously re plastered (or rendered) following insertion of the 20<sup>th</sup> century fireplaces.

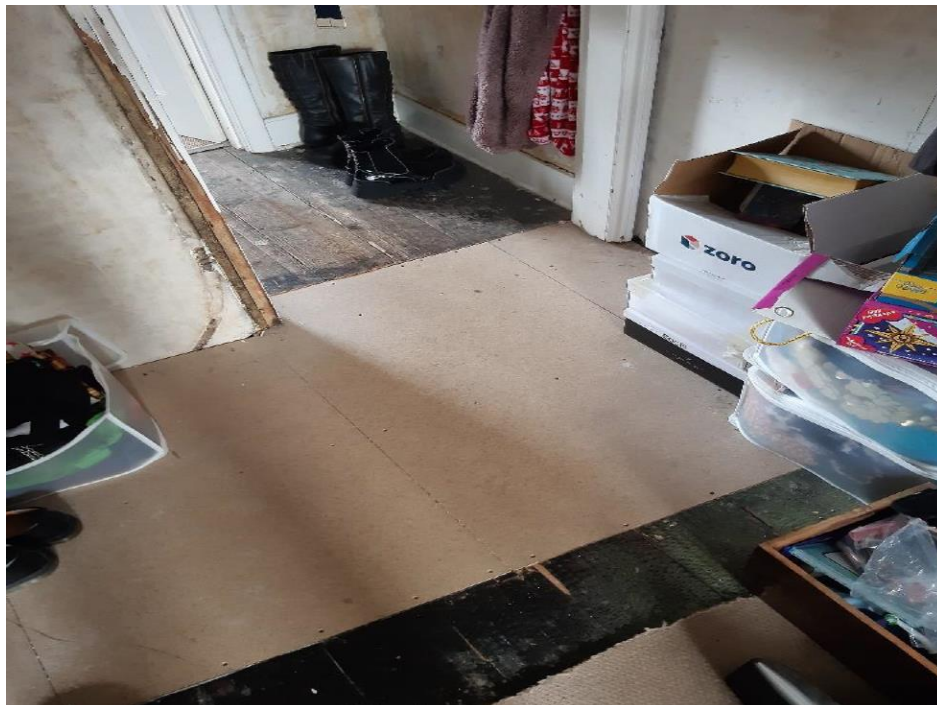
**Photograph 9:** Interior first floor. Temporary infill of former stair opening. Doorway is the remains of the historic first floor partition space beyond was in the former bedroom now provides access to the bathroom to the west

The former opening for the staircase at first floor level has been temporarily infilled with chipboard panel awaiting clarification of the way forward. (*Appendix NPBM 3 Photograph 9*) It is proposed to permanently infill the opening and to do so with reclaimed pine timber floorboards of 19th century character. This would be historically more authentic and the existence of the former opening would still be

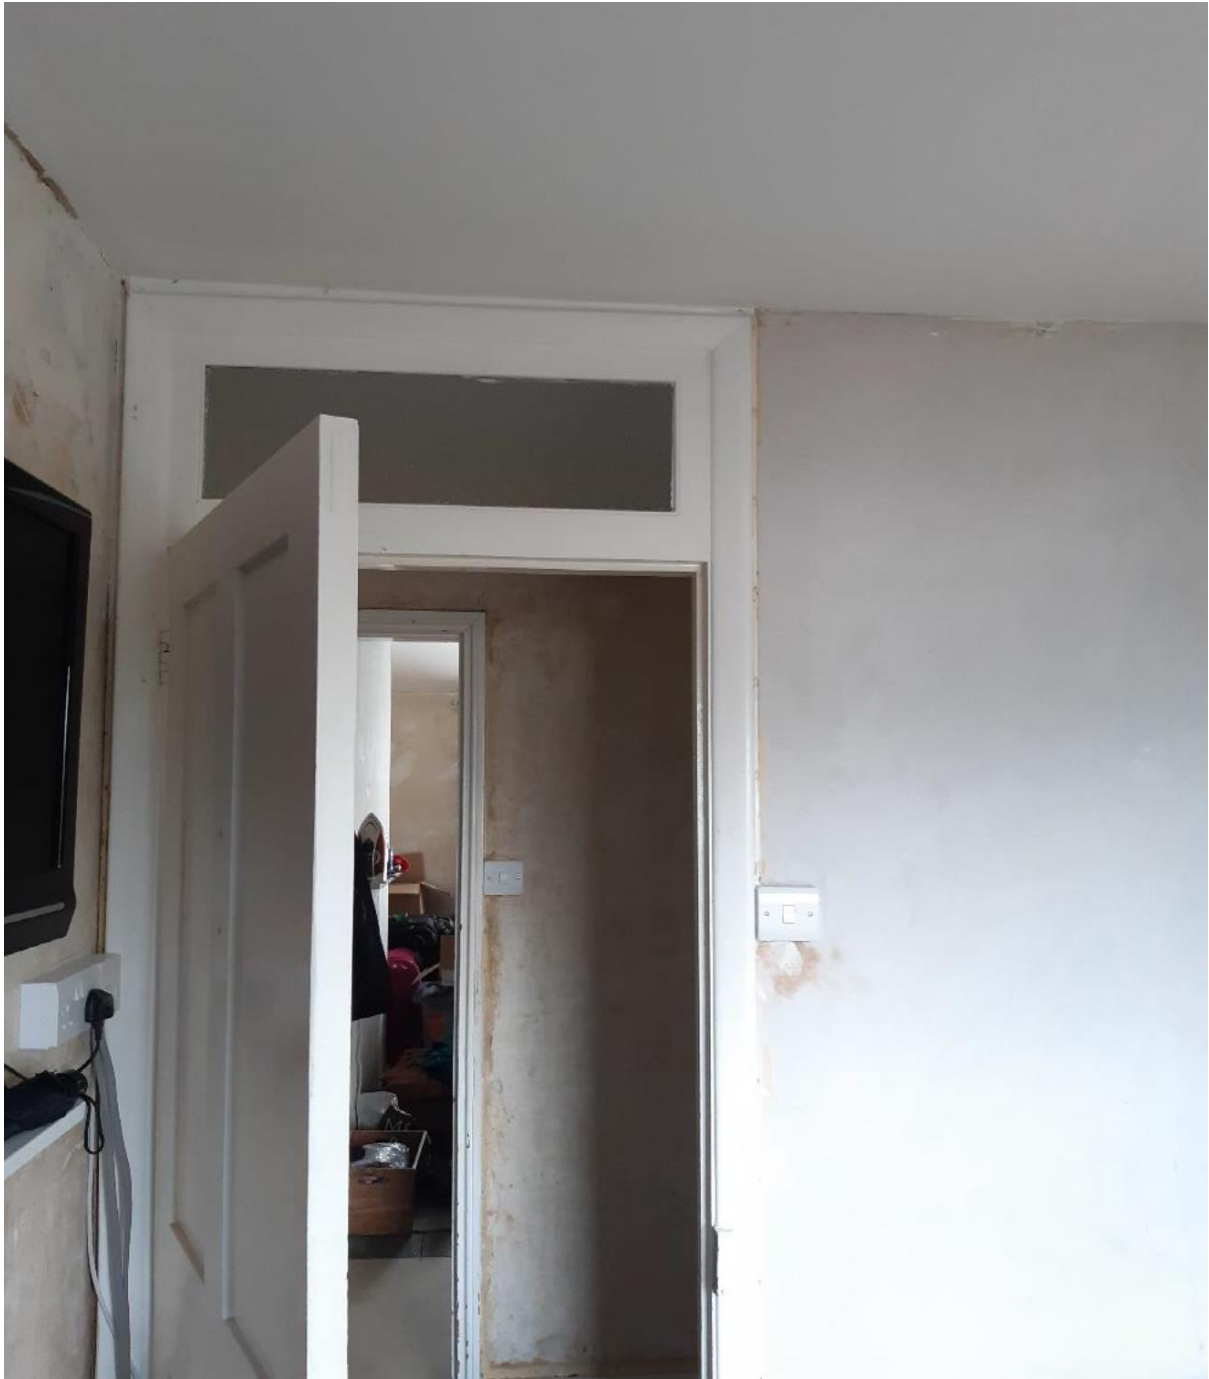
Photograph 10: Interior first floor north bedroom looking south to the new partition attached to the chimney breast with the modern door opening under the glazed transom light. The original partition is beyond leading to the first-floor south bedroom.

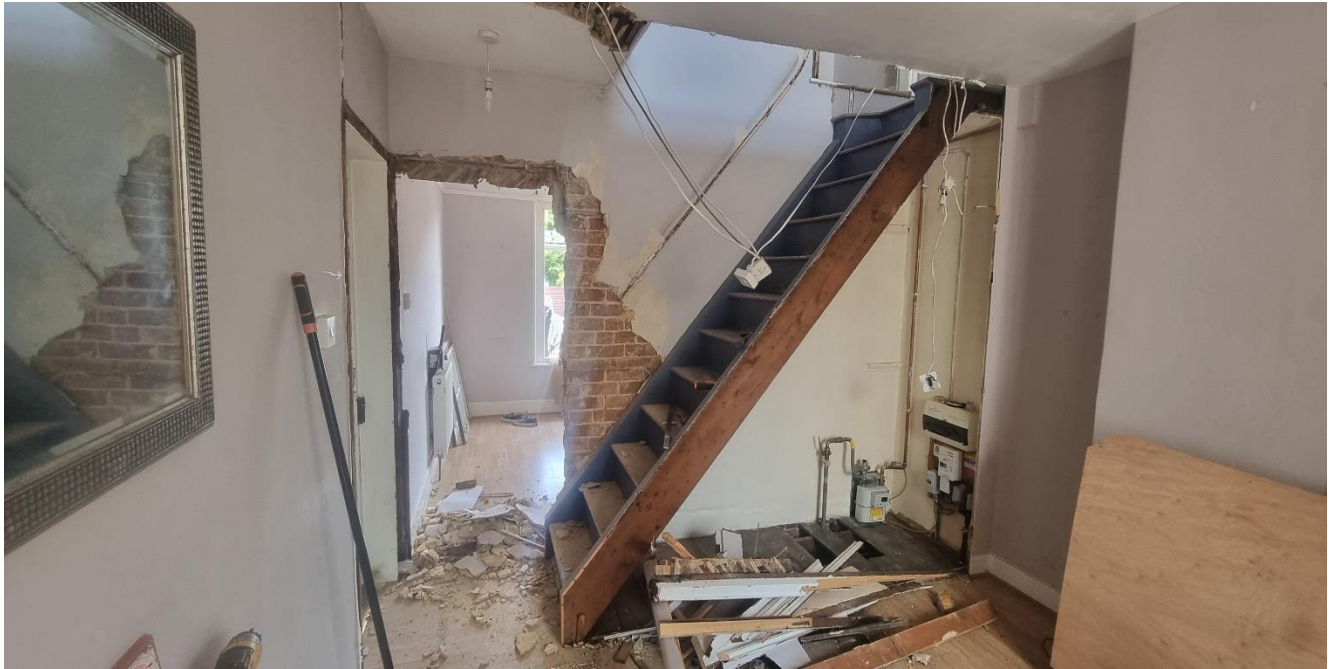
**Photograph 11:** Interior former stair now removed. Note the steep pitch because it had to be inserted in a restricted space between the new western entrance and the blocked opening at first floor level in order to be able to serve the existing bedroom doorways. The landing is therefore effectively in the form of an enlarged upper step and attached to the restricted area above the former connecting door between the two properties. It could not block the existing opening between the two rooms and it is therefore more akin to a ladder with a closed string and no balustrade, being enclosed between an existing and an inserted partition. The existing partition was brick which is seen exposed in this photograph and the later partition to the south was very thin and timber.

required a separate stair to access the first floor. This was placed between the front and rear rooms along the side of an existing brick partition. (*Appendix NPBM 3 Photograph 11*)

The former stair (*Appendix NPBM Photograph 11*) was almost certainly a later insertion into the building carried out when it was separated off from the adjacent house. As the list description notes, the small “entrance- wing” was added to the west which facilitated the later, side entrance. The rake of the stair and the cramped nature of the upper landing all point to it being a later insertion into an existing building; as does the ad-hoc nature of the partitions to one side that formerly enclosed it at first and ground floor levels. The stair that has been removed is clearly of later 19<sup>th</sup> or 20<sup>th</sup> Century date and had no architectural interest; its removal returns the volume of the rear room to something closer to its earlier historic form. The stair was possibly as late as the 1930’s as number 37 was purchased at that time by Bertram Gatwood who carried out significant alterations which were intended to bring the property up to more modern standards.
