Project **Langton Green Recreation Ground**

Title **Tree Protection & Removal Plan**

Job Ref **JSL4914** Scale @ **A1** Date Created **Dec 2023**  
 1:500

RPS Drawing / Figure Number **710** Rev **-**

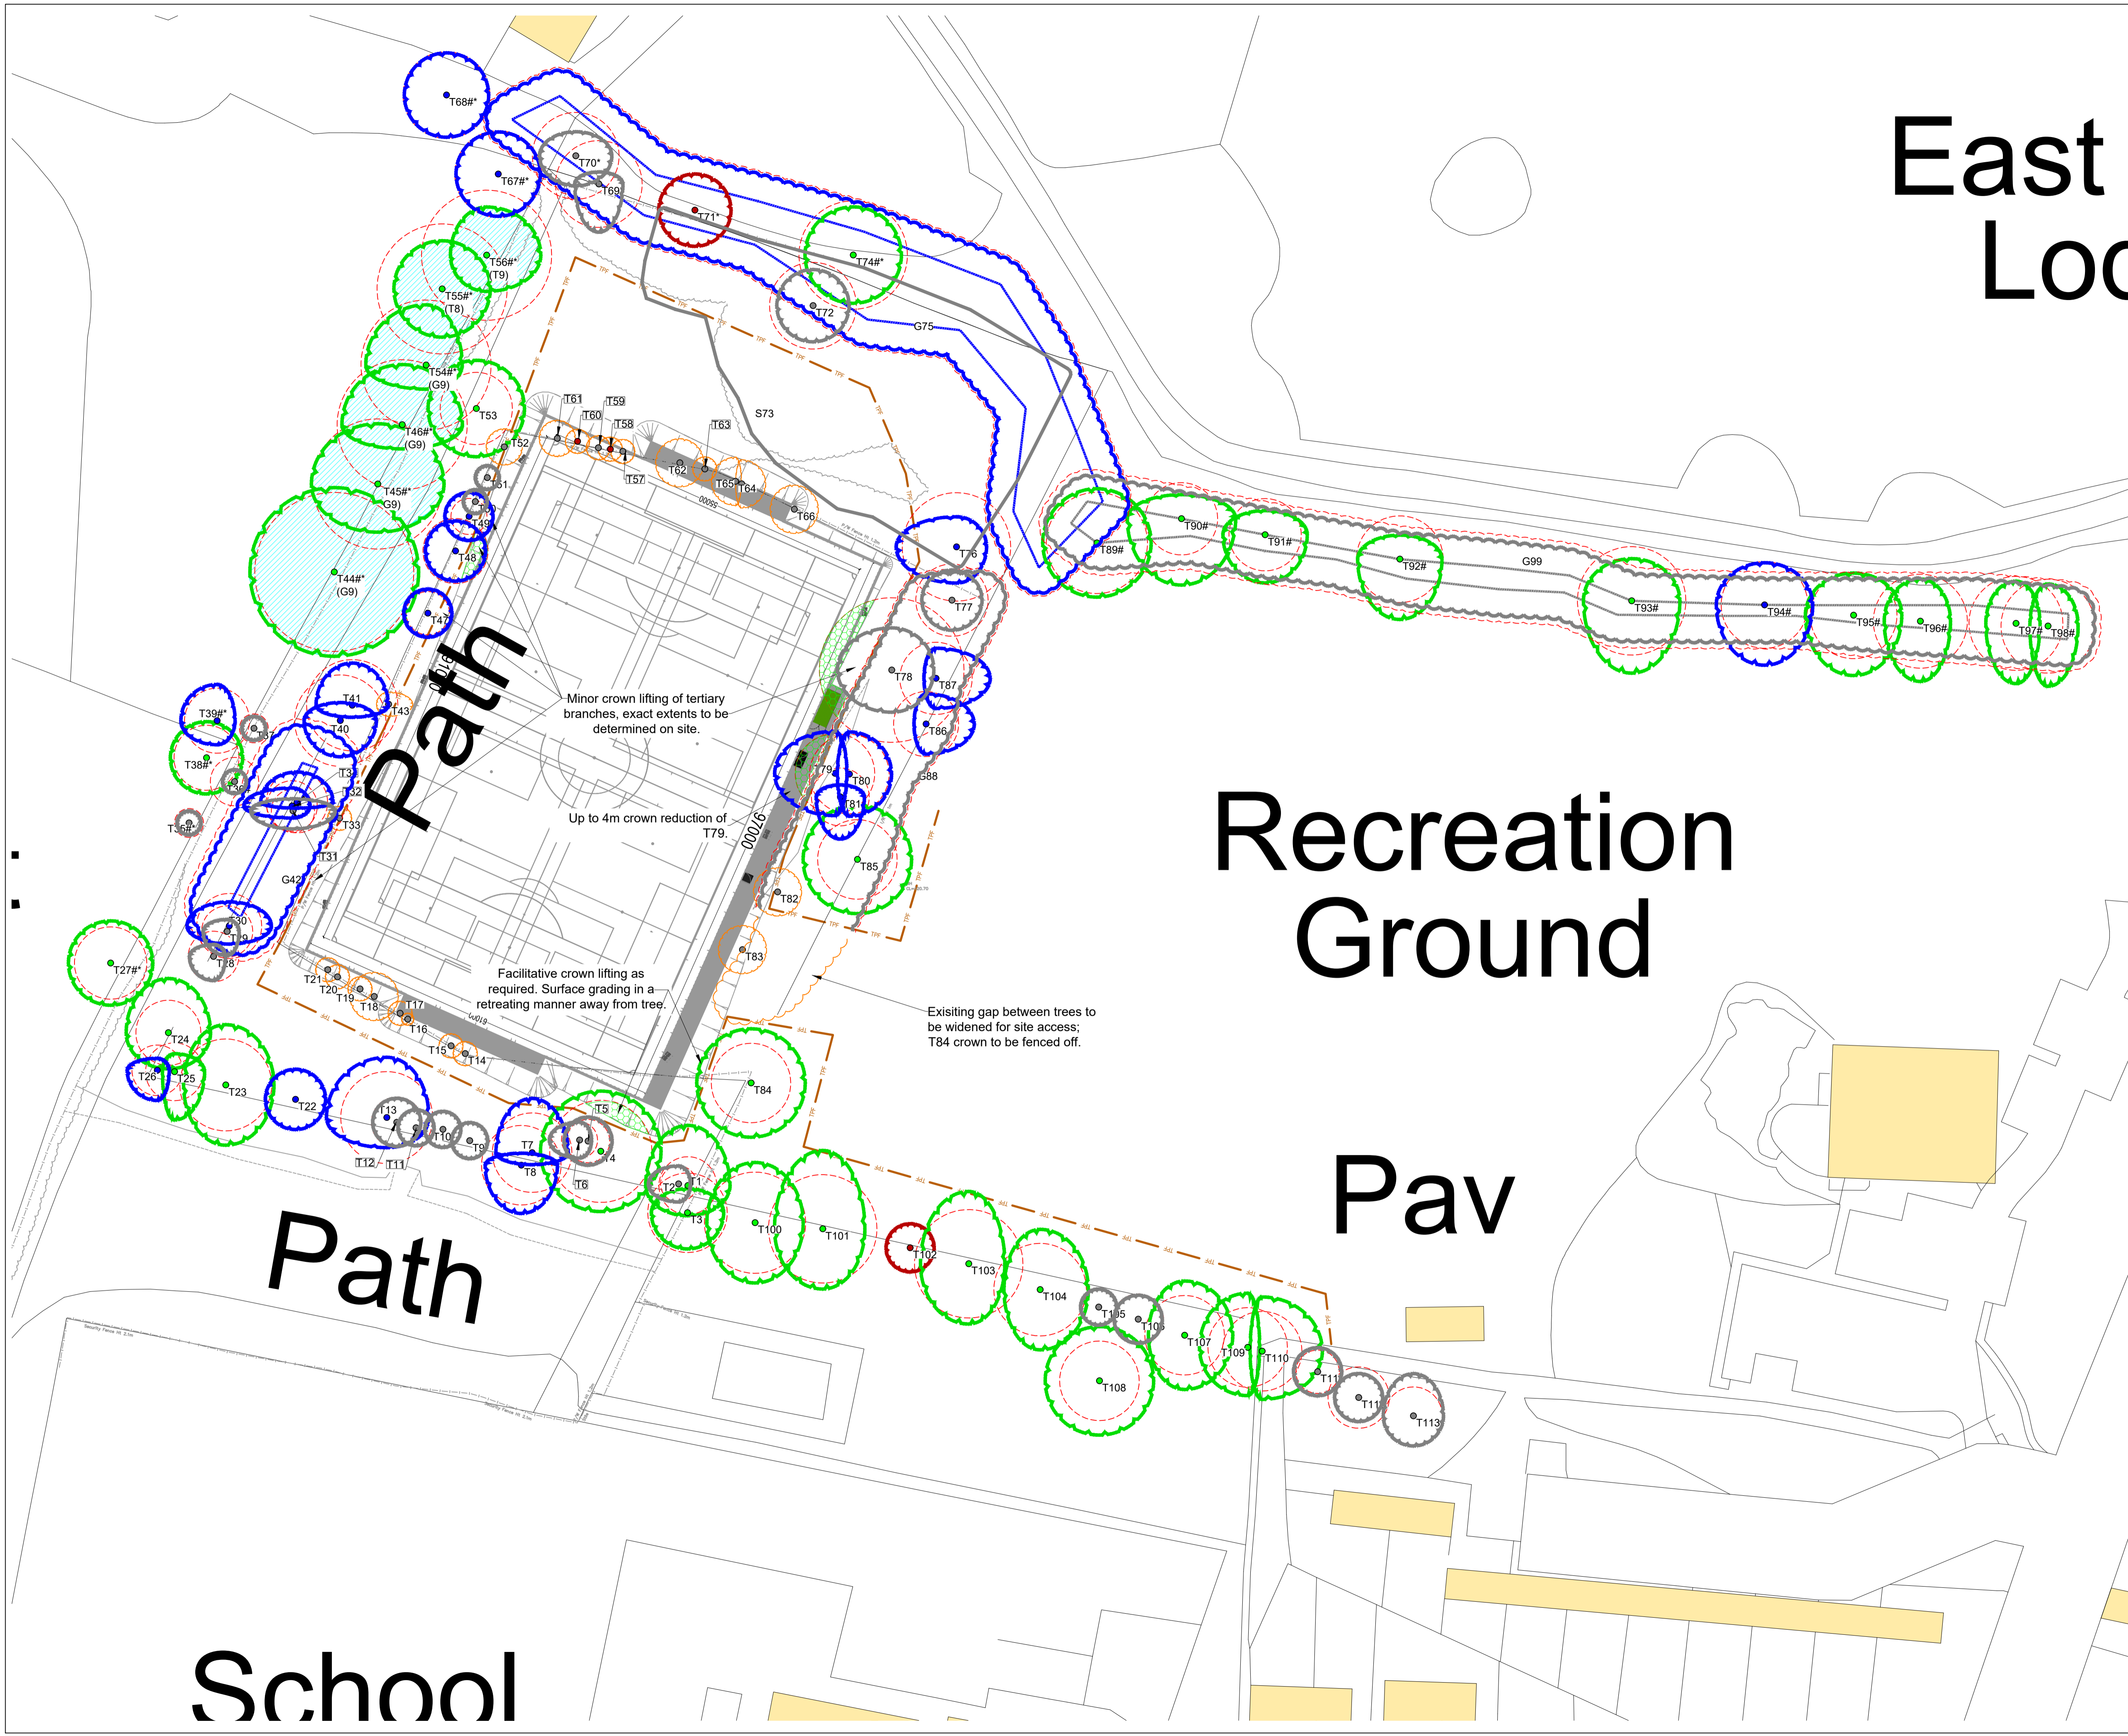
Temporary protective fencing in accordance with Section 6.2 - BS5837:2012. See inset details for example details.
-

Proposed level changes within RPA - excavation to be supervised. Pruning of roots over 25mmØ to be monitored by arboriculturalist, with ongoing monitoring of trees condition by an arboriculturalist being recommended.
