**ARBORICULTURAL REPORT**  
at  
**1a Durley Avenue**  
**Waterlooville**  
**Hampshire**  
**PO8 8XA**

- 1.1.1 This arboricultural report is required by our client as part of an investigation into soil shrinkage subsidence damage at:

**1a Durley Avenue, Waterlooville, Hampshire, PO8 8XA.**

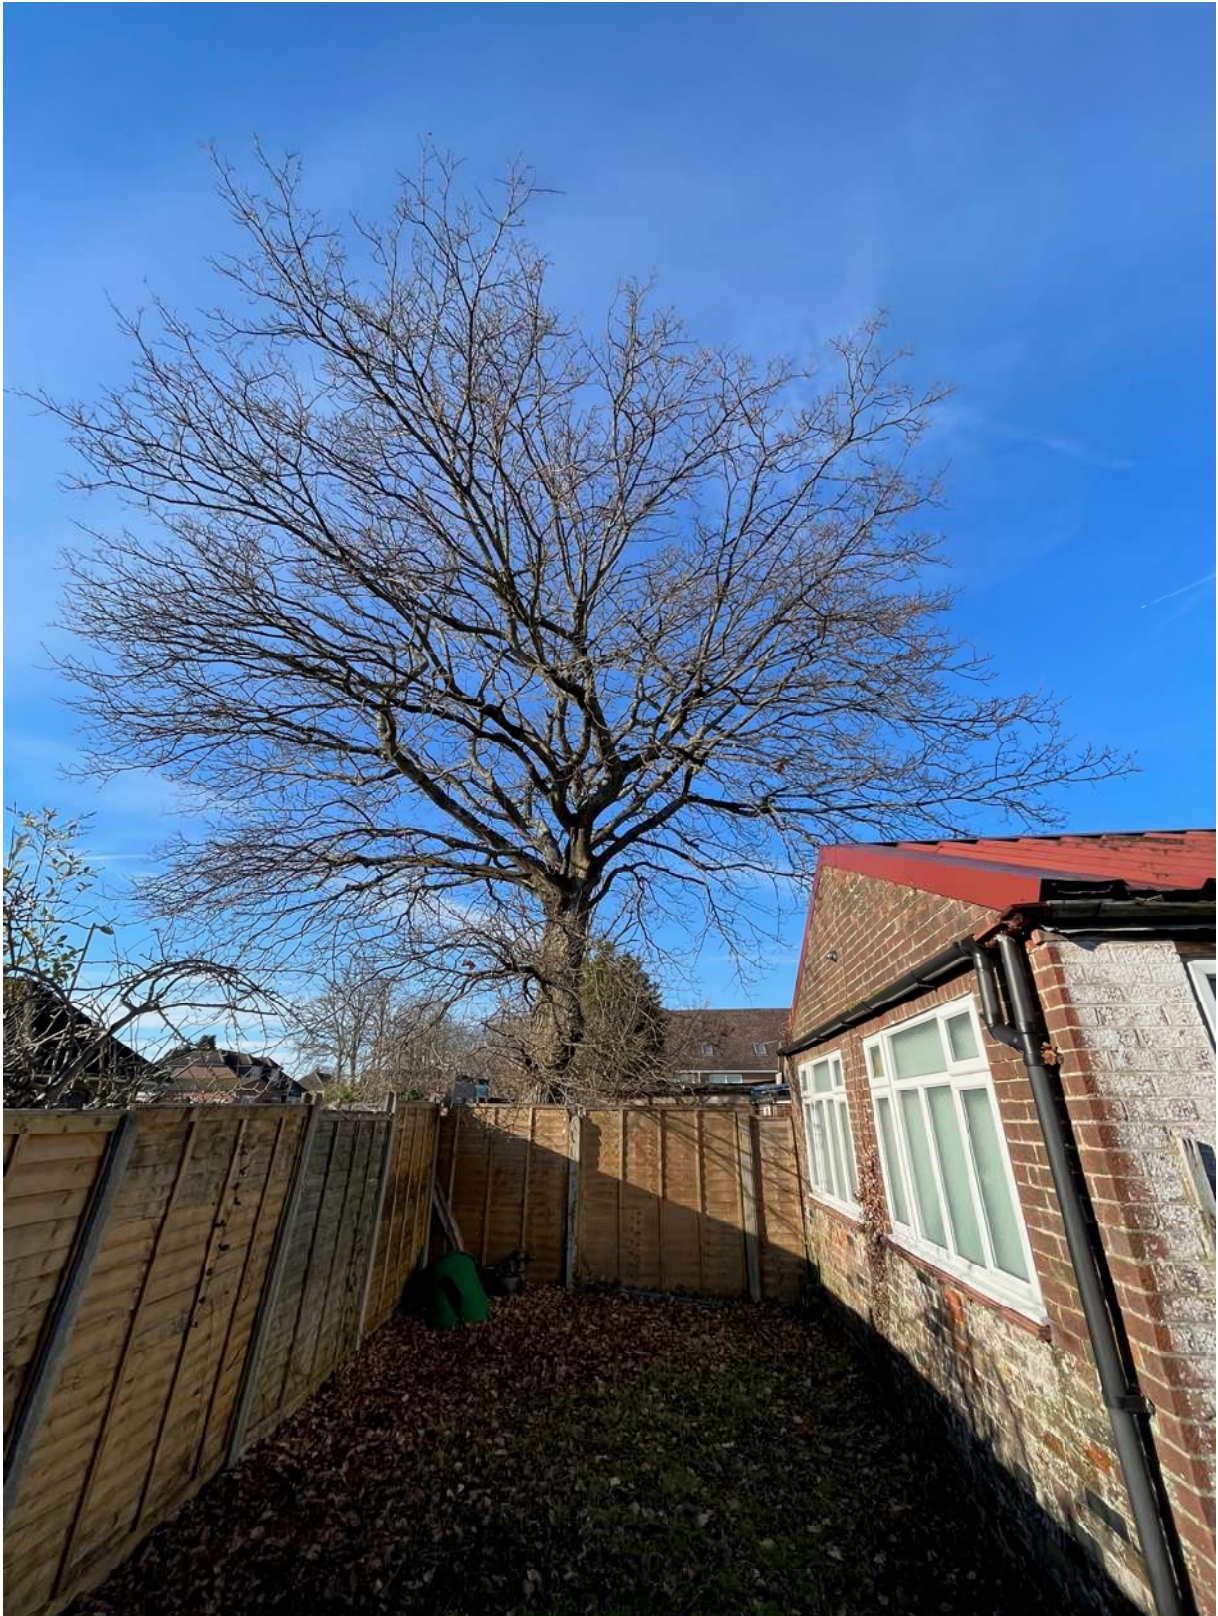
**Photo 1:** Showing T1 (English Oak)

- 6.1 We have been informed by our client that the damage observed at the property is due to clay shrinkage caused by vegetation.
- 6.2 Based on this information, having made a detailed survey of the site and having given due consideration to the other information supplied, it is likely that in this case some subsidence damage has occurred as a result of drying shrinkage caused by **T1**, as identified in this report. In order to negate its influence, the only vegetation management option available is to remove **T1** to ground level and treat its stump to prevent regrowth.

Item	Species	Recommended Actions	Location/Ownership	Planning Restriction
<b>T1</b>	English Oak	Remove to ground level and treat the stump to prevent regrowth.	Third Party - No. 1 (Primrose Cottage)	None
<b>G2</b>	Mixed	Maintain at current height and spread.	Policy Holder	None
<b>S3</b>	Privet	Maintain at current height and spread.	Policy Holder	None
