HERITAGE STATEMENT

Trailfinders, 24 High Street, Windsor SL4 1LH

Prepared by Lustedgreen – 21/12/2023

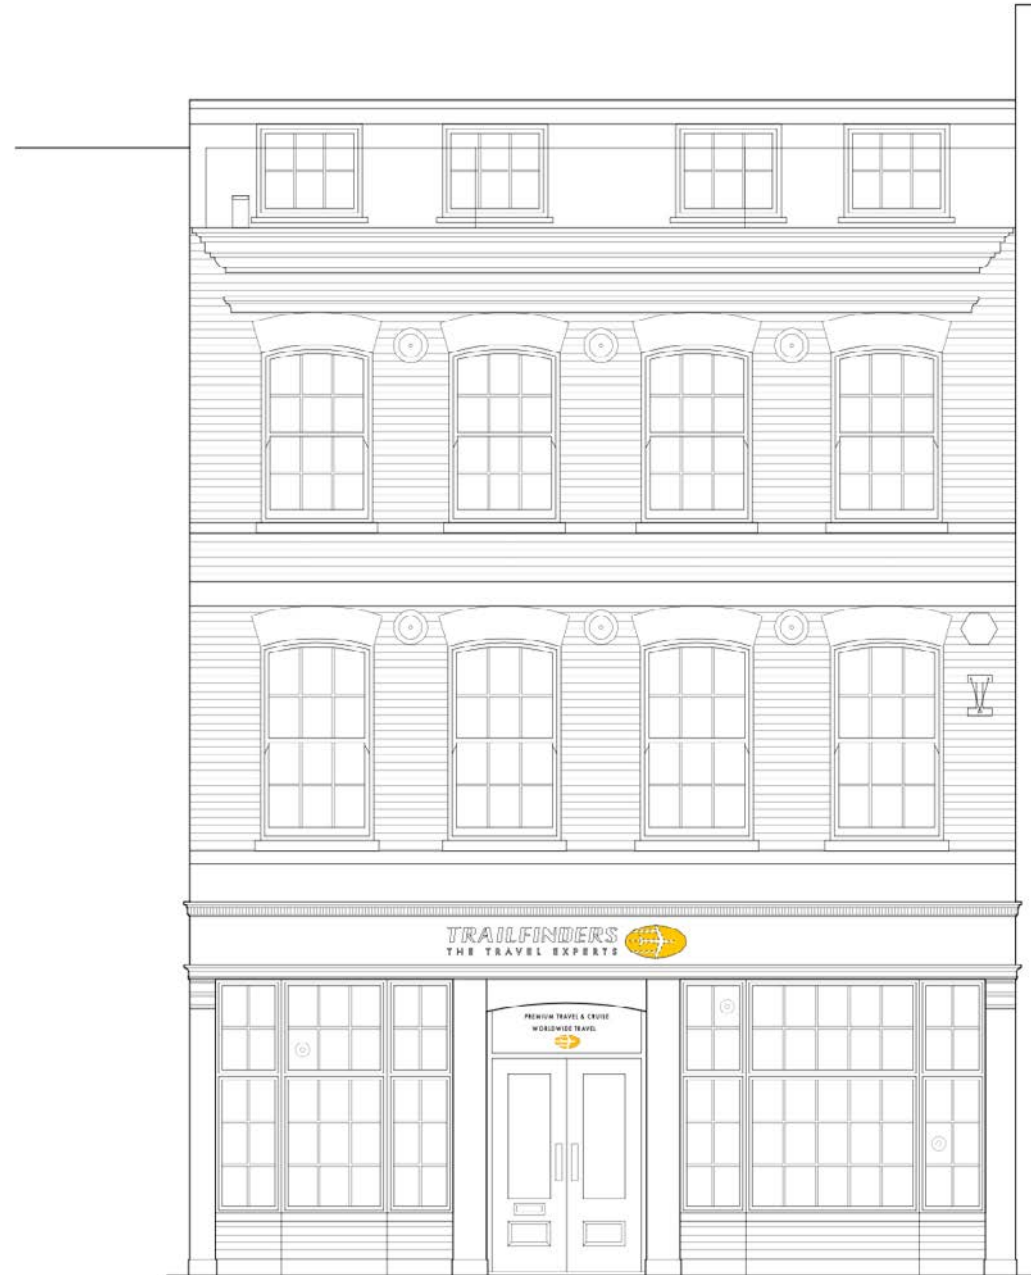
Proposed Shopfront

All original features, including glazing, to be retained

The shopfront and its glazing will be retained, made good and redecorated in line with Trailfinders branding – this being subject to a separate Consent to Advertise application.
