Existing Rear Elevation - 1:100

SEABROOK

NN173DY
e Tiles/Windows
— Checked by
ТВ
Revision
А

SB23029-P-001

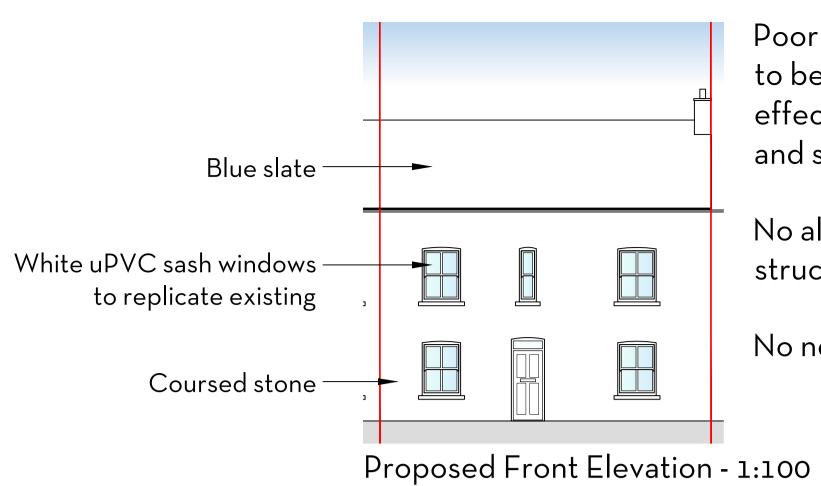
Blue slate

Coursed stone

Concrete tiles -

White/off white render

Poor condition timber windows to be replaced with white timber effect uPVC to replicate style and size of existing.

No alterations to existing structural openings.

No new structural openings.
