## ROOF DETAILS

5 Farleigh Road, Norton St Philip, BA2 7PG

December 2023

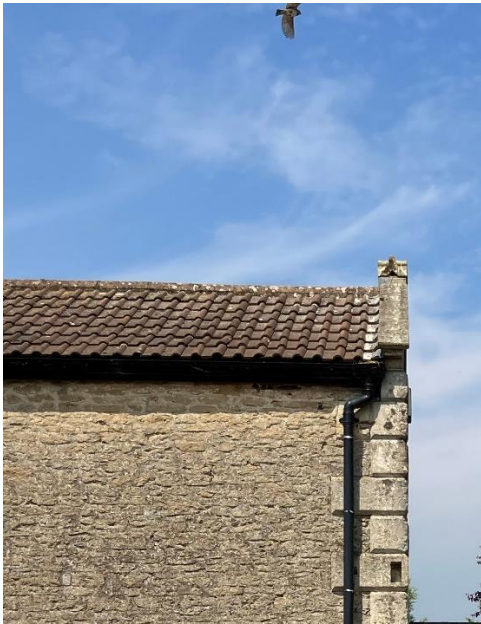
The ridge tiles are bedded on mortar with a parapet detail to the northeast facing gable and mortar bedded hip roof to the southwest end, where no.5 Farleigh Road adjoins nos 1 & 3. There is a clipped eaves detail to three sides, where the fascia board is fixed close to the external wall with no overhang, see Figs.3 & 4.

Fig.3 Mortar bedding to ridge tiles and lead flashing to verge parapet

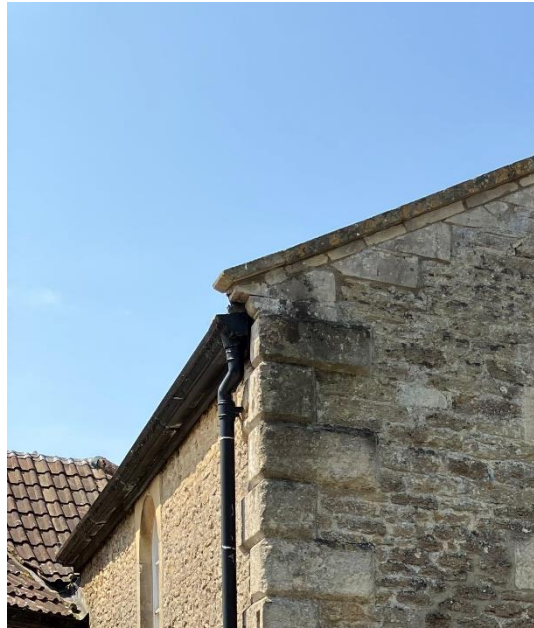
Fig.4 Clipped eaves with fascia board, courtyard elevation, same detail to roadside elevation

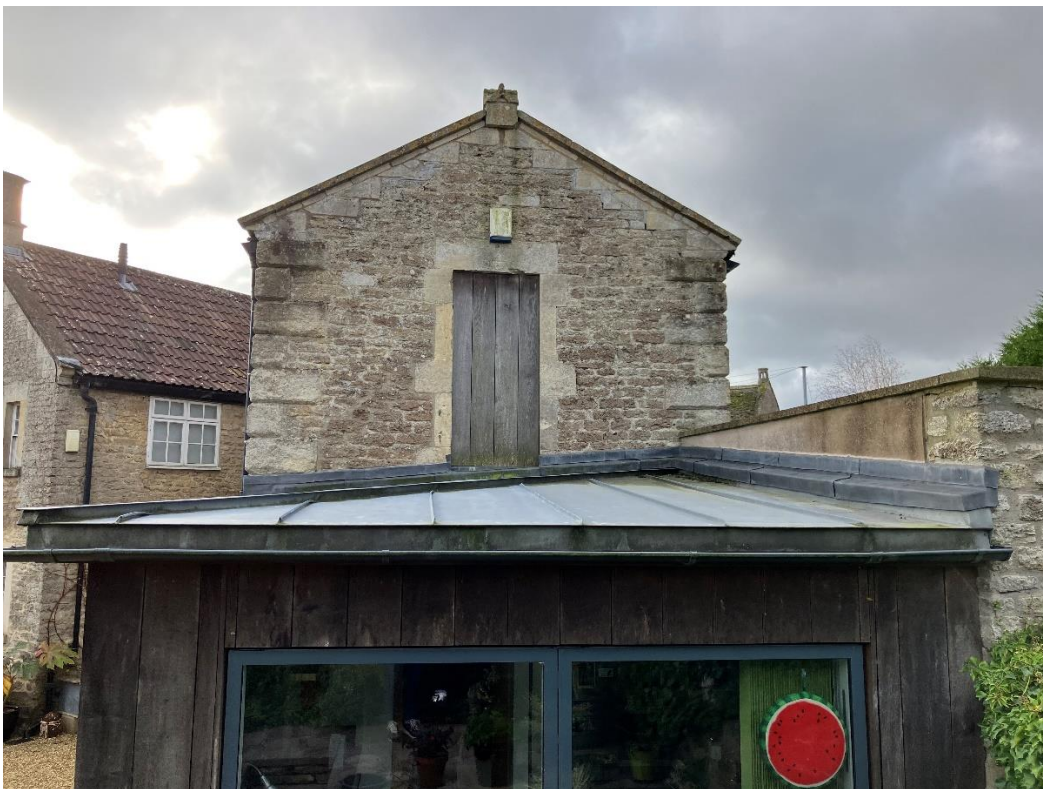
The roof is a standing seam zinc sheet roof with deep, enclosed eaves and lead upstand at the abutments with the existing stone gable and roadside walls, see Fig.5.

Fig.5 Zinc roof, shallow pitch with deep overhang at eaves and stepped lead detail at abutments with the existing stone gable and stone/render wall to roadside.
