PROJECT
COMMUNITY OPEN GARDEN
UMBERLY ROAD
SHORTLEES, KA1 5LB

DETAILS
DETAILS OF WATER ACCESS TO
SHED AND COMPOST TOILET
(PLANNING CONDITION 2 REFERS)

DRG. NO. COGS PL(2) 10

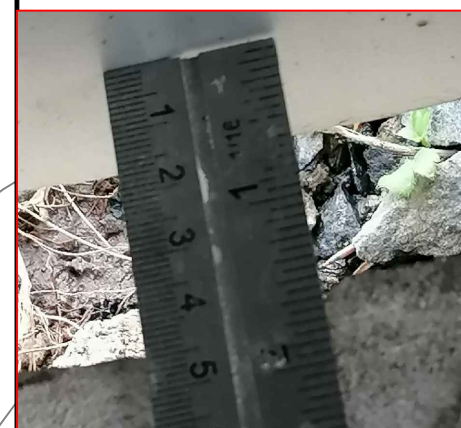
Image showing contin. 45mm gap

Broken line indicates continuous 45mm gap at bottom of shed wall cladding to allow surface water to enter during times of flooding over the site - see photos opposite for details
