CLIENT		
MR & MRS KELSE	Υ	
PROJECT TITLE		
PROPOSED WORKS	THE PUNCH BOWL,	THE STREET
HIGH EASTER, CHELN	ISFORD, ESSEX, CM1	4QW
DRAWING TITLE		
MODERN SOLE PI	ATE REPAIR DET	AIL
PROJECT No	DRAWING	REVISION
5640	D2	
SCALE	DATE	DRAWN
AS SHOWN	JAN '24	AS

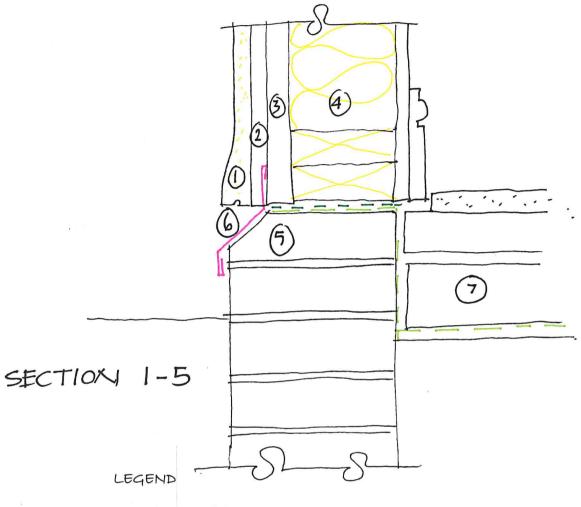
- 01. Make good and repair in matching materials existing sand and cement render and renew background support with stainless steel lath.
- 02. Repair existing vertical battens and reinstate any damaged lining membrane.
- 03. Reinstate any external ply cladding.
- 04. Modern 100 x 50 tímber frame retaíned.
- 05. Existing plinth replaced and repaired on a matching basis.
- 06. New code four lead cover flashing dressed over retained and repaired modern plinth.
- OF. Modern oversite, dpm and screed.
