Timber Window Repairs and Replacements

Replacement Sills

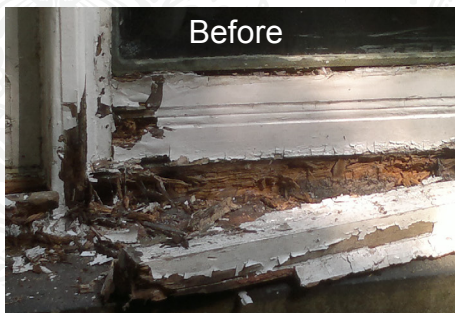
Rotten unsalvageable sill

To replace the rotten sill we also replace the lower sections of the pulley stile and outside facing to remove any underlying rot and ensure the repair will last as long as the original. When the new sill is fully installed we then prime the exposed timbers ready for final painting by others. Our preferred timber for replacement sills is treated Grade 1 Redwood.

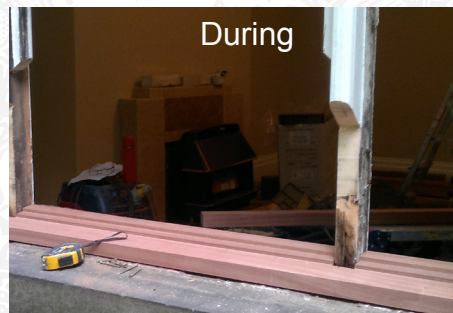
Sill replaced with bespoke new timber and rot cut out from sash frame

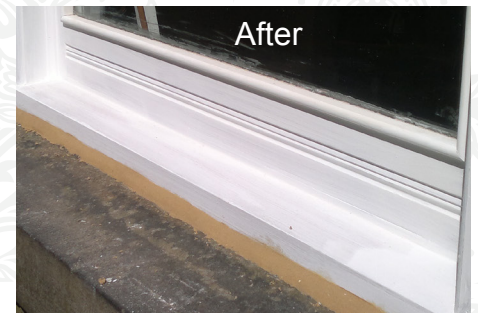
New bespoke timber spliced in with primer coat ready for painting
