Glendurgan Front Gate

October 2023

National Trust

COOKSON & TICKNER
LANDSCAPE ARCHITECTURE

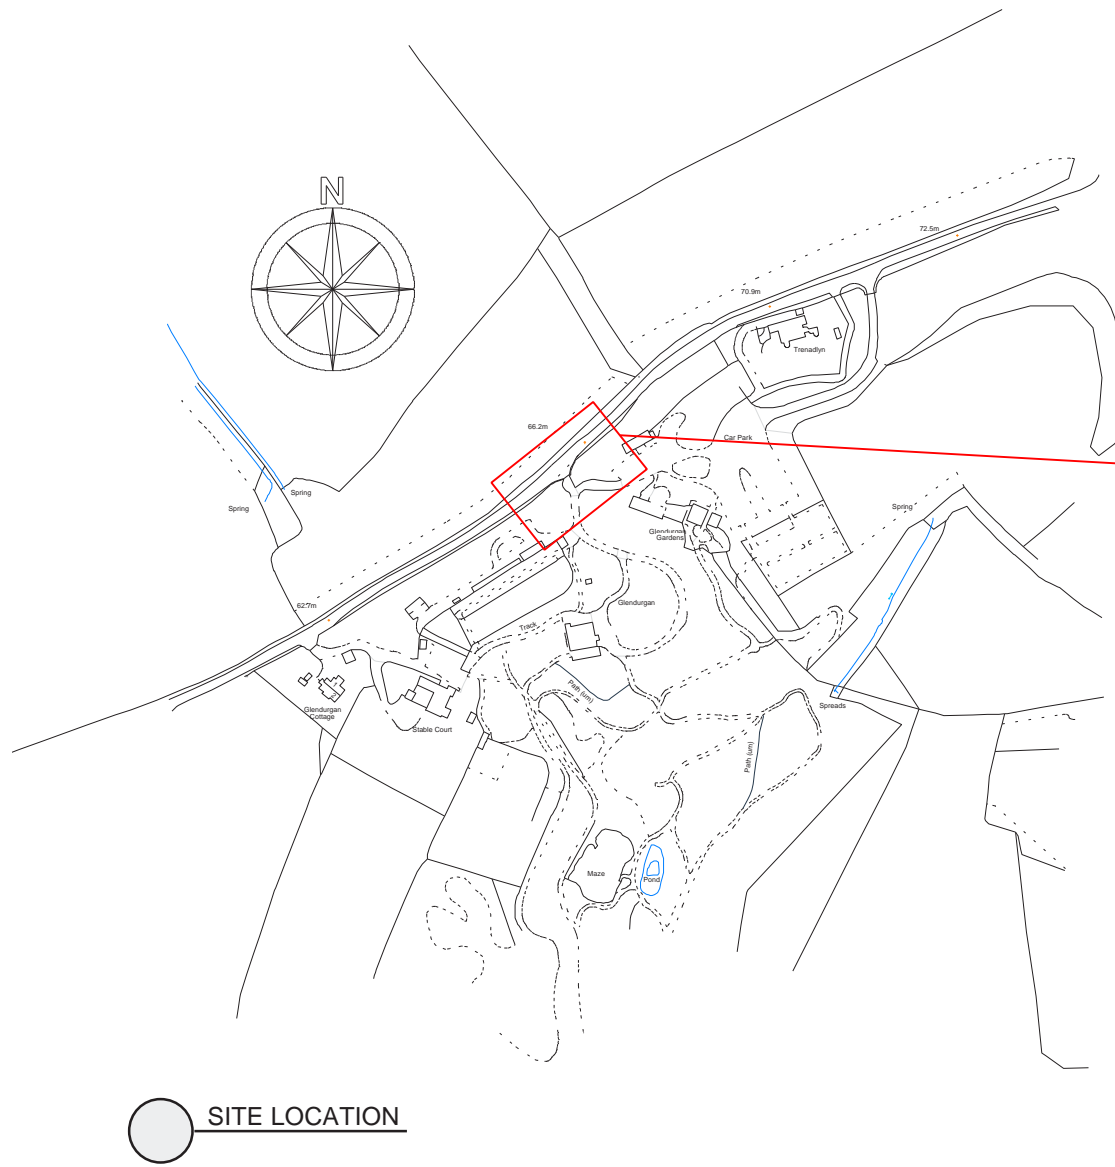
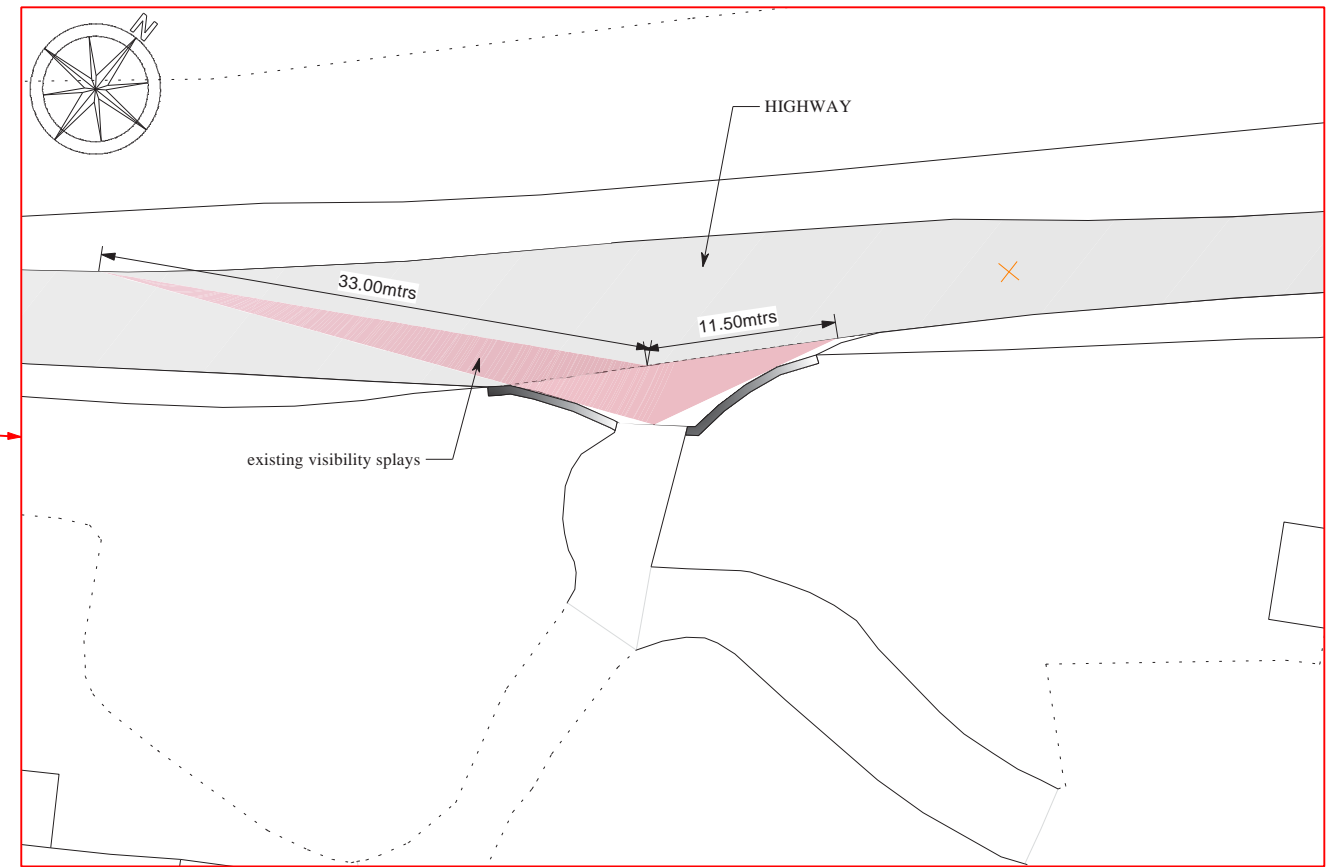
● EXISTING VISIBILITY SPLAY

Please see full sized A1 scale plan CT193.02, in attached documents

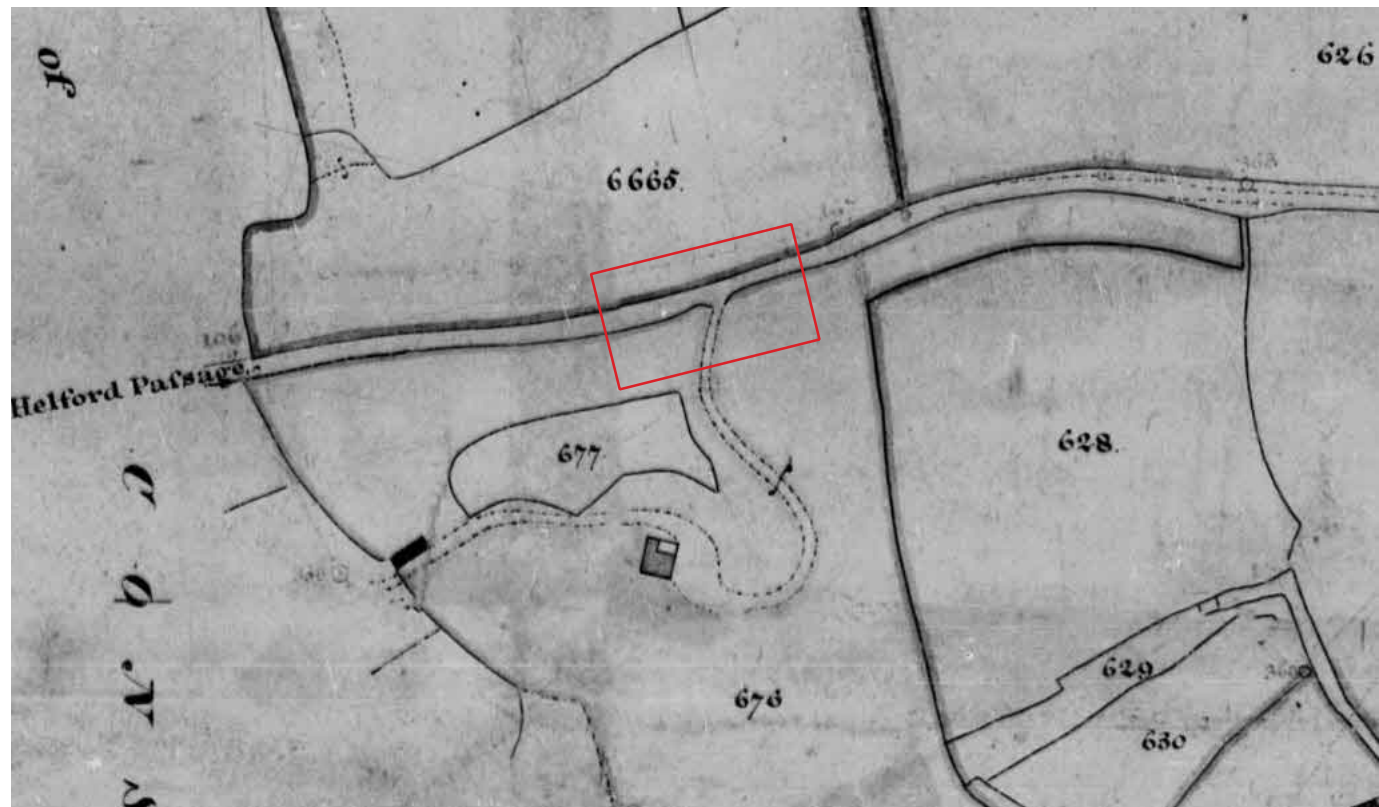
Tithe map showing Glen Durgan, 6th April 1839

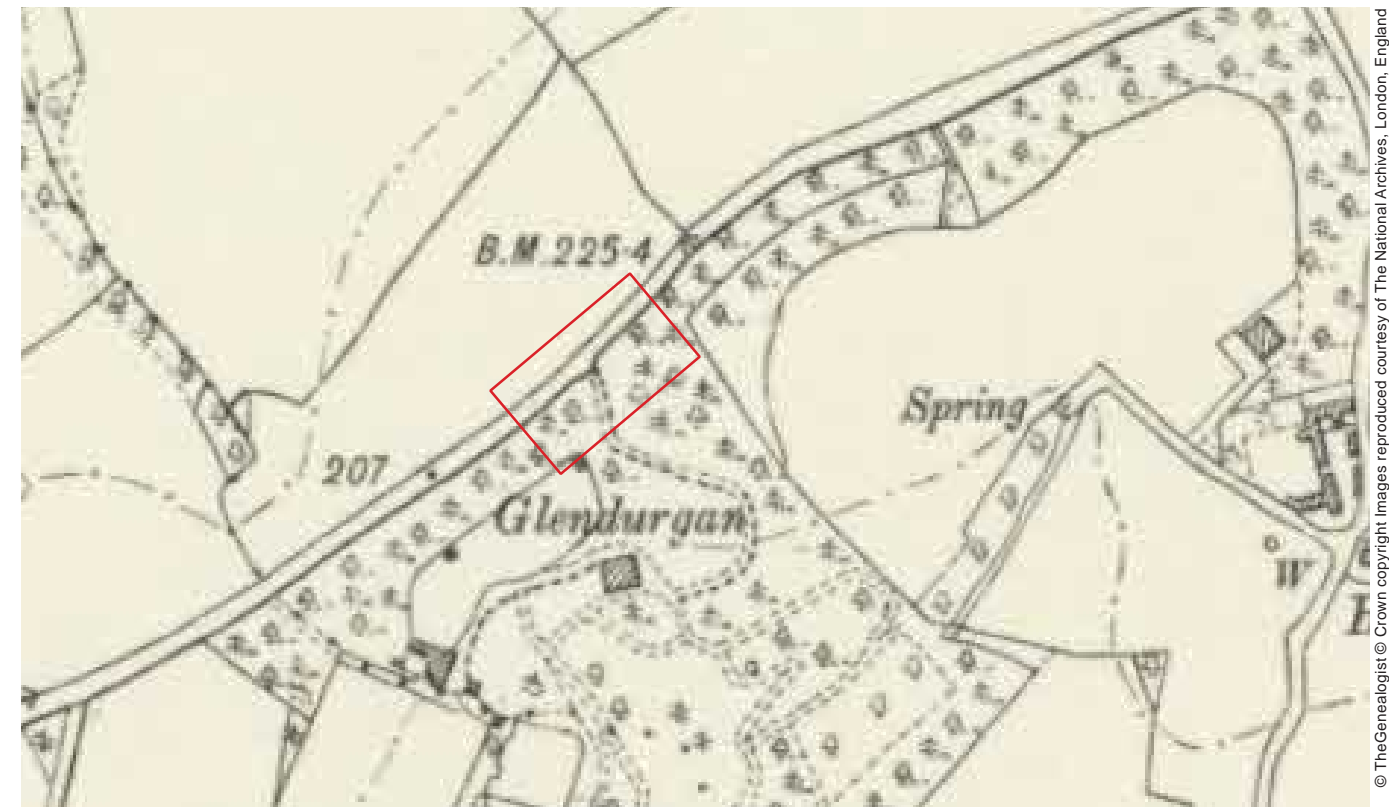
2nd Edition Ordnance Survey map 1906, published 1908

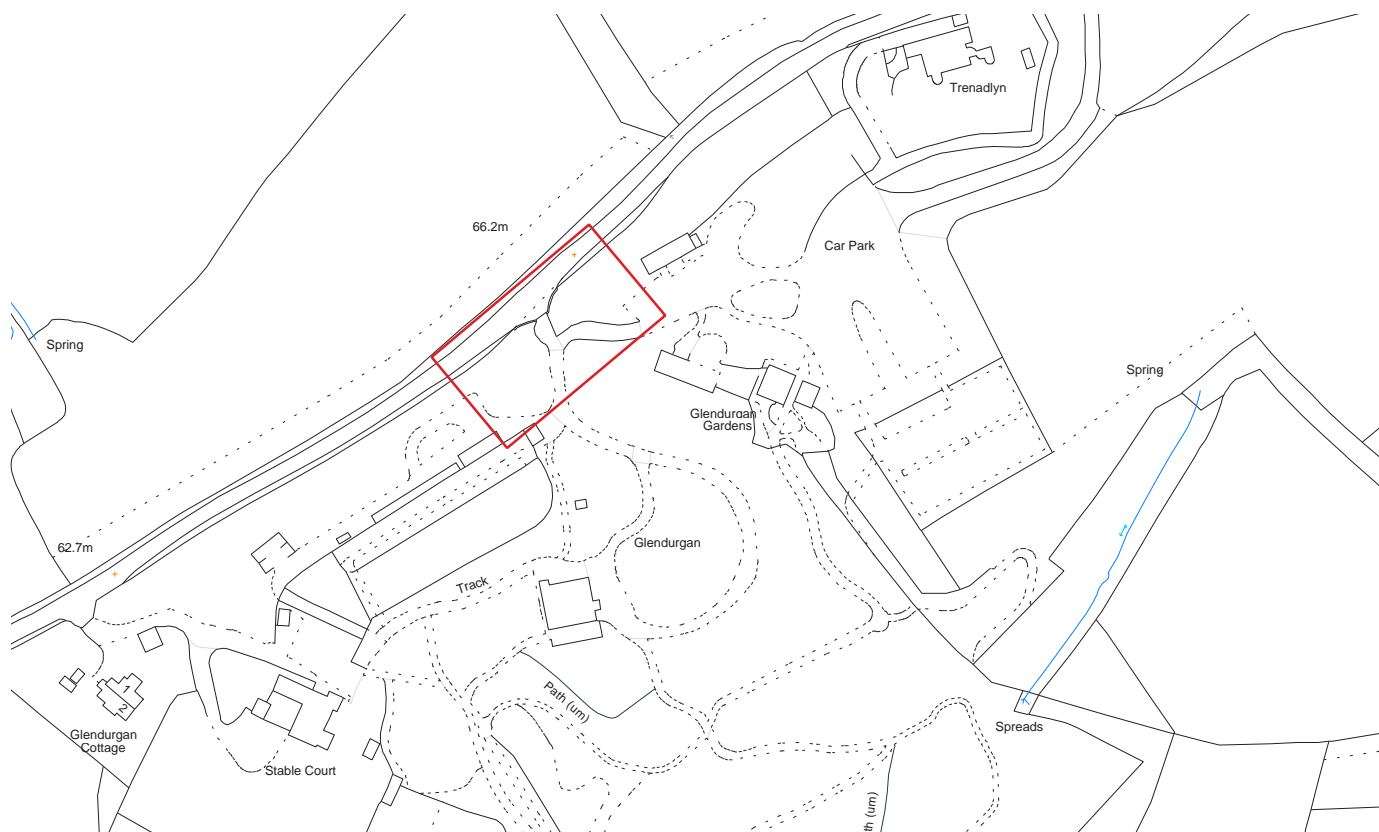
Present day Ordnance Survey mastermap indicates the existing gateway and drive to Glendurgan House

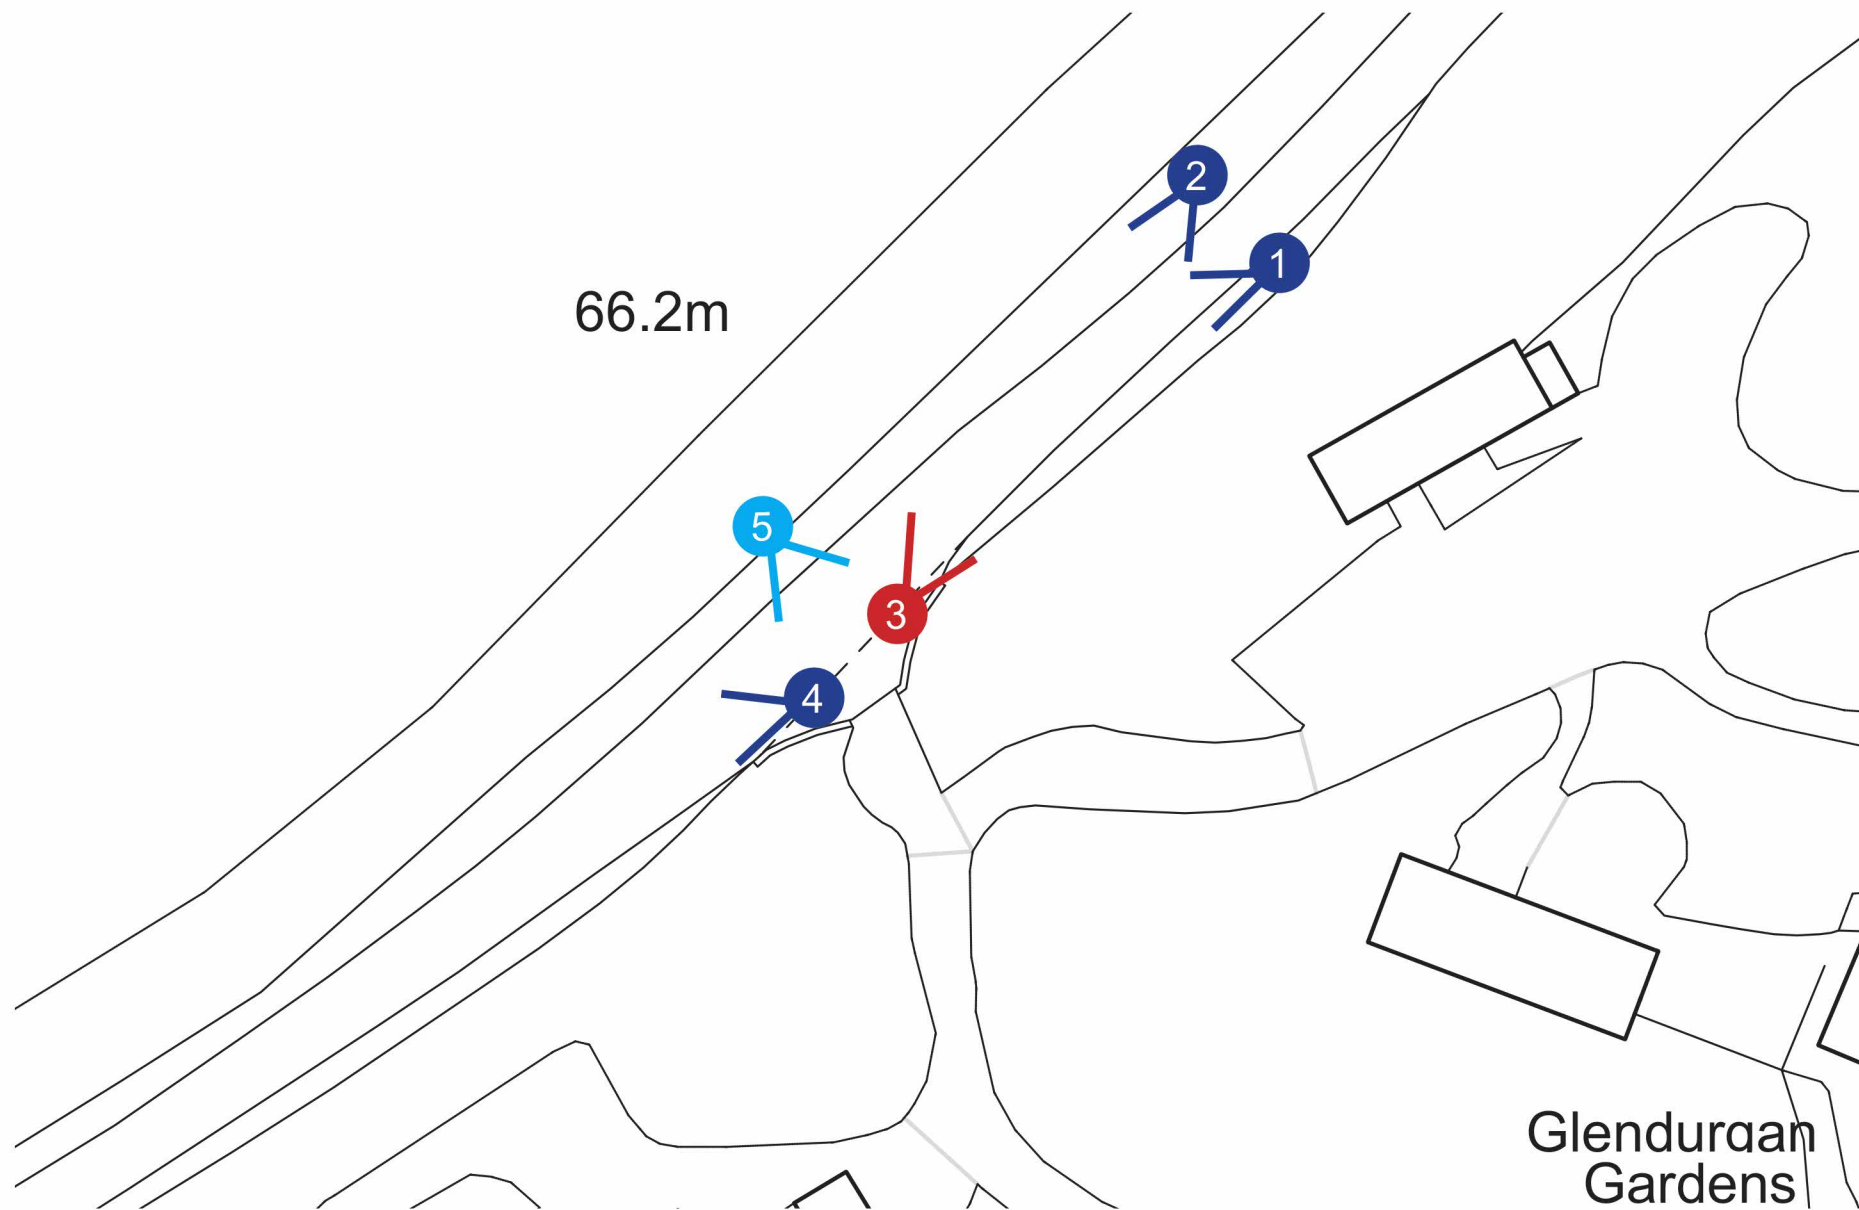
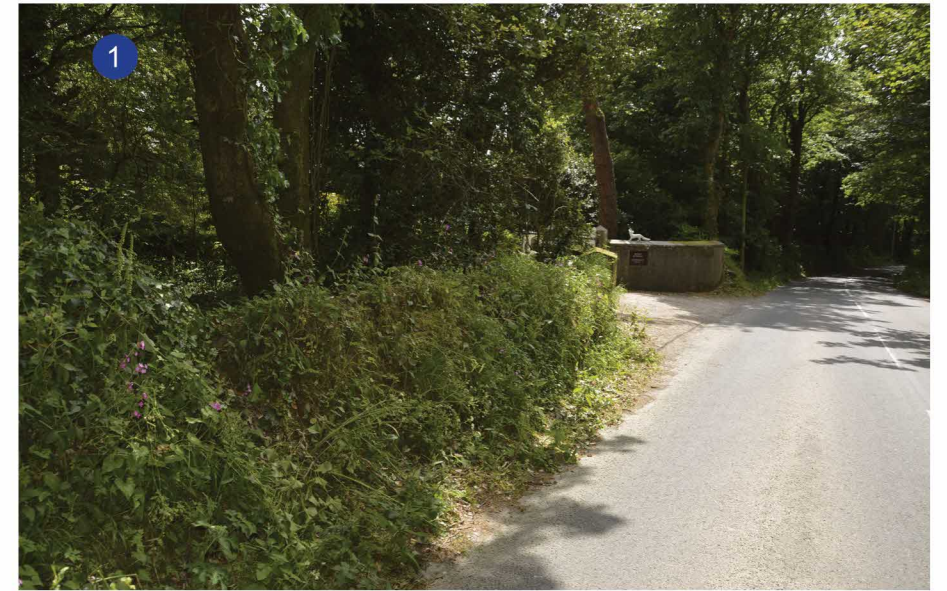
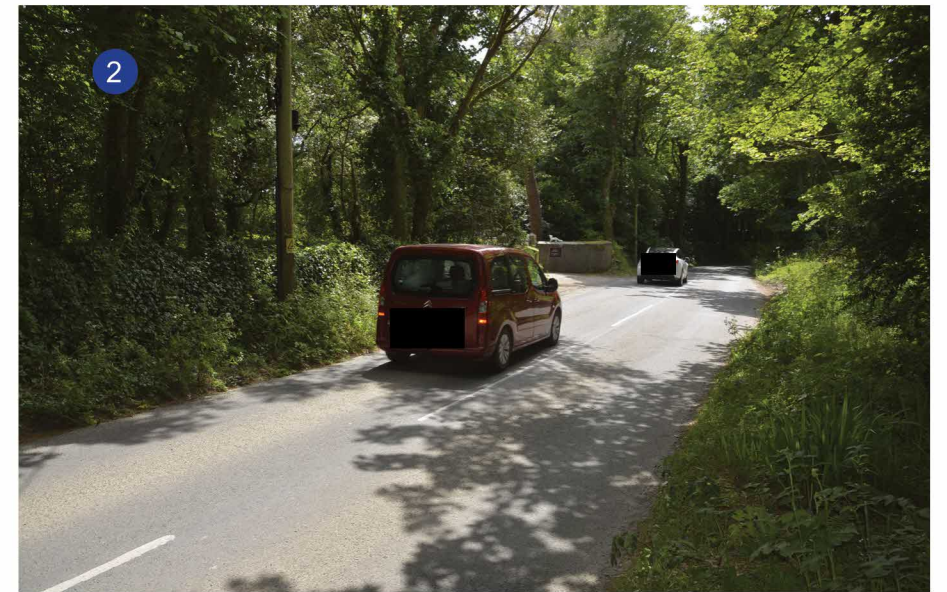
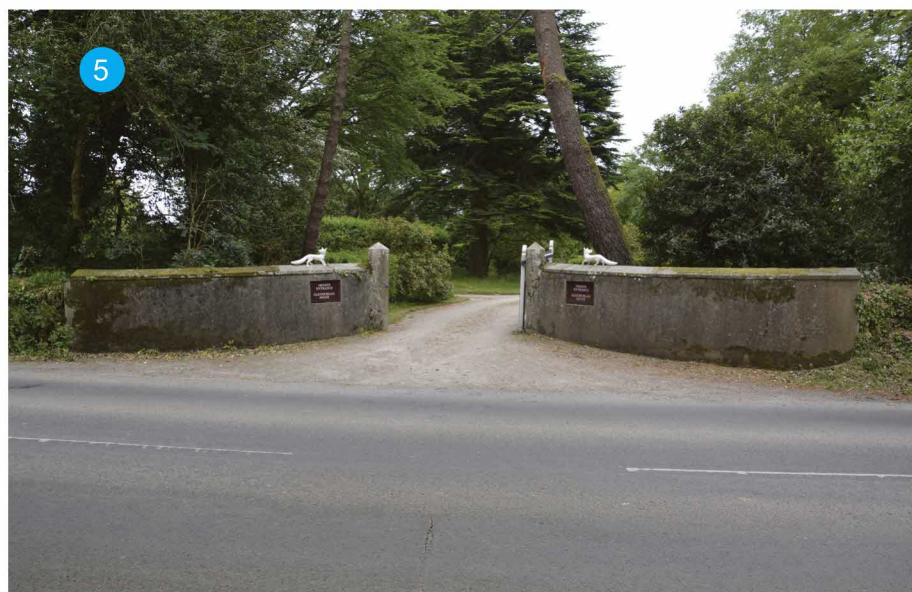
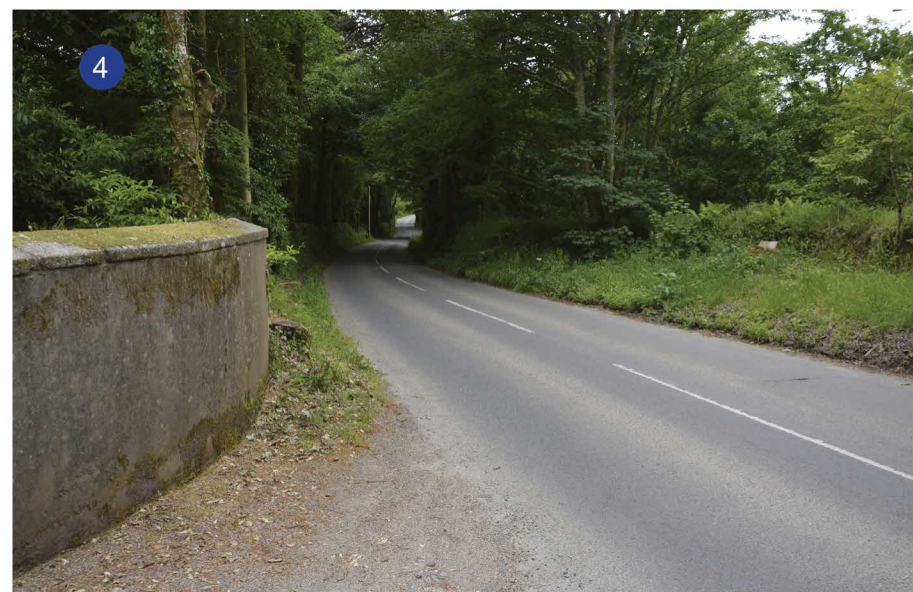
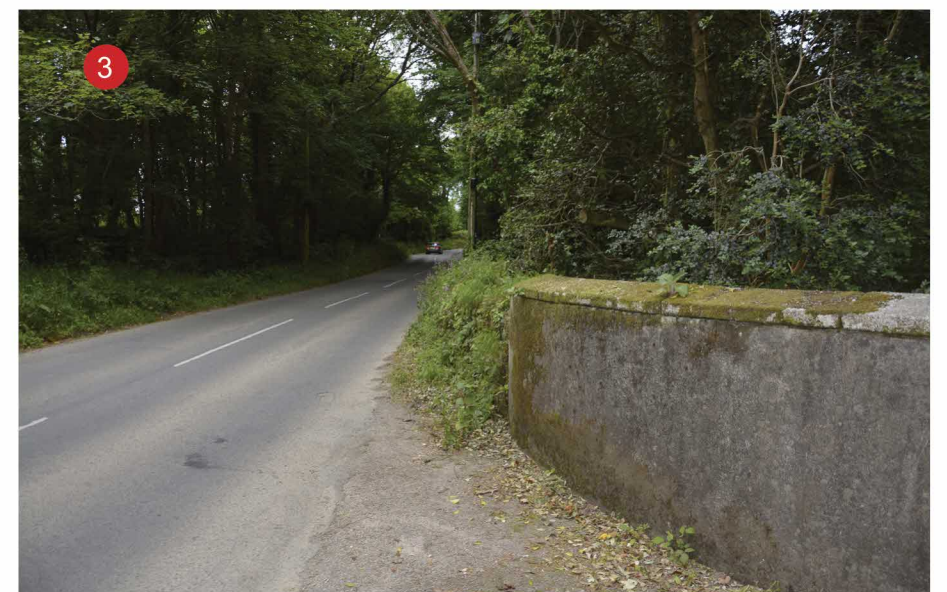
Photographs of existing gateway visual splay

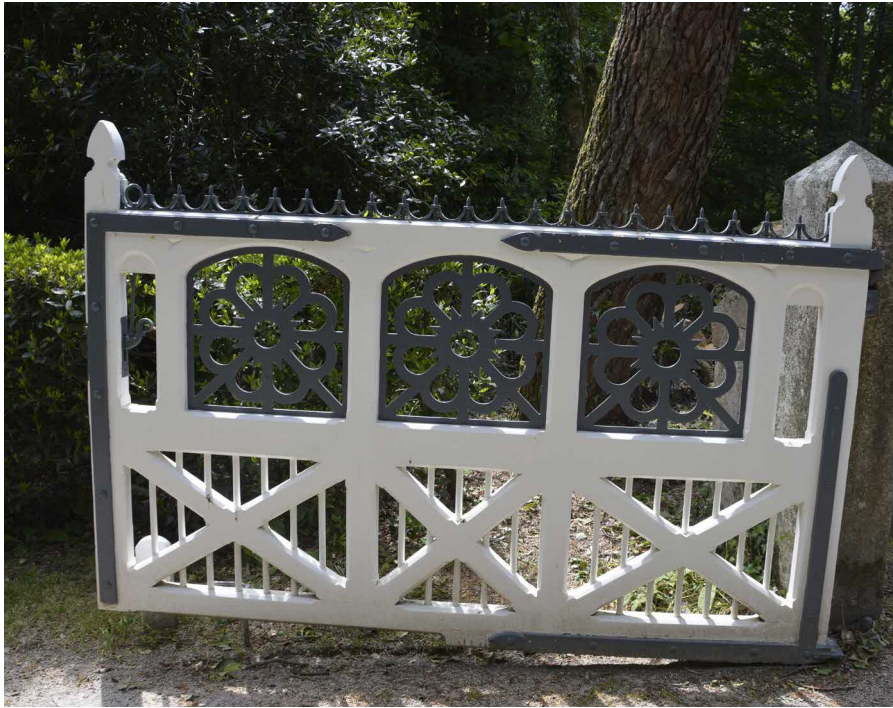
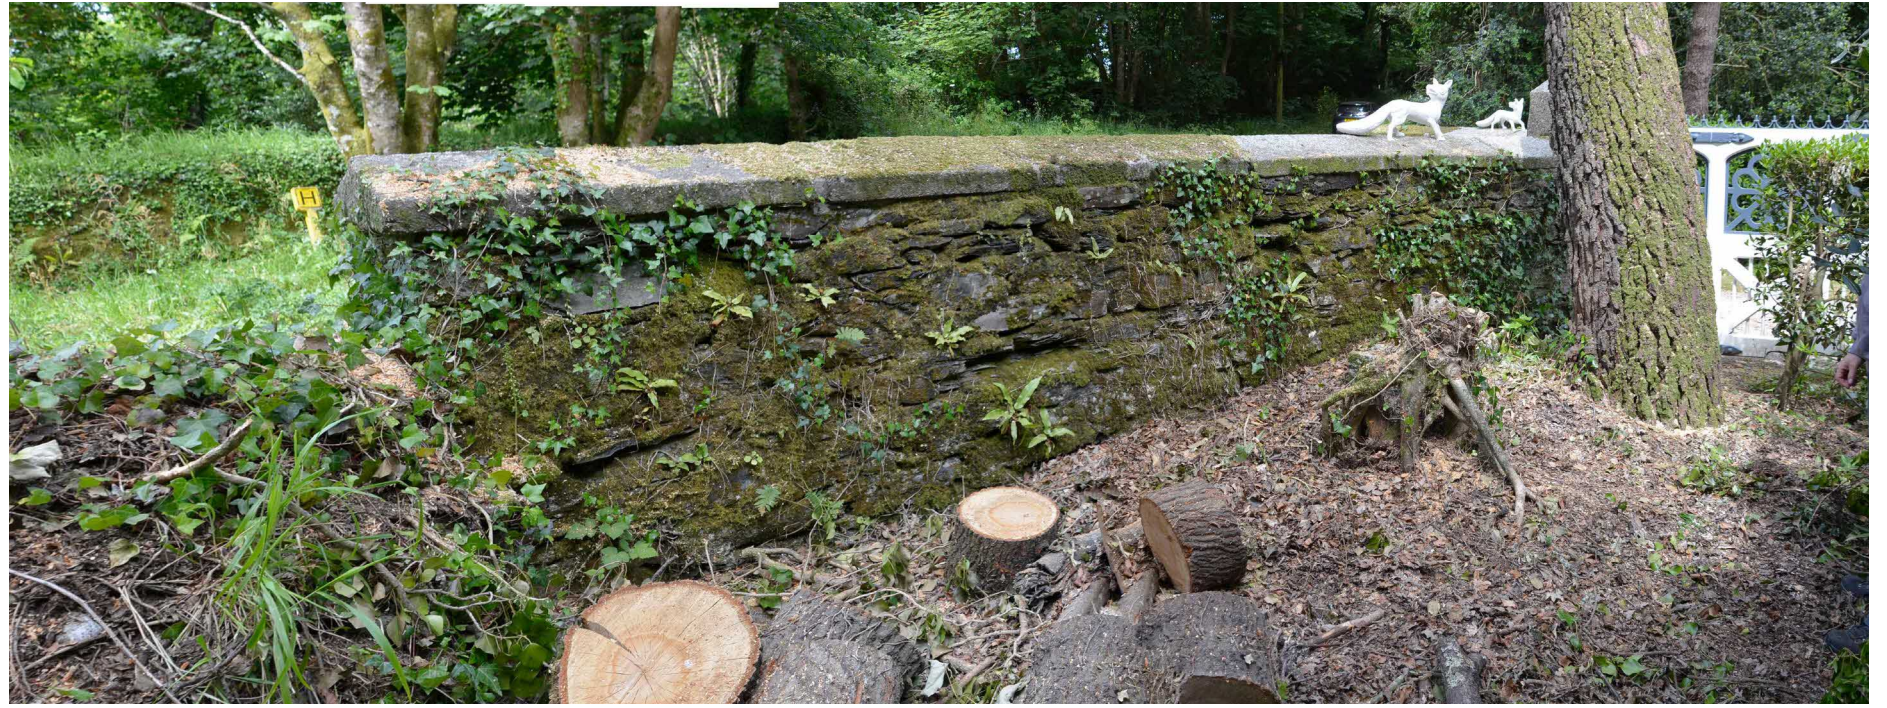
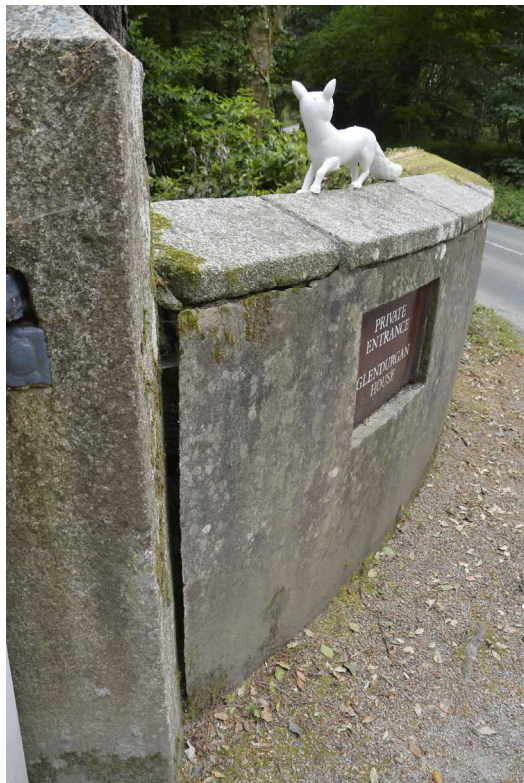
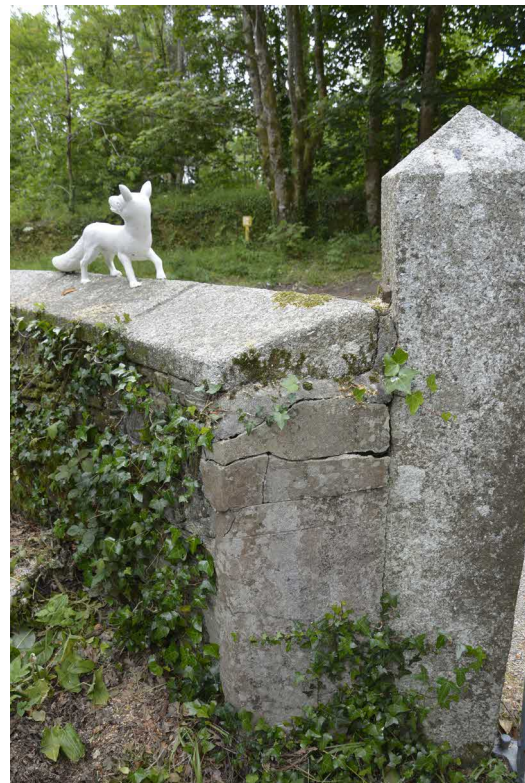
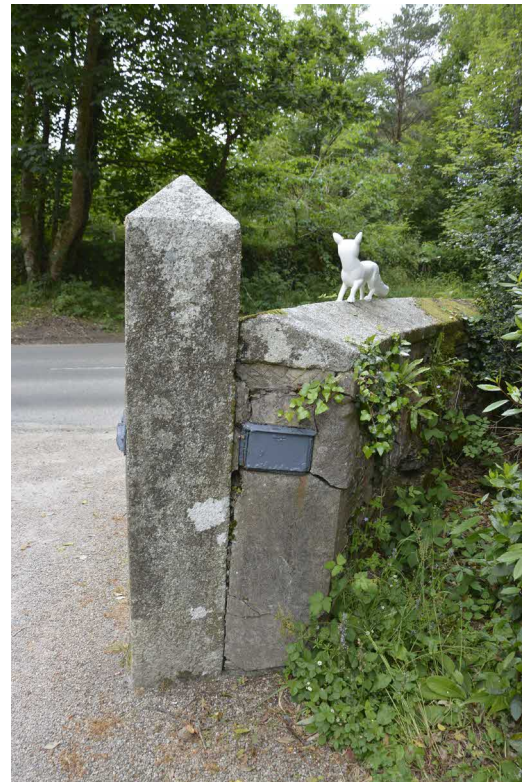
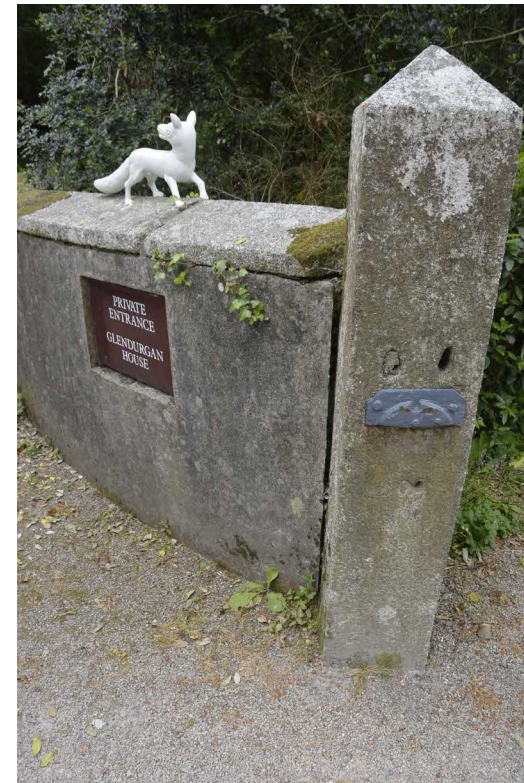
Historic fabric

'The C19 entrance to Glendurgan House is situated c 200m south-west of the late C20 visitors' entrance on the minor road to the north of the site. The entrance comprises an ornamental mid or late C19 timber and cast-iron gate with three cast-iron floral motifs in the upper section above vertical rails and saltire stretchers in the lower section. The gate is supported and flanked by a pair of obelisk-shaped granite piers which are in turn flanked by quadrant stone walls. To east and west of the entrance the walls support a pair of white-painted metal running foxes. The entrance leads to a gravelled drive which sweeps south and south-east through mixed ornamental shrubbery and specimen trees planted on lawns, before turning west to approach the carriage court on the east side of the House. A service drive continues round the north side of the House to reach the service quarters to the north-west, and the stables c 80m west of the House. The C19 stables have been

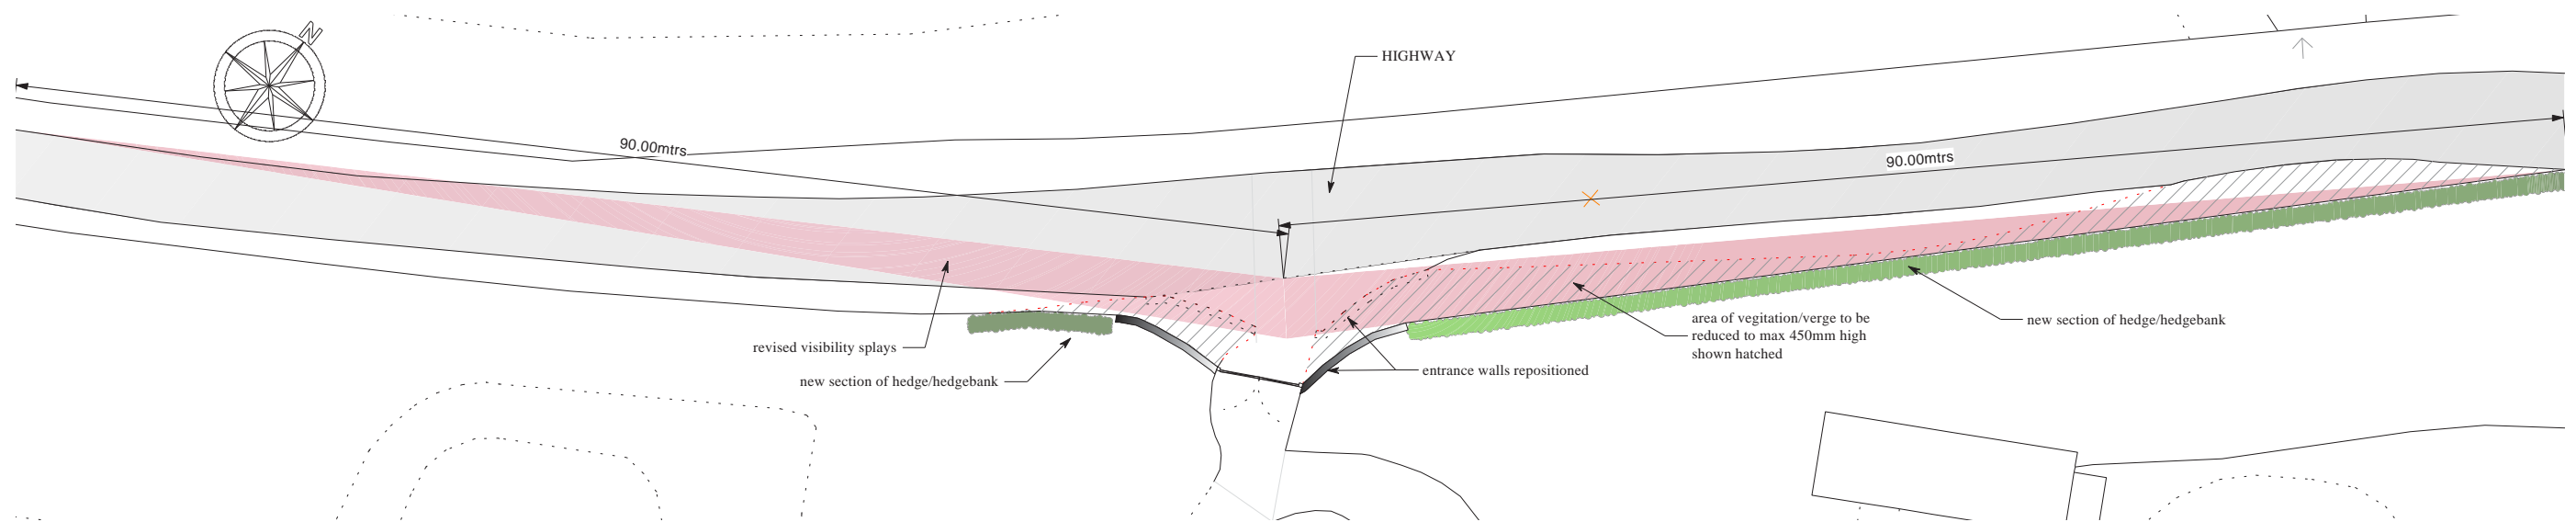
PROPOSED VISIBILITY SPLAY

Please see full sized A1 scale plan *CT193.02*, in attached documents

Drawing *CT193.02* shows a possible approach to the rearrangement of the front gate which involves relocating the gateway a short distance back from the highway to increase sightlines and widen the entrance. It would involve the relocation of Cornish hedgebanks and is likely to affect a number of trees. The existing historic fabric, comprising the gate, gateposts and stonework associated with the hedgebanks, would be retained, and relocated.

A small new section of gate to match the existing historic gate would be created to enable the full wider gateway to be closed if required. The new gate leaf could be presented as a pedestrian scale

gate to provide a rationale for this smaller section.

The outline proposal is shown with a 90m visibility splay for discussion and it is expected that ecological and agricultural surveys will further inform the final design, along with feedback from Cornwall Council Highways officers.
