PROPOSED NORTH ELEVATION - REAR YARD

PROPOSED SOUTH ELEVATION - GARDEN AND HOUSE SECTION

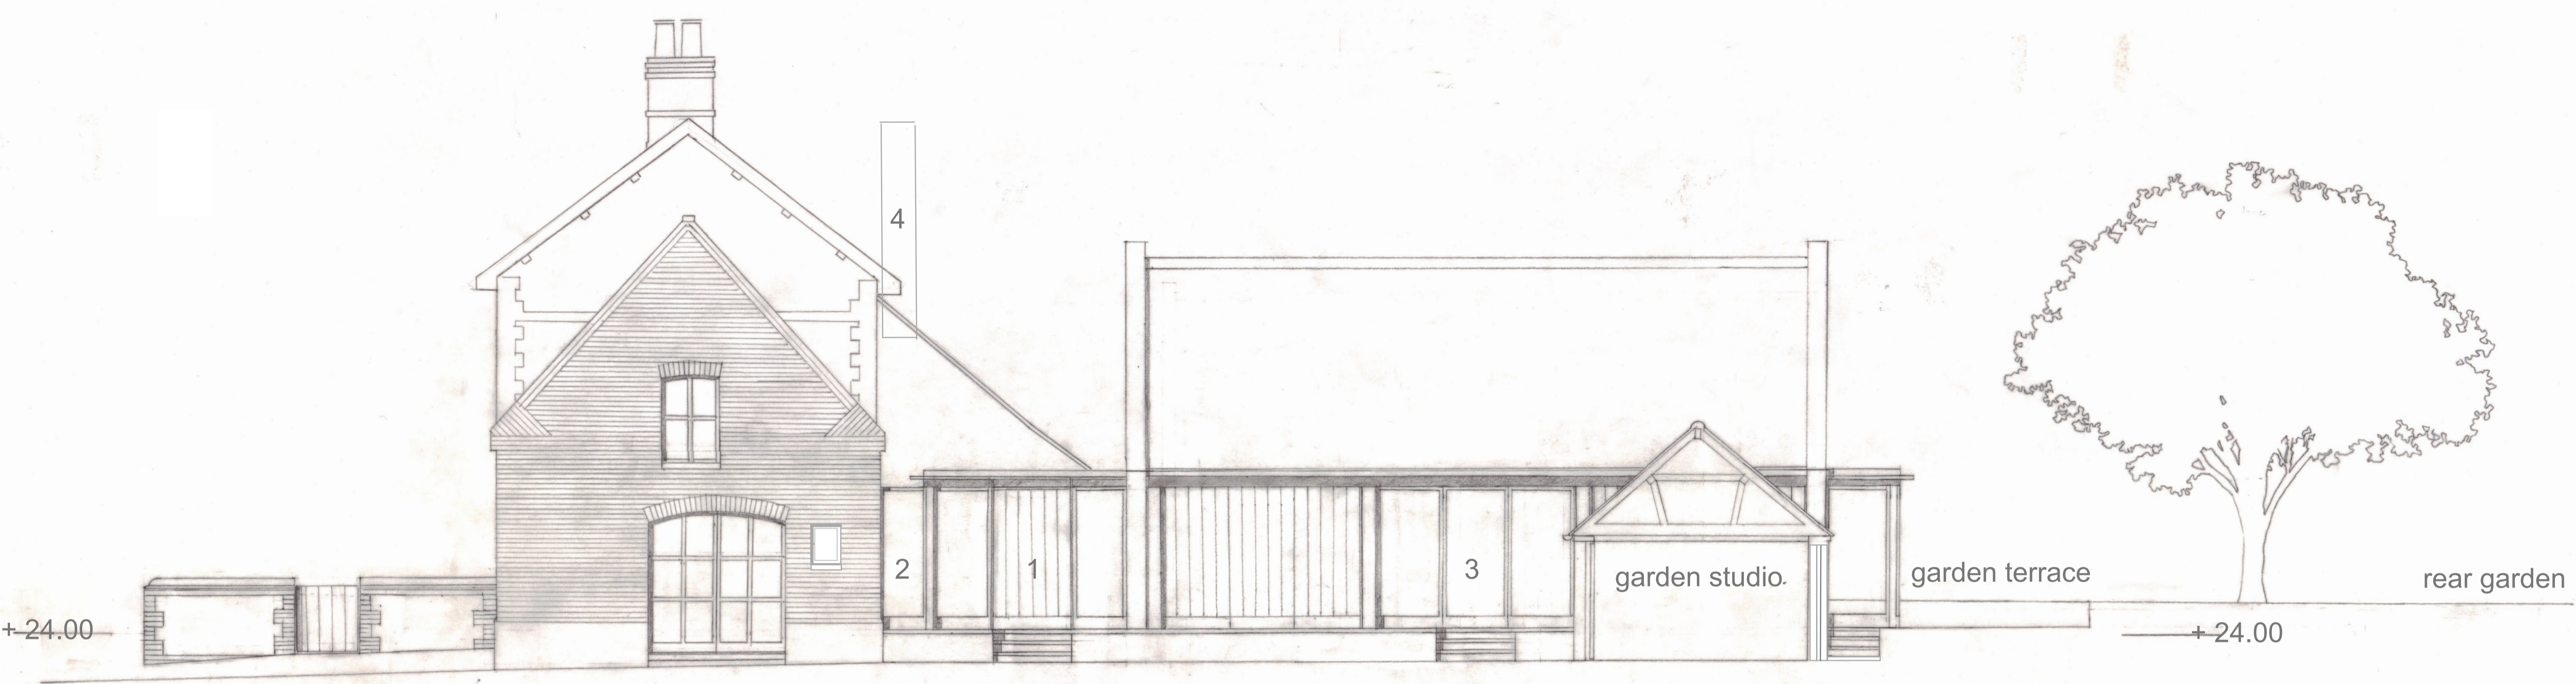
flint and reclaimed brick wall with metal gate

New timber framed windows in former stable openings. Paint removed and brickwork repaired to received lime plaster render

- 1 - proposed timber framed hall extension with metal framed windows and timber door
- 2 - minimal glass and metal framed link to existing house
- 3 - proposed garden room extension with timber panels, metal windows and pantile roof
- 4 - remove existing chimney stack
