Back Elevation

PROJECT:	22 GLOUCESTER STREET, CIRENCESTER			
DWG TITLE:	OPTION 9 ELEVATIONS			
SCALE:	1:50 @ A1	DRAWN	: IT	CHECKED:
DWG NO:	23.037.PL.19	REV:	A	DATE: 09.01.23

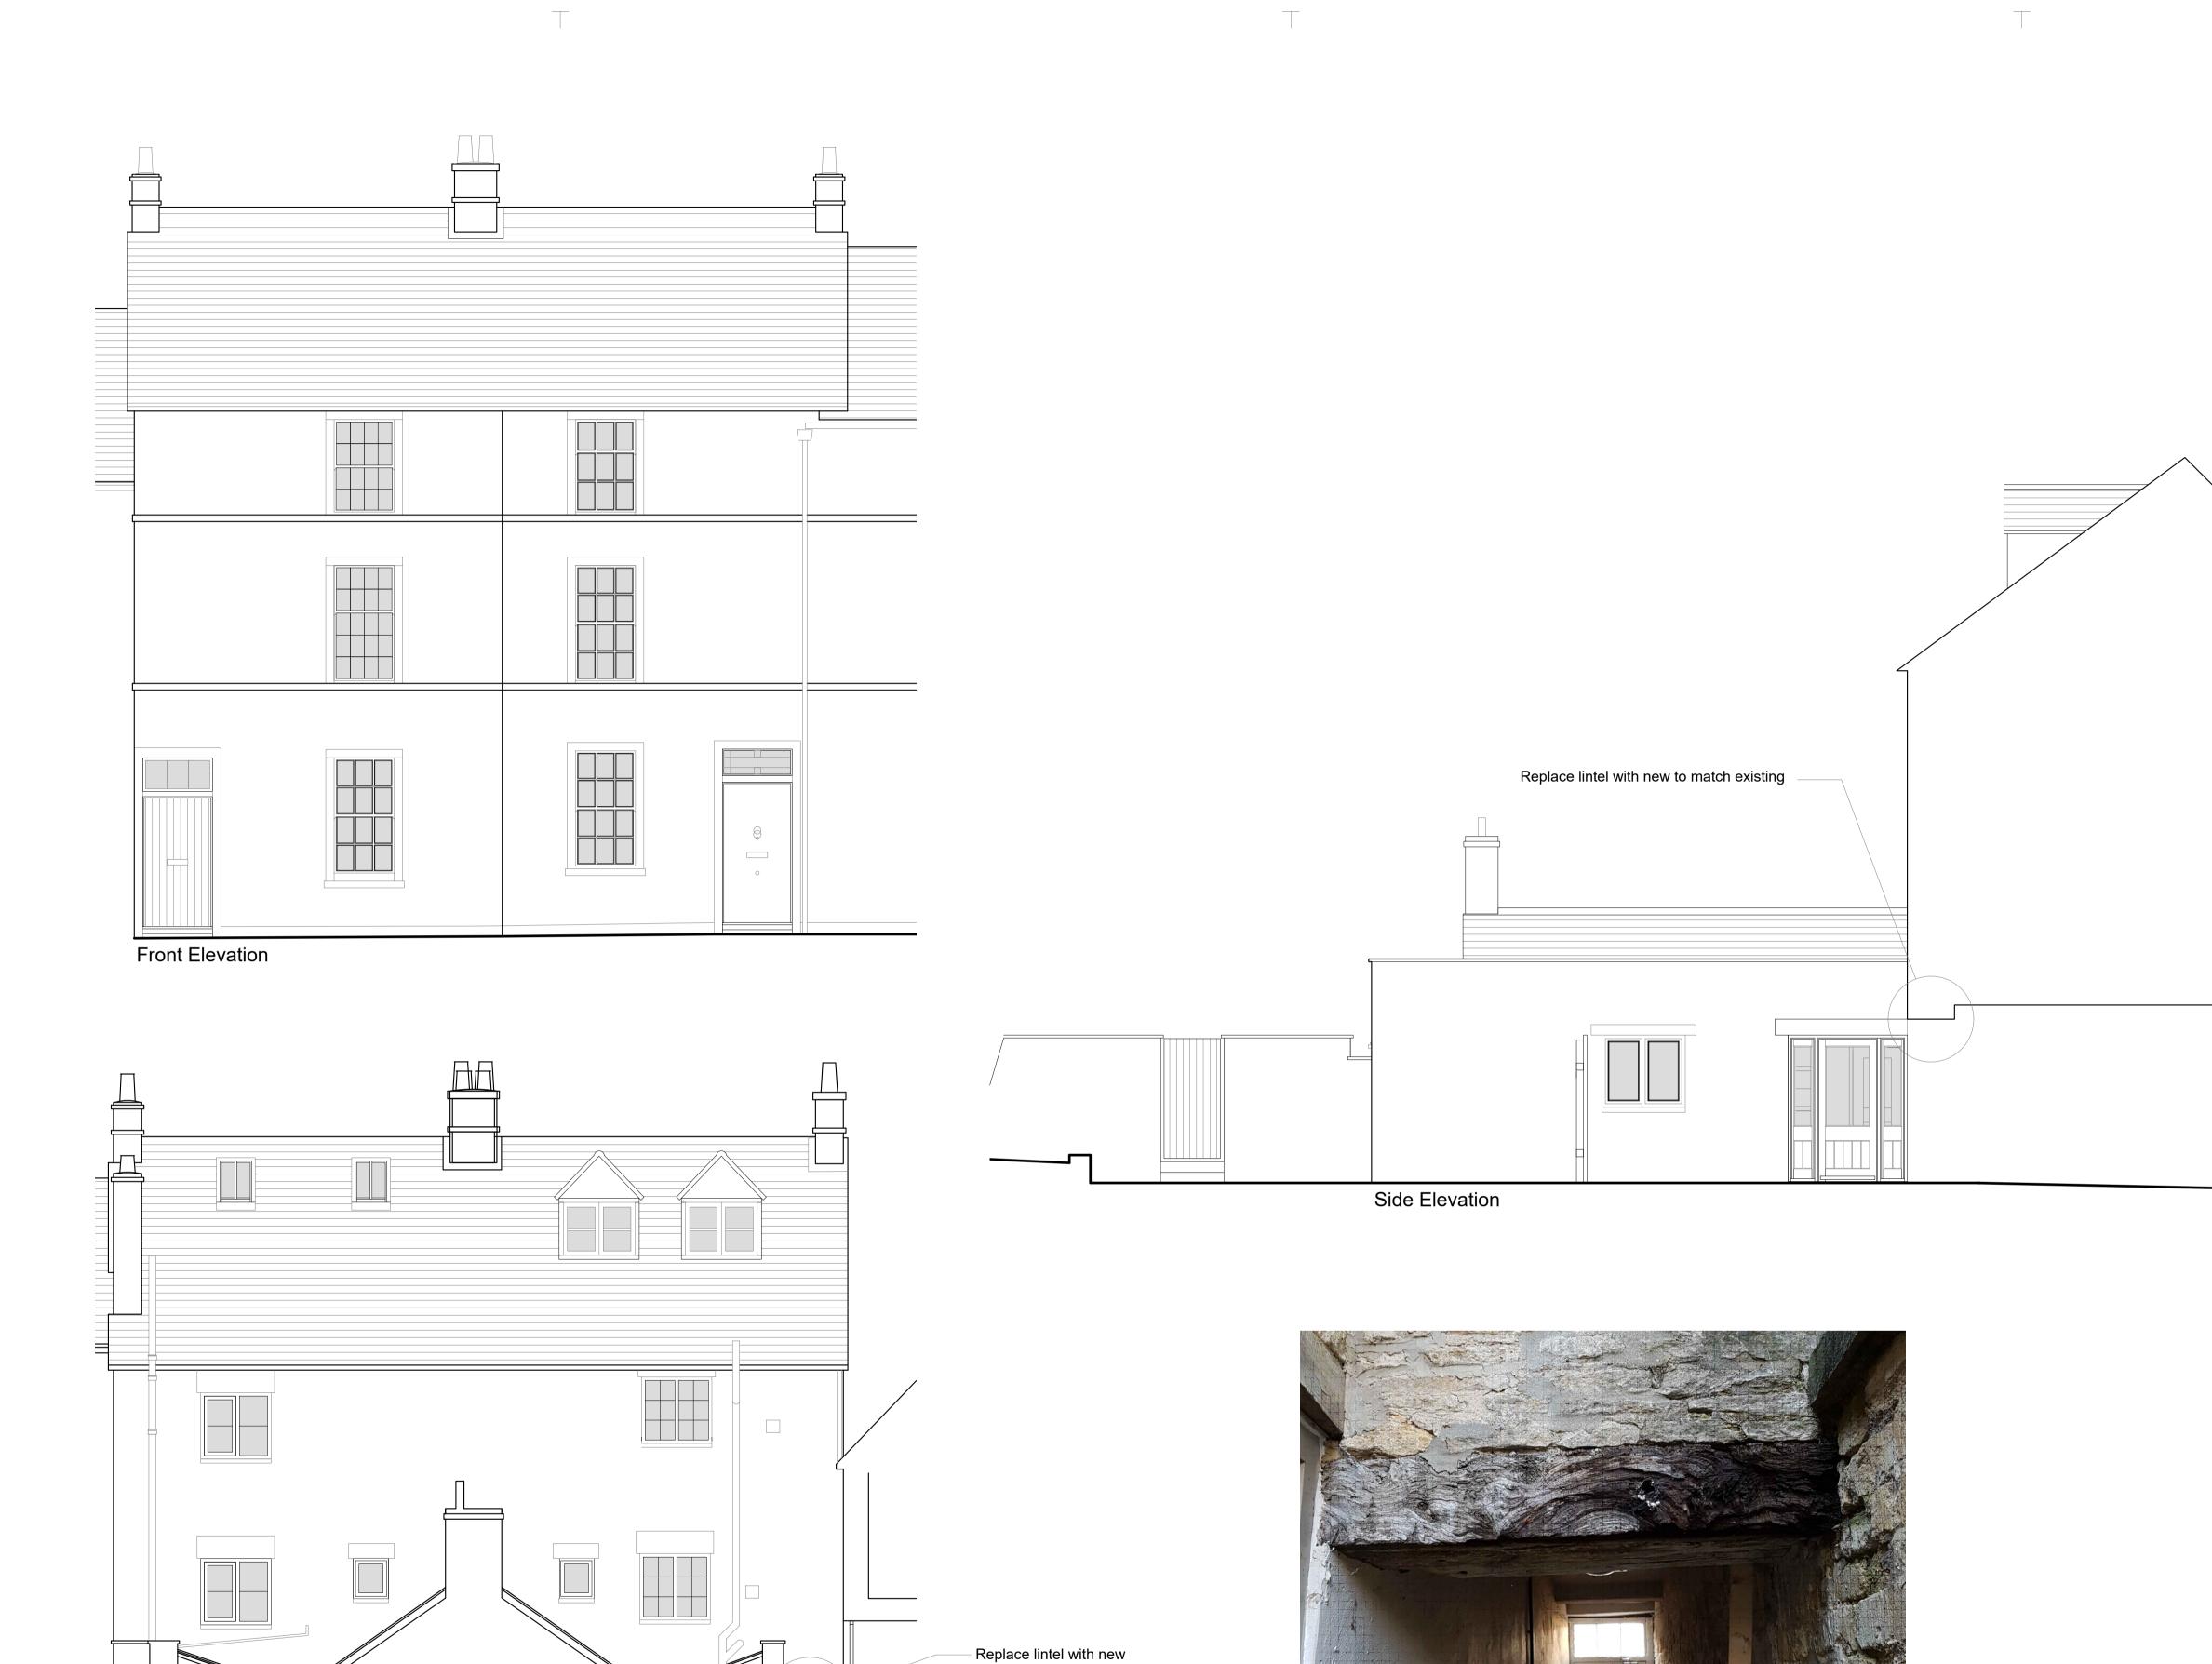
to match existing

Existing lintel over side access is rotten. Resin or scarf repairs would be inadequate given the weight of walling stone above and therefore the lintel msut be replaced with new timber of matching species and dimensions.
