# LEVEL MONITORING

## for Subsidence Management Services

### 3 High Meadows, Kirk Ella, Hull, HU10 7NJ

Client:	Subsidence Management Services
Client Contact:	John Morrison
Claim Number:	500387177
Client Reference:	IFS-LBG-SUB-22-0101724
Policy Holder:	Nicholas Richardson
Report Date:	18 August 2023
Our Ref:	M20534

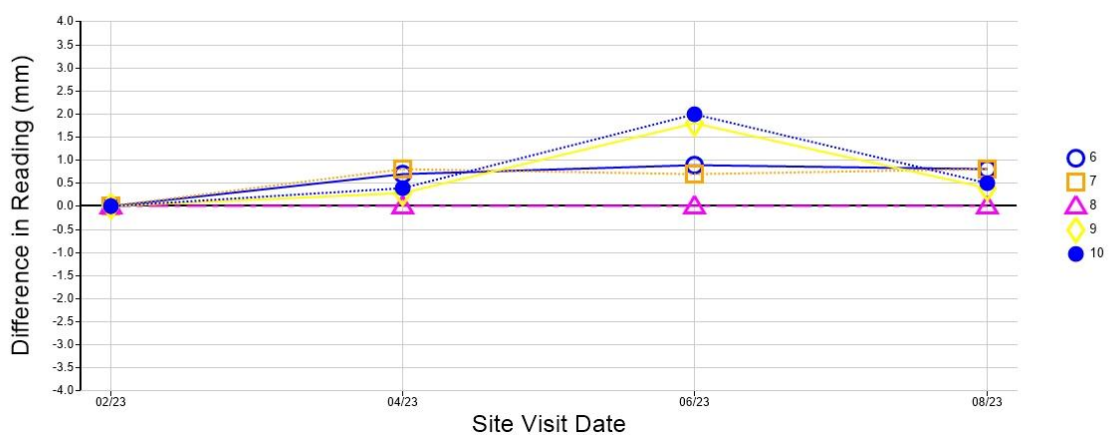
## Level Monitoring Difference Graphs

The following graphs display the progressive movement that each Level Monitoring Station recorded at each separate site visit date to give an overall look at how much the property is moving.
