RURAL ELM  
BESPOKE RENOVATIONS

DOCUMENT NO: RE-BB19-MIM-D01

DOCUMENT DESCRIPTION: Design and Access and Heritage Impact Assessment

This document accompanies the application for listed building consent for proposed alterations to The Corn Exchange, High Street, Moreton-In-Marsh, Gloucestershire GL56 0BB. This is a proportionate assessment for works to a Grade II\* listed building. The building is referred to under a variety of names; The Corn Exchange, The Gateway, The Steps. This document will use the name The Corn Exchange.

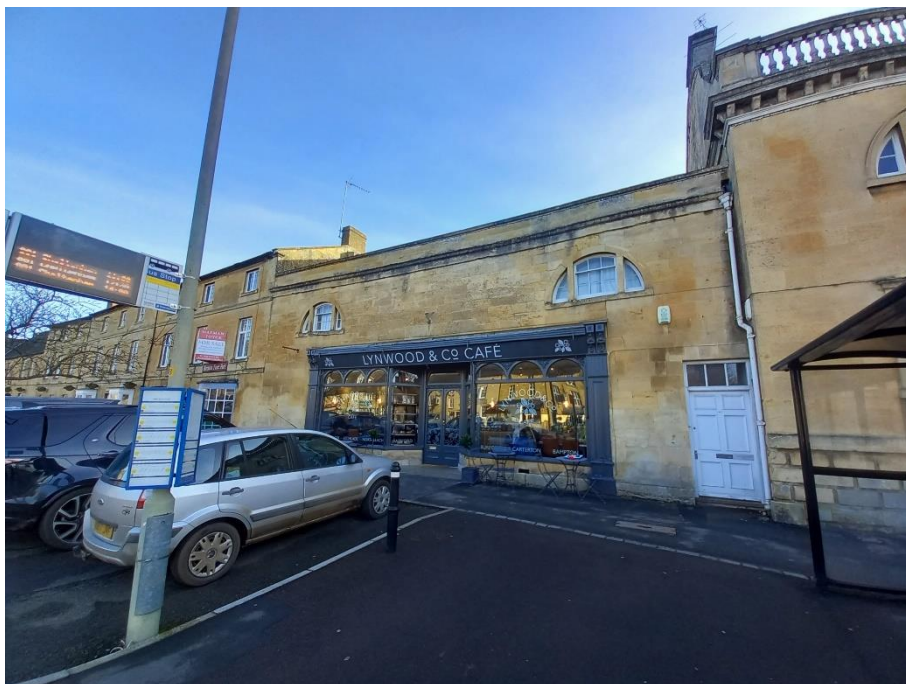
Above: North wing of The Corn Exchange.

The Corn Exchange is an extensive building. Facing the market place, it has been used as a dwelling and a place of commerce (Corn Exchange, grocers, stationary shop and café). This application relates to the ground floor façade of the north wing referred to above.

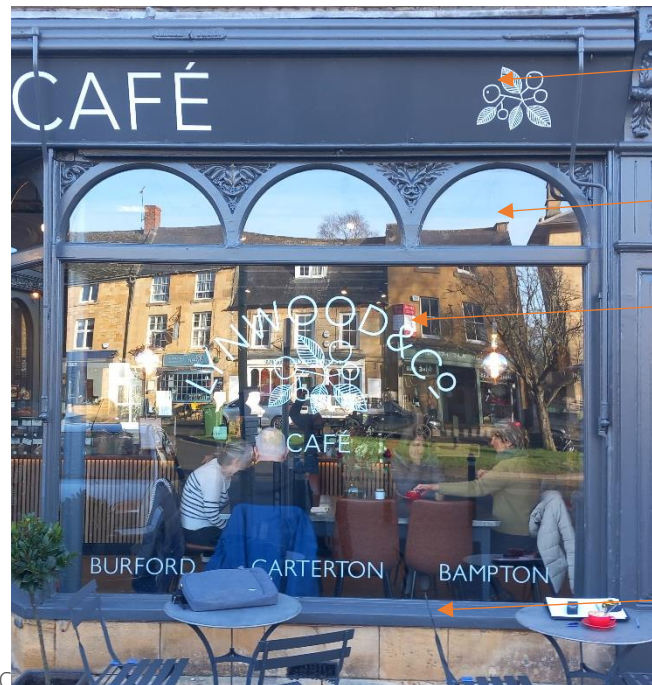
Existing Plywood sign board.

Half round windows, with putty and many layers of historic paint to infill detail.

Timber mullions previously removed and no putty to glazing.

Replacement cills.

Above: Detail of window bay showing previous adjustments.

Historic paint layers have not been stripped and vinyl lettering is easily removable.
