The Old Rectory, Eversley, Hook, RG270PX

W5 replacement  
Box sash window

SHEET NO:  
20F2

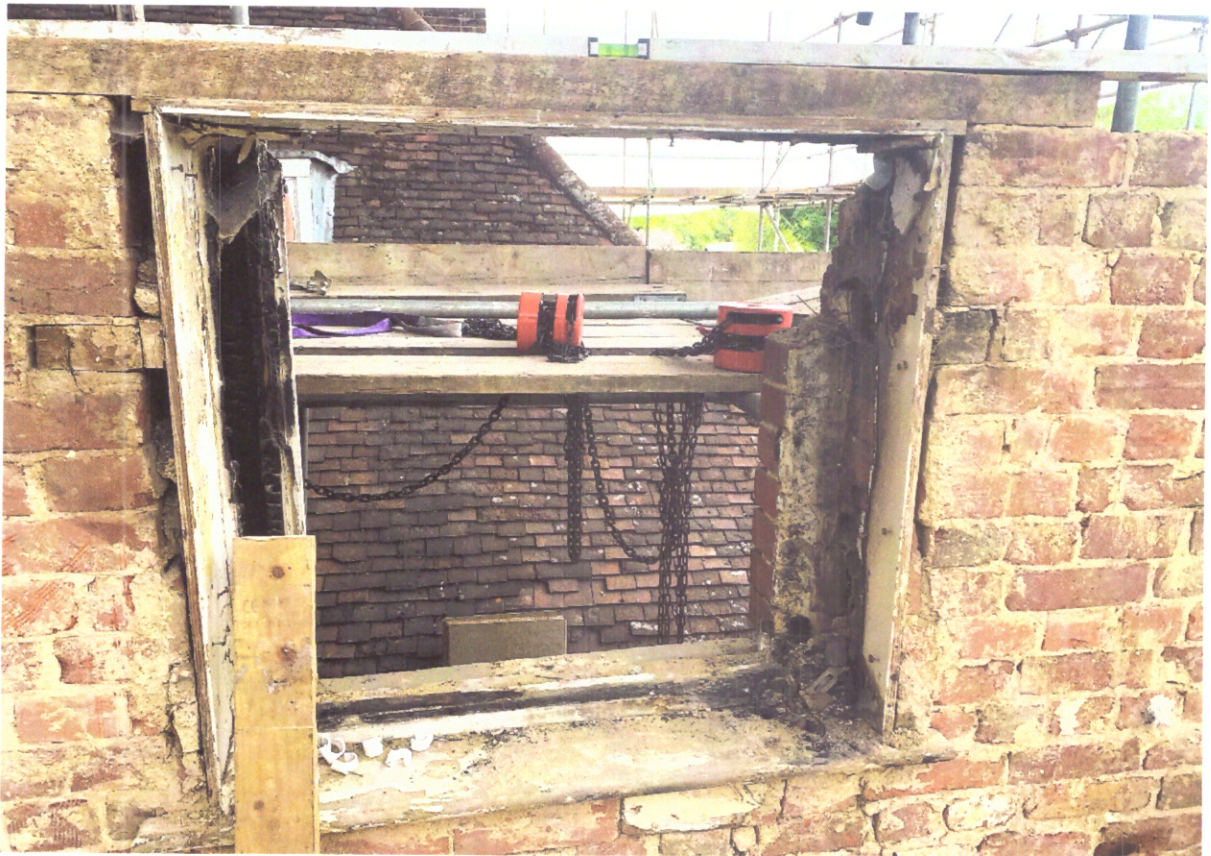
Structural opening left for W5

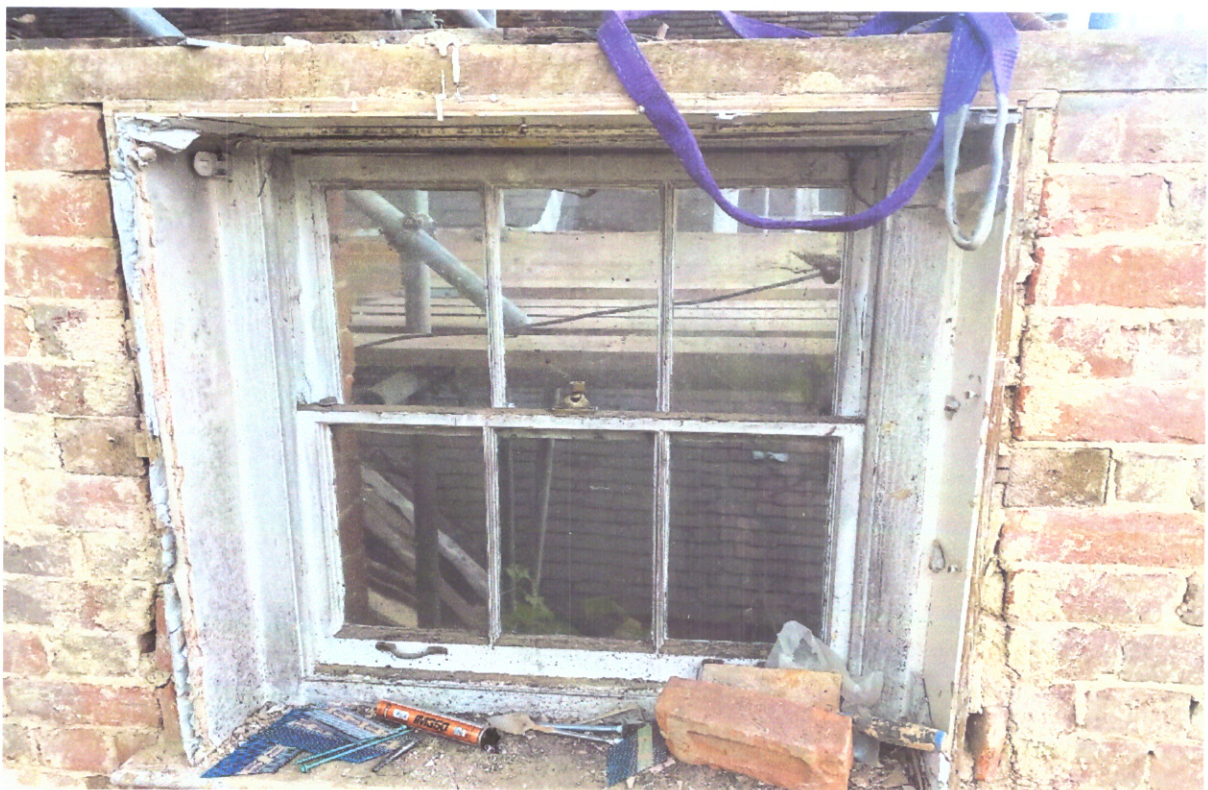
Window adjoining (W6) that W5 is to match as this is the same window.

Window (W5) to be replaced within existing structural opening.

Original window was completely destroyed by the fire, this new window (W5) is to replicate the original and to match the adjoining sash window that remains. (w6)

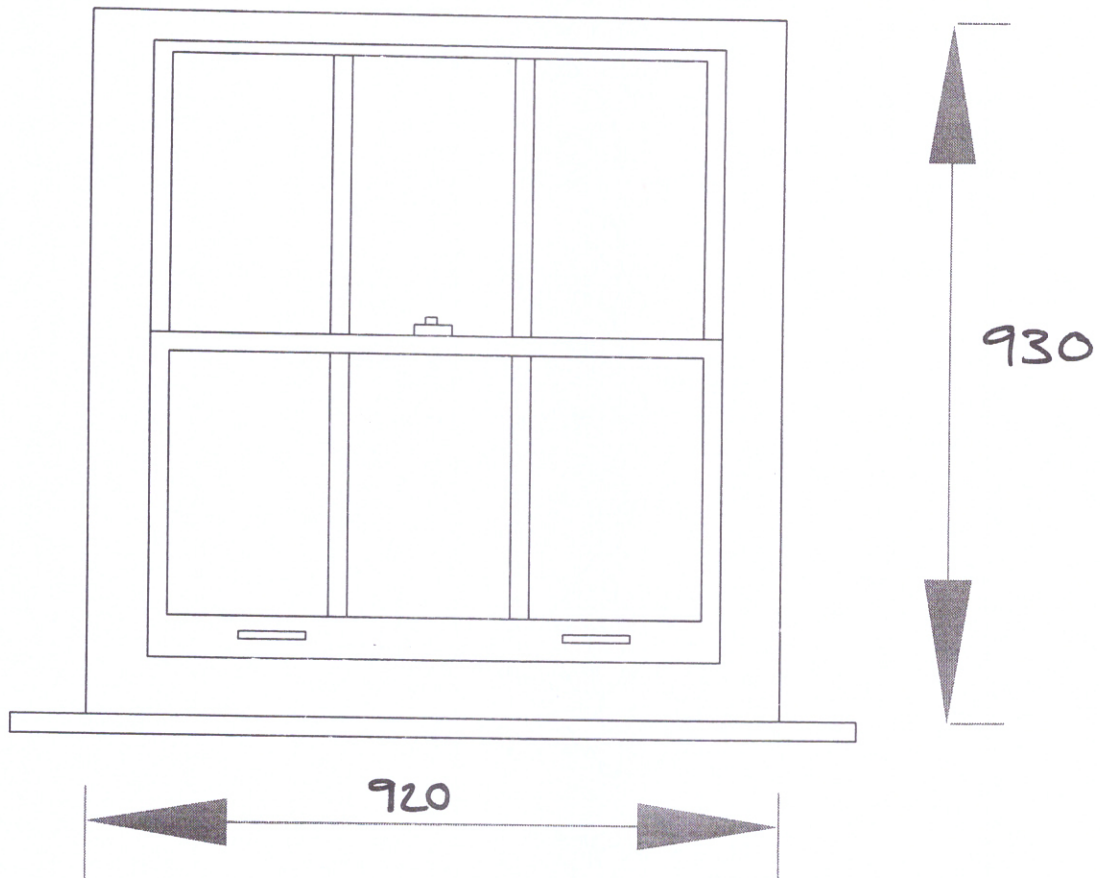
Single Box Sash Window (W5)

Softwood sashes/frame/cill

Jamb: Hollow box sash.

16mm glazing bar (profile Ovolo) to accept 4mm single glazed conservation glass.

Painted finish internally/externally (oil based paint)

Sash cords/2 brass lift handles/1 brass fitch catch

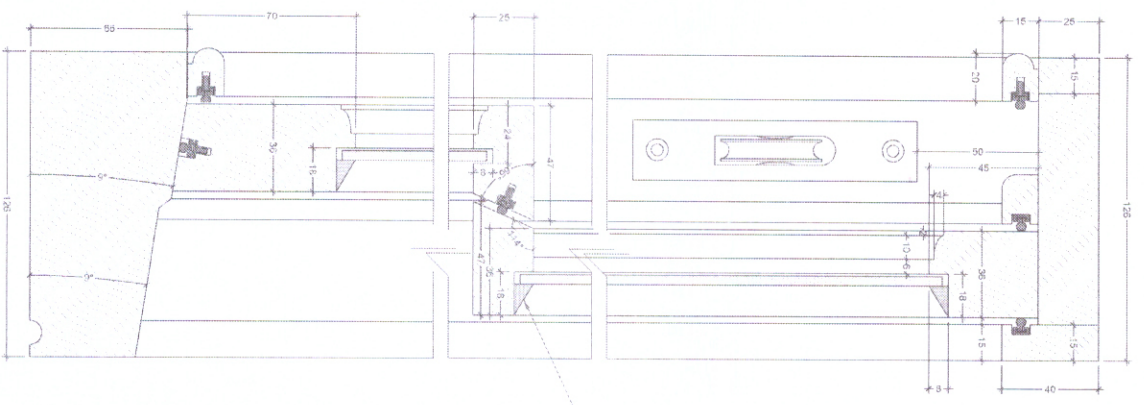
Conservation glazing to window

Lined oil putty to glass.

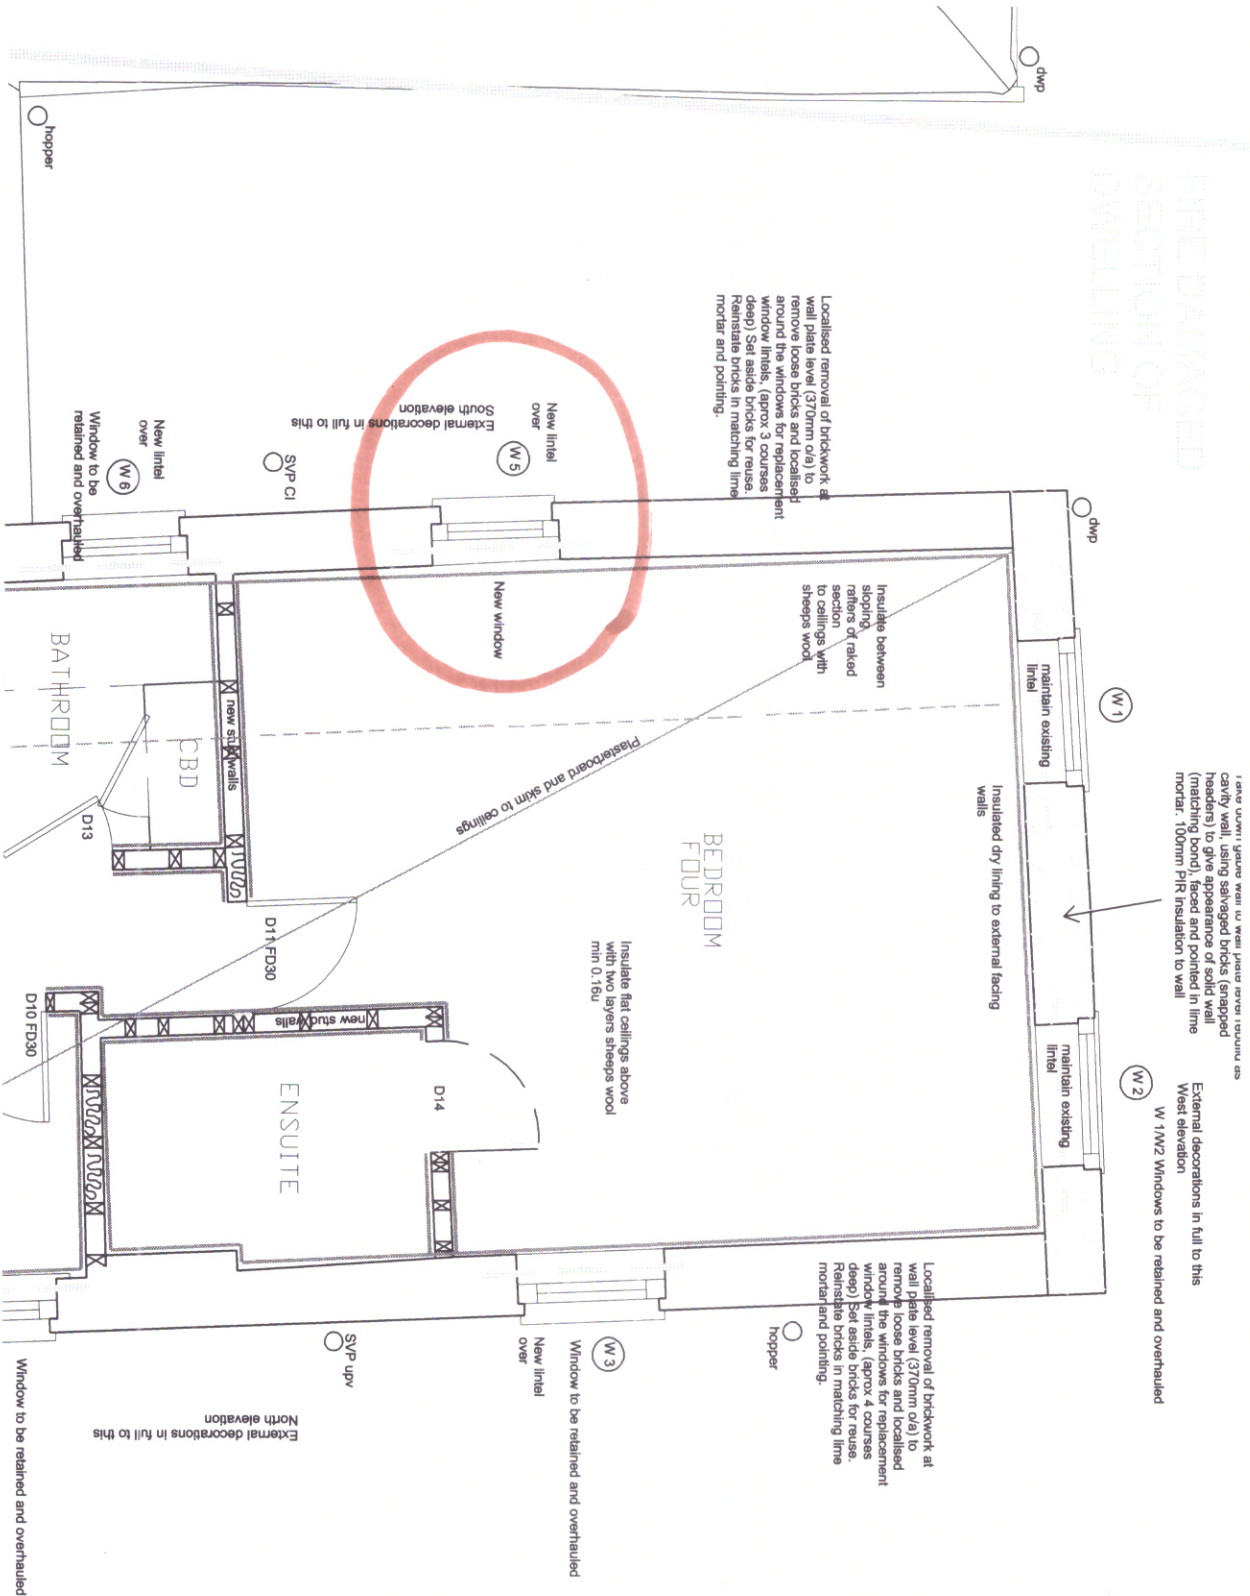
1. Large corner upright wall to west party above insulation cavity wall. Using salvaged bricks (snapped headers) to give appearance of solid wall (matching bond), fixed and pointed in lime mortar. 100mm PIR insulation to wall

External decorations in full to this West elevation  
W 1/W2 Windows to be retained and overhauled

Localised removal of brickwork at wall plate level (370mm o/a) to remove loose bricks and localised around the windows for replacement window lintels. (approx 3 courses deep) Set aside bricks for reuse. Reinstall bricks in matching lime mortar and pointing.

Localised removal of brickwork at wall plate level (370mm o/a) to remove loose bricks and localised around the windows for replacement window lintels. (approx 4 courses deep) Set aside bricks for reuse. Reinstall bricks in matching lime mortar and pointing.

Window to be retained and overhauled

Window 5 - to be replaced (first floor - North Wing)

Insulate between sloping rafters of raked section to ceilings with sheeps wool

Insulated dry lining to external facing walls

Insulate flat ceilings above with two layers sheeps wool min 0.16u

External decorations in full to this North elevation
