33 MAIN STREET, LARGS, KA30 8AE

**STATEMENT IN SUPPORT OF
PROPOSED BOUTIQUE HOTEL,
LIFT INSTALLATION & ROOF TERRACE DOME.**

Client : Sanote Ltd

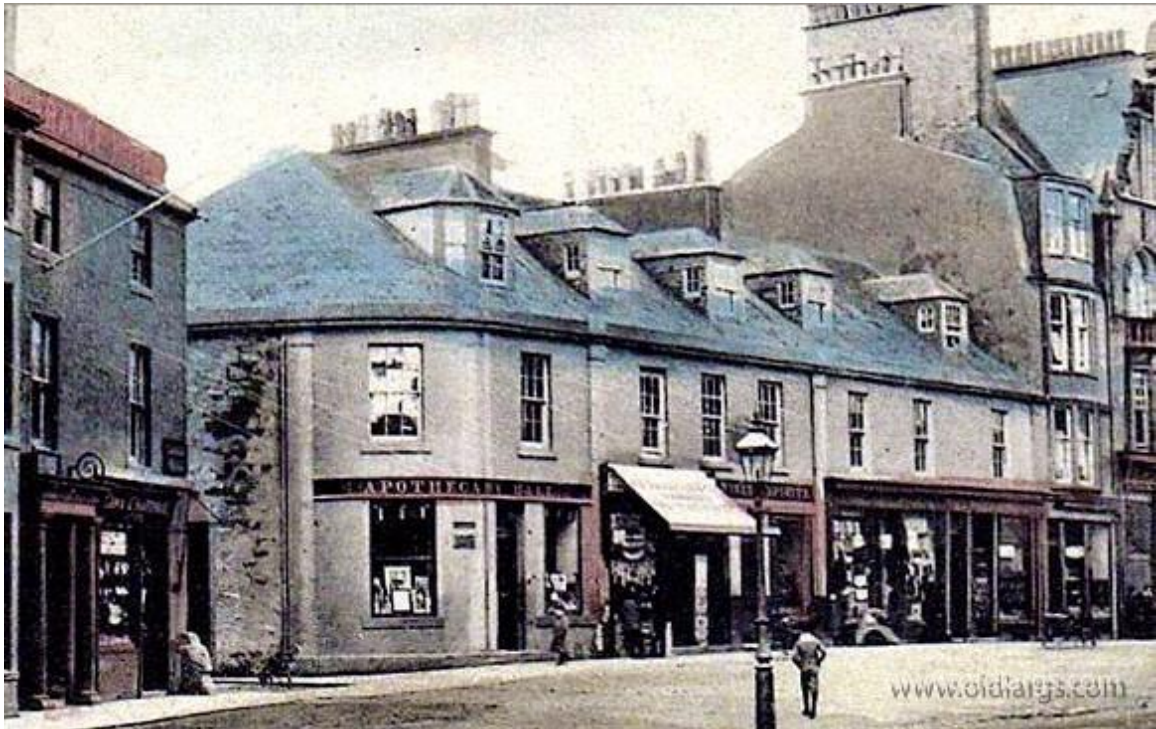
Pre- 1920s Streetscape, Showing One of The Adjacent Buildings Later to be Demolished to Create The Two Storey Wing Addition

He later in about 1926 acquired and removed the two buildings at either side to create the additional two storey wings, which resulted in the now seamless symmetrical massing.

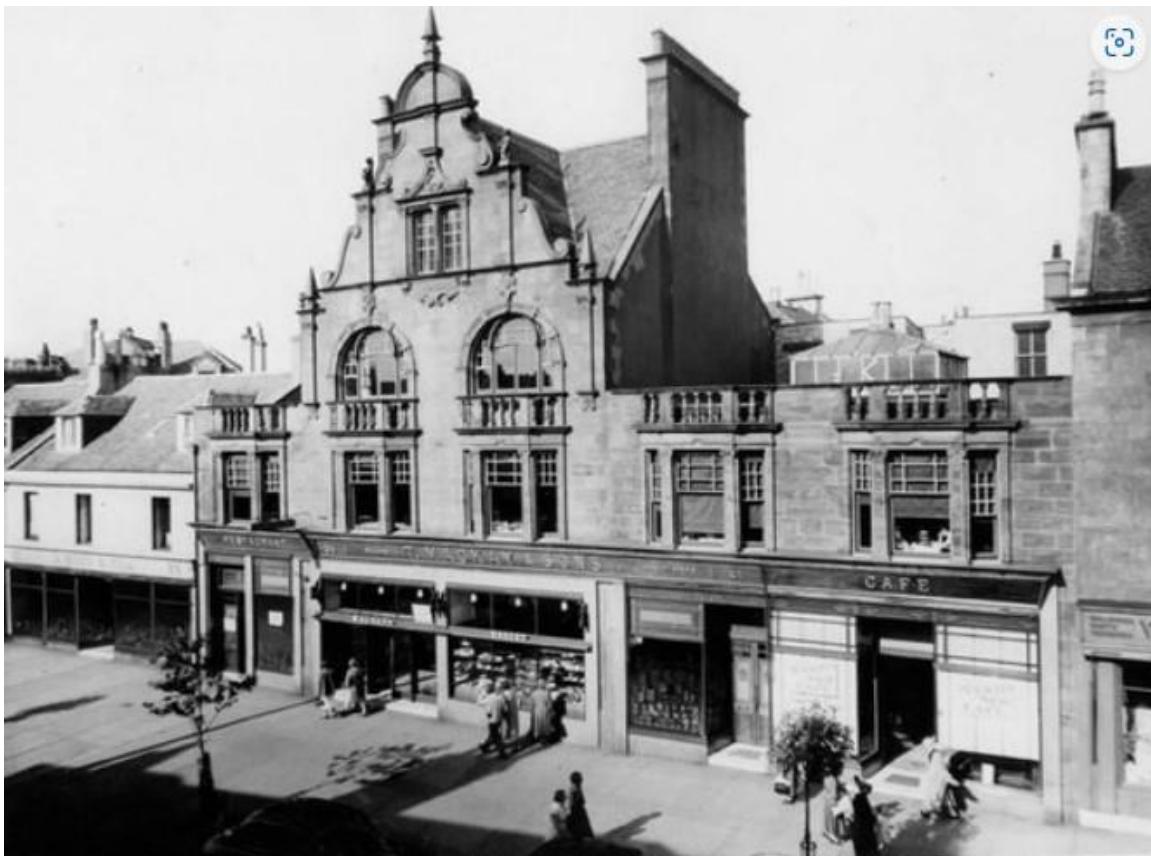
Street Frontage 1920's Showing the original Upper Tearoom
Cupola Roof-light Lantern, The Now Removed First Floor Stone
Balustrading and The Pediment Features No Longer In Place.
Showing Also The Increased Level And Height of Glazing At Ground
Floor Level.

Around this time various key features were either removed or masked to suit operational needs, including the removal of the glazed cupola from above the now restaurant area to allow the formation of the roof terrace and the replacement of the main stairway glazed dome with an inferior fiberglass pastiche.

As previously noted, there have been significant elements removed from this façade, such as the stone balustrading to the restaurant window bays and the diamond shaped stone pediment features from the central gable.

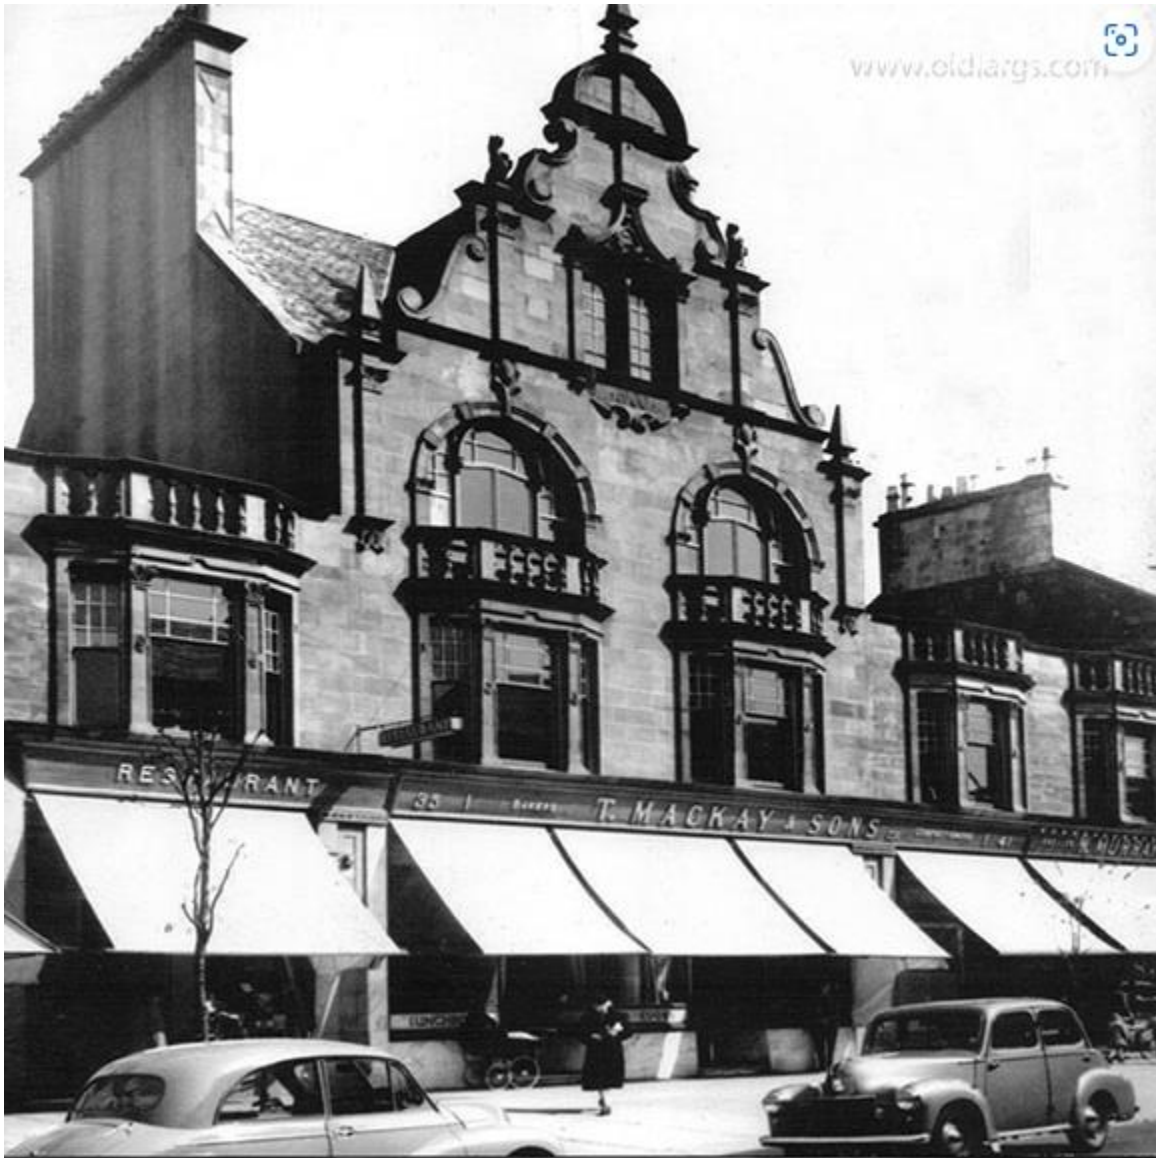
Street View 1950's Showing First Floor Stone Balustrades And Pinnacles Still In Position & Considerable Ground Level Glazing With Retractable Shades.

Other prominent features were lost, such as the stone external balustrades from the central bay windows, presumably as in such disrepair they were considered as too much of a financial commitment for restoration.

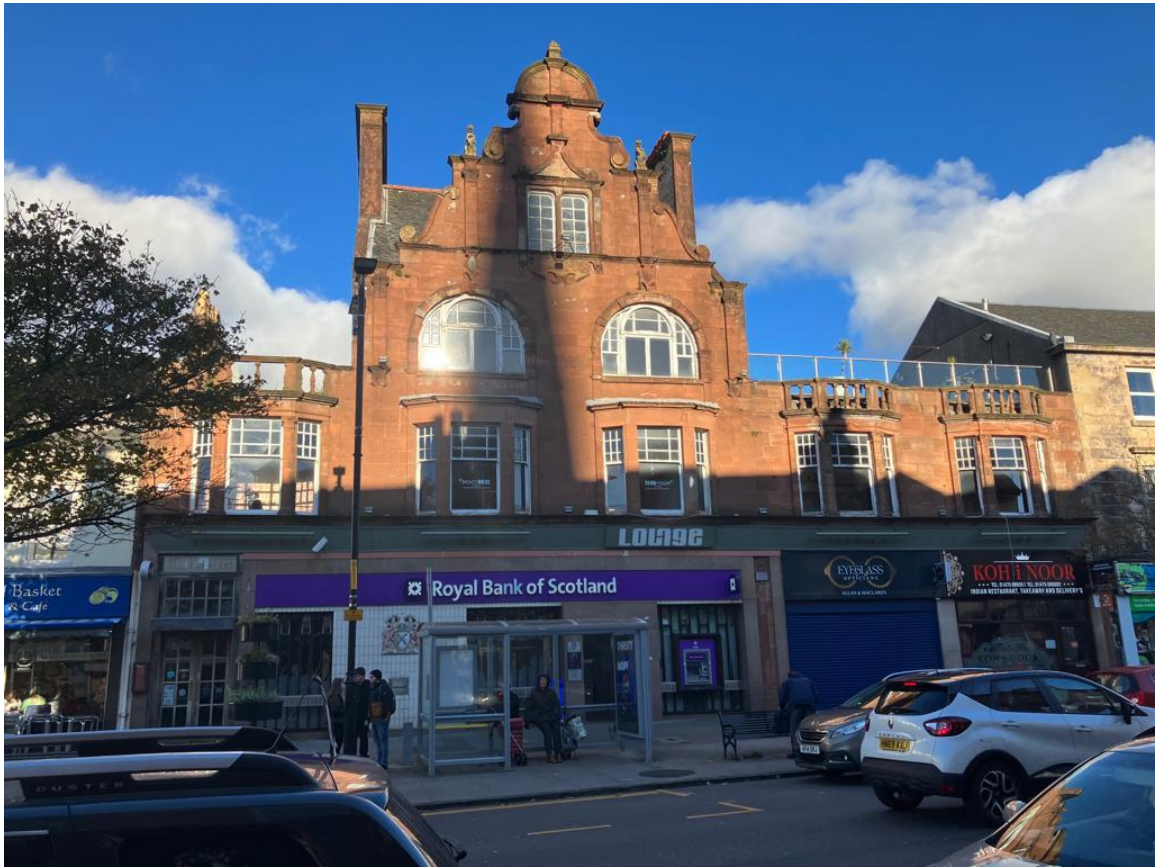
Current Street View Showing First Floor Stone Balustrades And Pinnacles Removed & Ground Level Glazing Dramatically Reduced By Post 1970's Interventions.

A façade contemporary for the period was imposed, resulting in the removal of the marble cladding to be replaced with the now present pink and grey mottled granite, used frequently in this period, as well as clinical white tiling and modernist window configurations.

In terms of the front elevation, it is clear that 70's interventions at ground floor level dramatically intervened to downplay the exploitation of verticality and transparency and it is our wish to in some way pay homage to the original intent within the confines of the entrance area attributed to No.33 and give a clear insight into the grandiosity within.

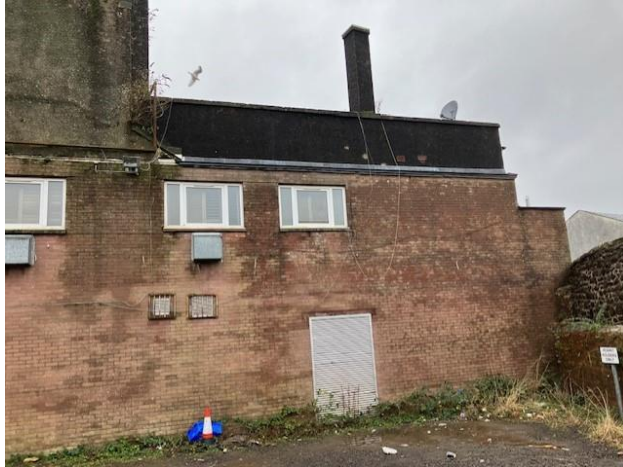
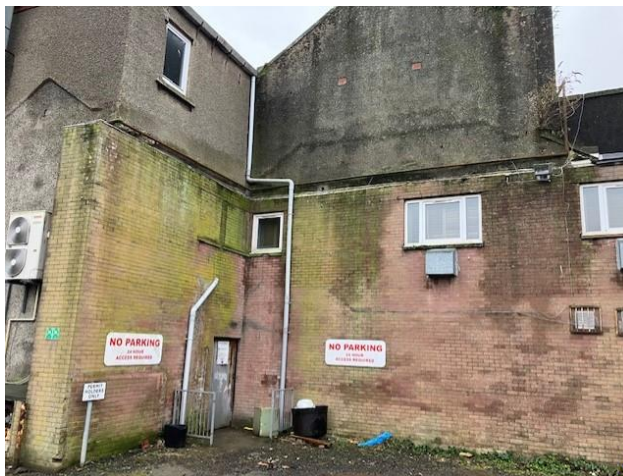
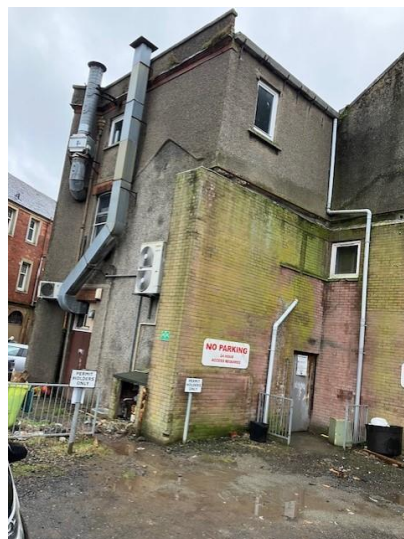
Rear Elevation Showing Myriad Of Finishes & Physical Interventions

The rear elevation currently exists as a myriad of materials, imposed at various stages within the complex evolution and it is our intention to rationalize and unify the finishes, predominantly using painted wet render, with application of smooth banding at windows.

As the existing windows to this elevation are predominantly u.p.v.c., it is our intention to replace with like, but more traditionally configured and to a higher energy efficiency.
