Property:
Kings Theatre
Bath Street
Glasgow

Title:
External Masonry Repairs
Bath Street Elevation

Job No: P2023-0422	Drawn by: MD	Scale: A1@1:100
Drawing No: P001	Date: Dec 2023	Checked: MS

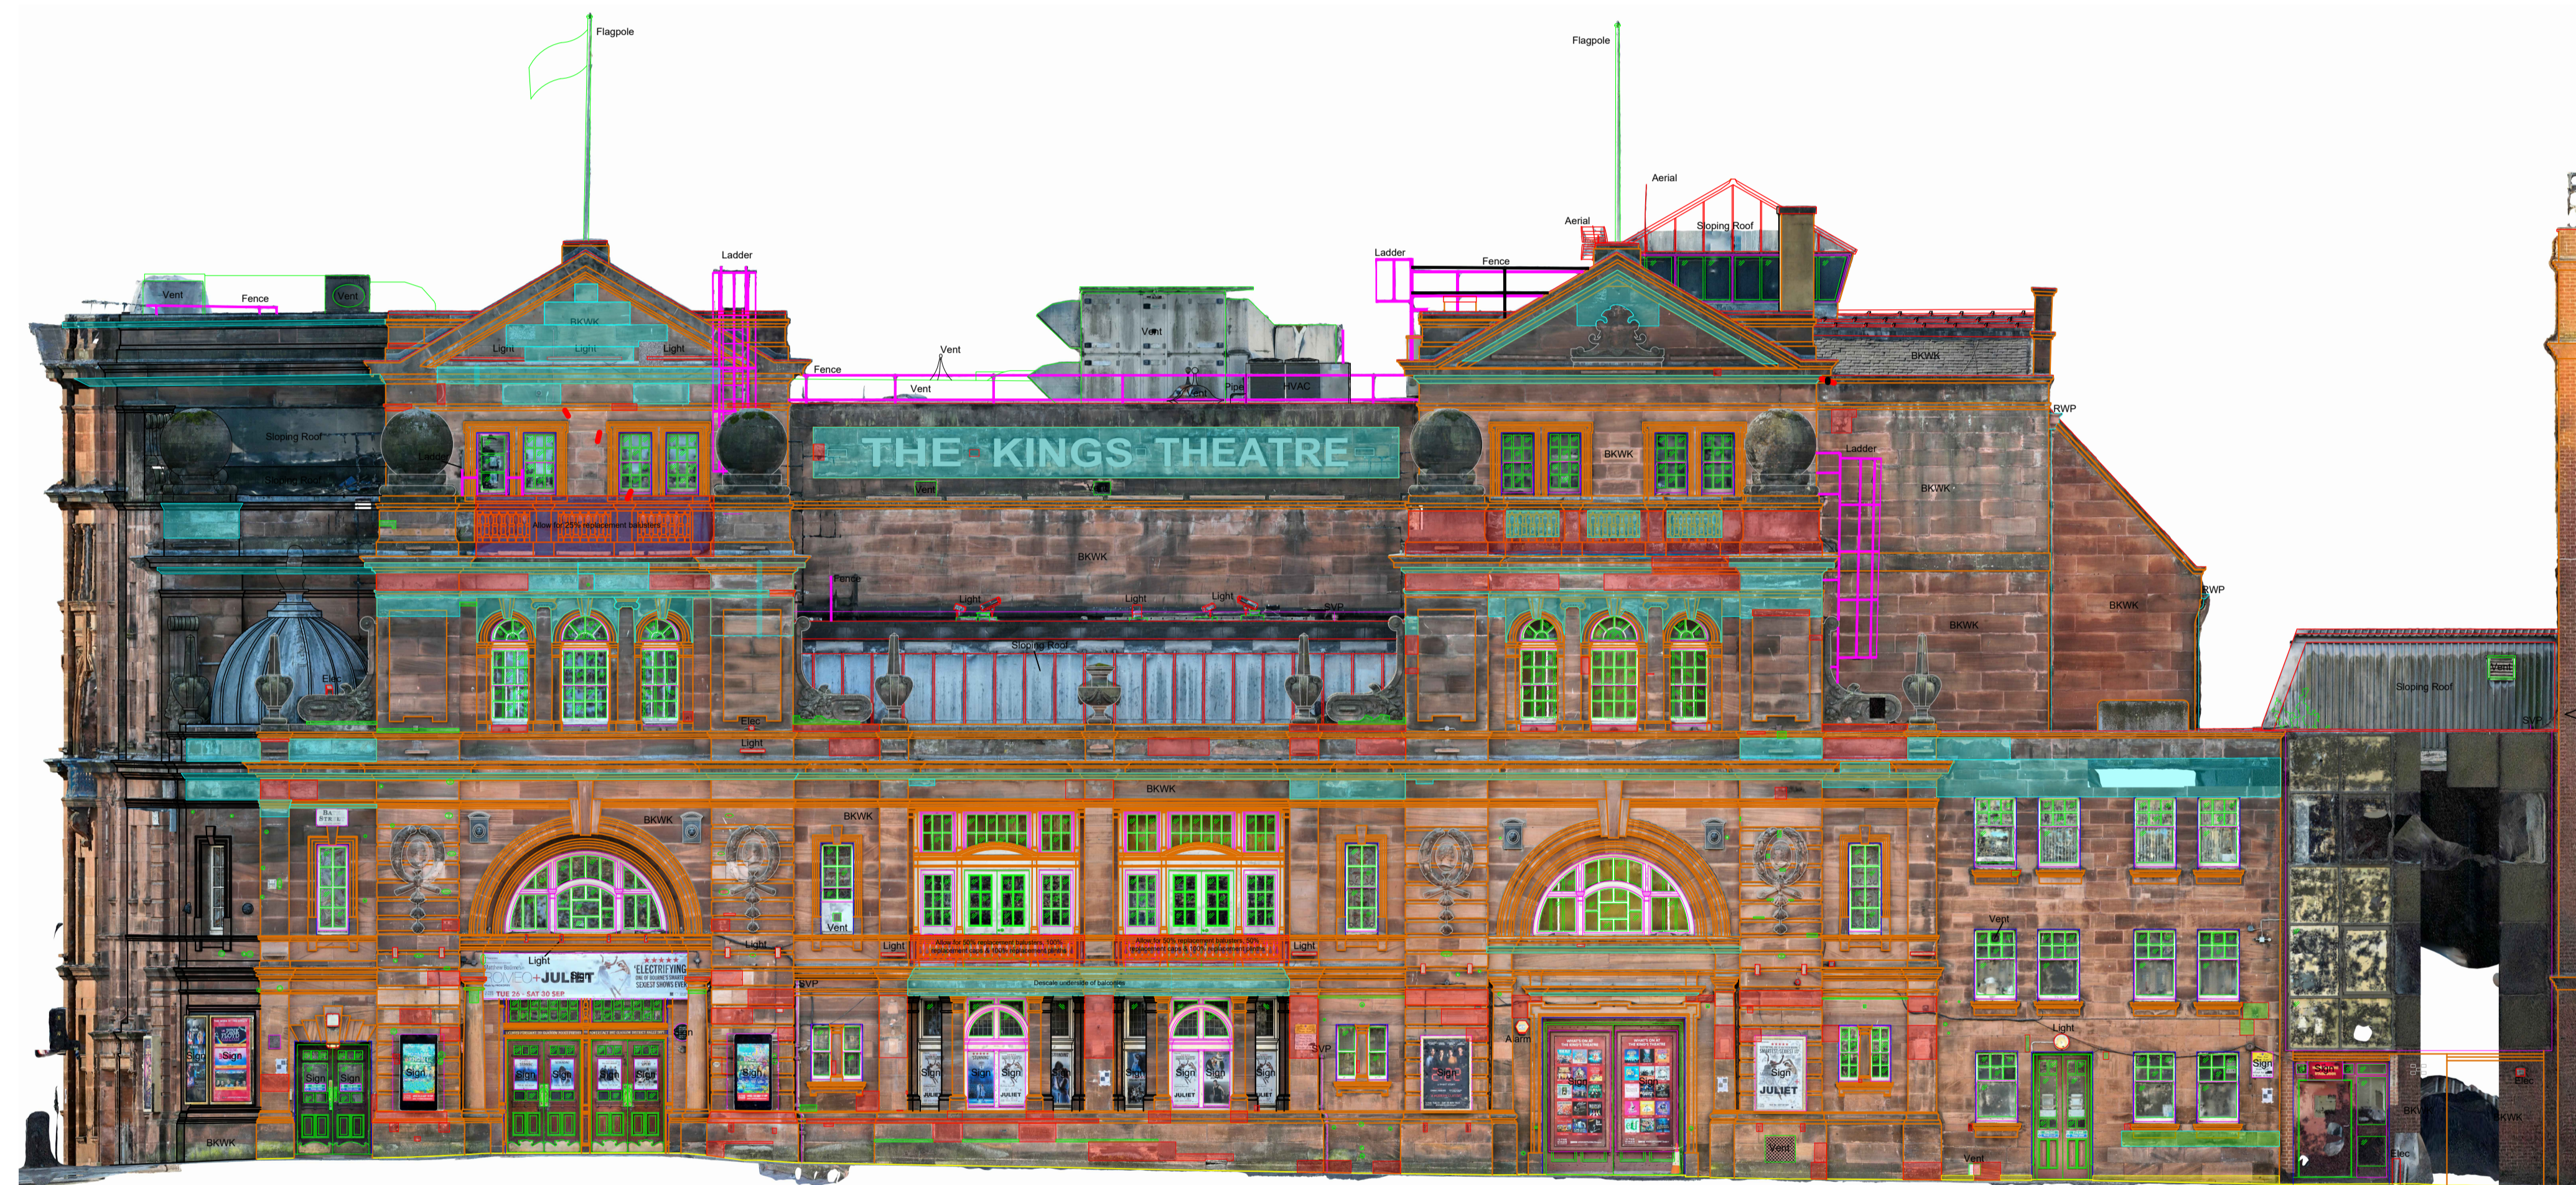
ELEVATION 1

- Stone replacement indent.
- Lime mortar surface repair.
- Descal loose / friable stone.
- Crack fill.
- Crack stitch and fill.
- Deep fill pointing.

Note:
Existing windows are to undergo refurbishment including overhauling and redecoration. Repairs will be undertaken on a like for like basis to match existing materials.
