Property:
Kings Theatre
Bath Street
Glasgow

Title:
External Masonry Repairs
Elmbank Street Elevation

Job No: P2023-0422	Drawn by: MD	Scale: A1@1:100
Drawing No: P002	Date: Dec 2023	Checked: MS

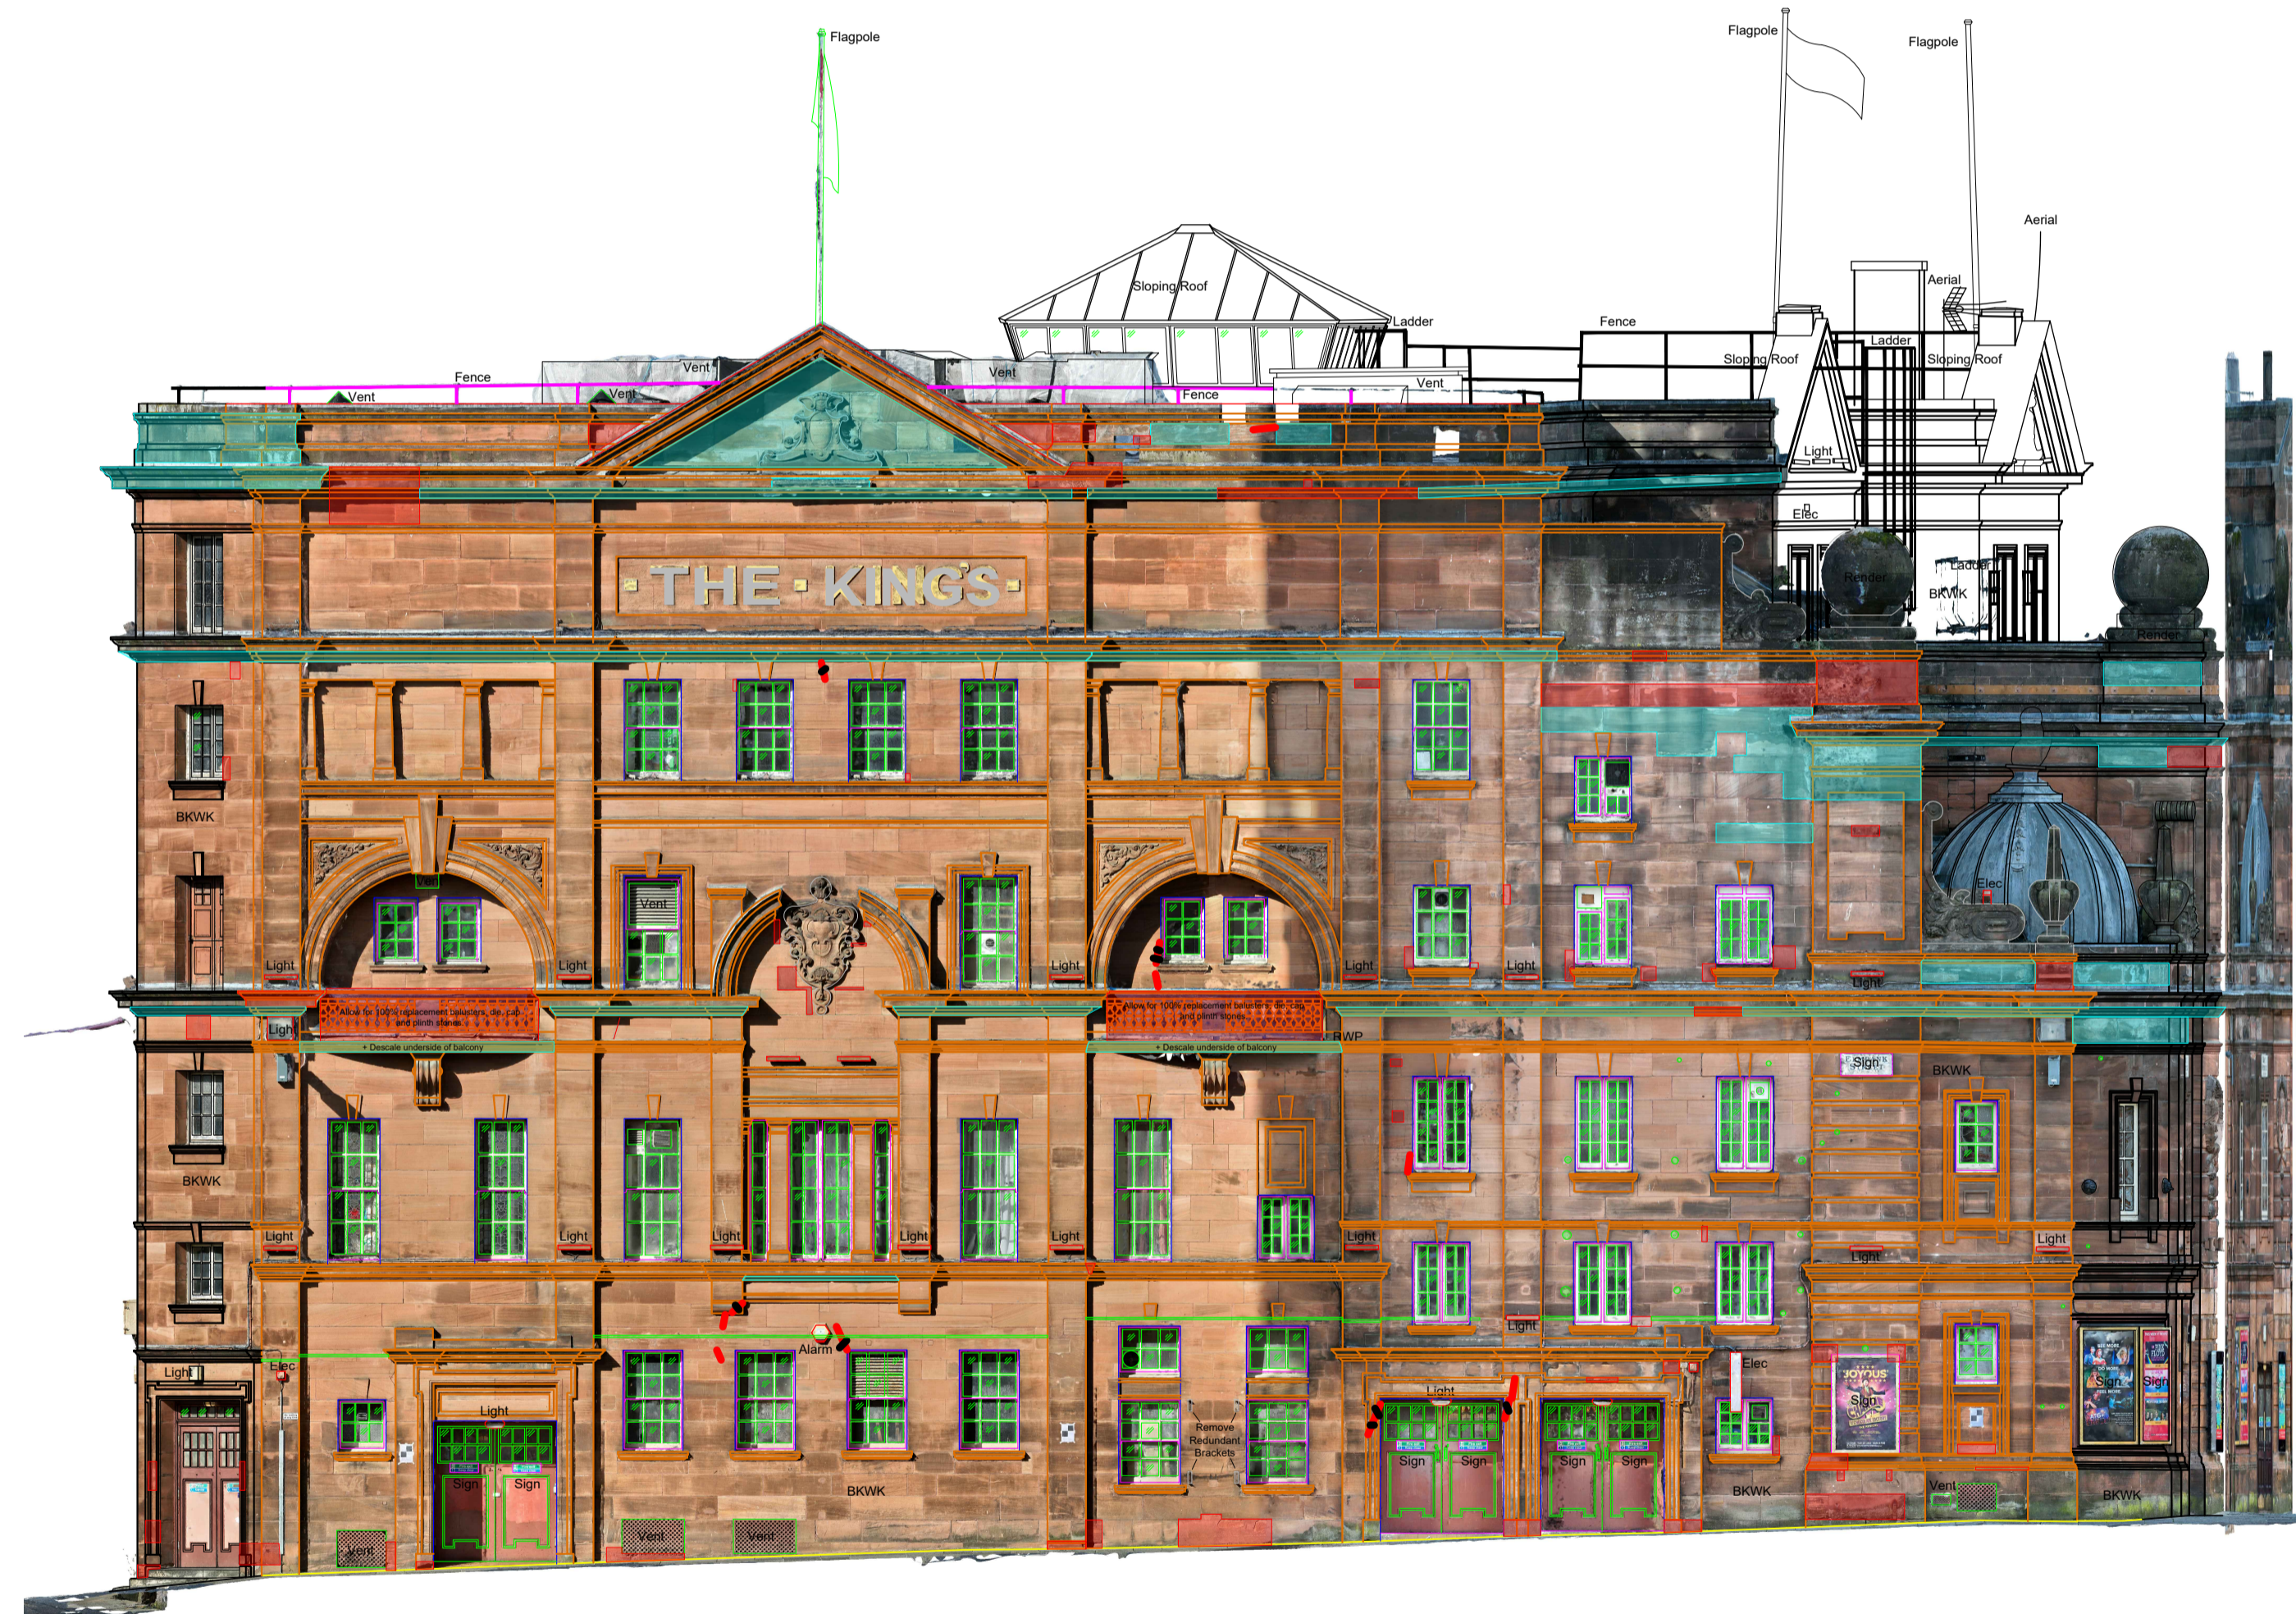
ELEVATION 2

- Stone replacement indent.
- Lime mortar surface repair.
- Descalce loose / friable stone.
- Crack fill.
- Crack stitch and fill.

Note:
Existing windows are to undergo refurbishment including overhauling and redecoration. Repairs will be undertaken on a like for like basis to match existing materials.
