Curtis Farm, Wicker Street Green, Suffolk Proposed Rendering and Replacement Window to Gable Elevation

DESIGN and ACCESS STATEMENT

with Heritage Impact Assessment

February 2024 Project ref. 21065

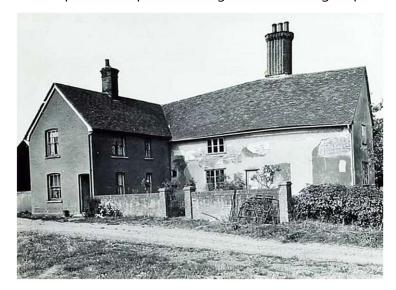
Royal Commission on Historic Monuments

Archive photograph showing the house in 1959, fronting the green, with red brick service wing and the rest of the house rendered. The south-east gable is to the right-hand side.
