Front Elevation

Images of existing walls to be repointed

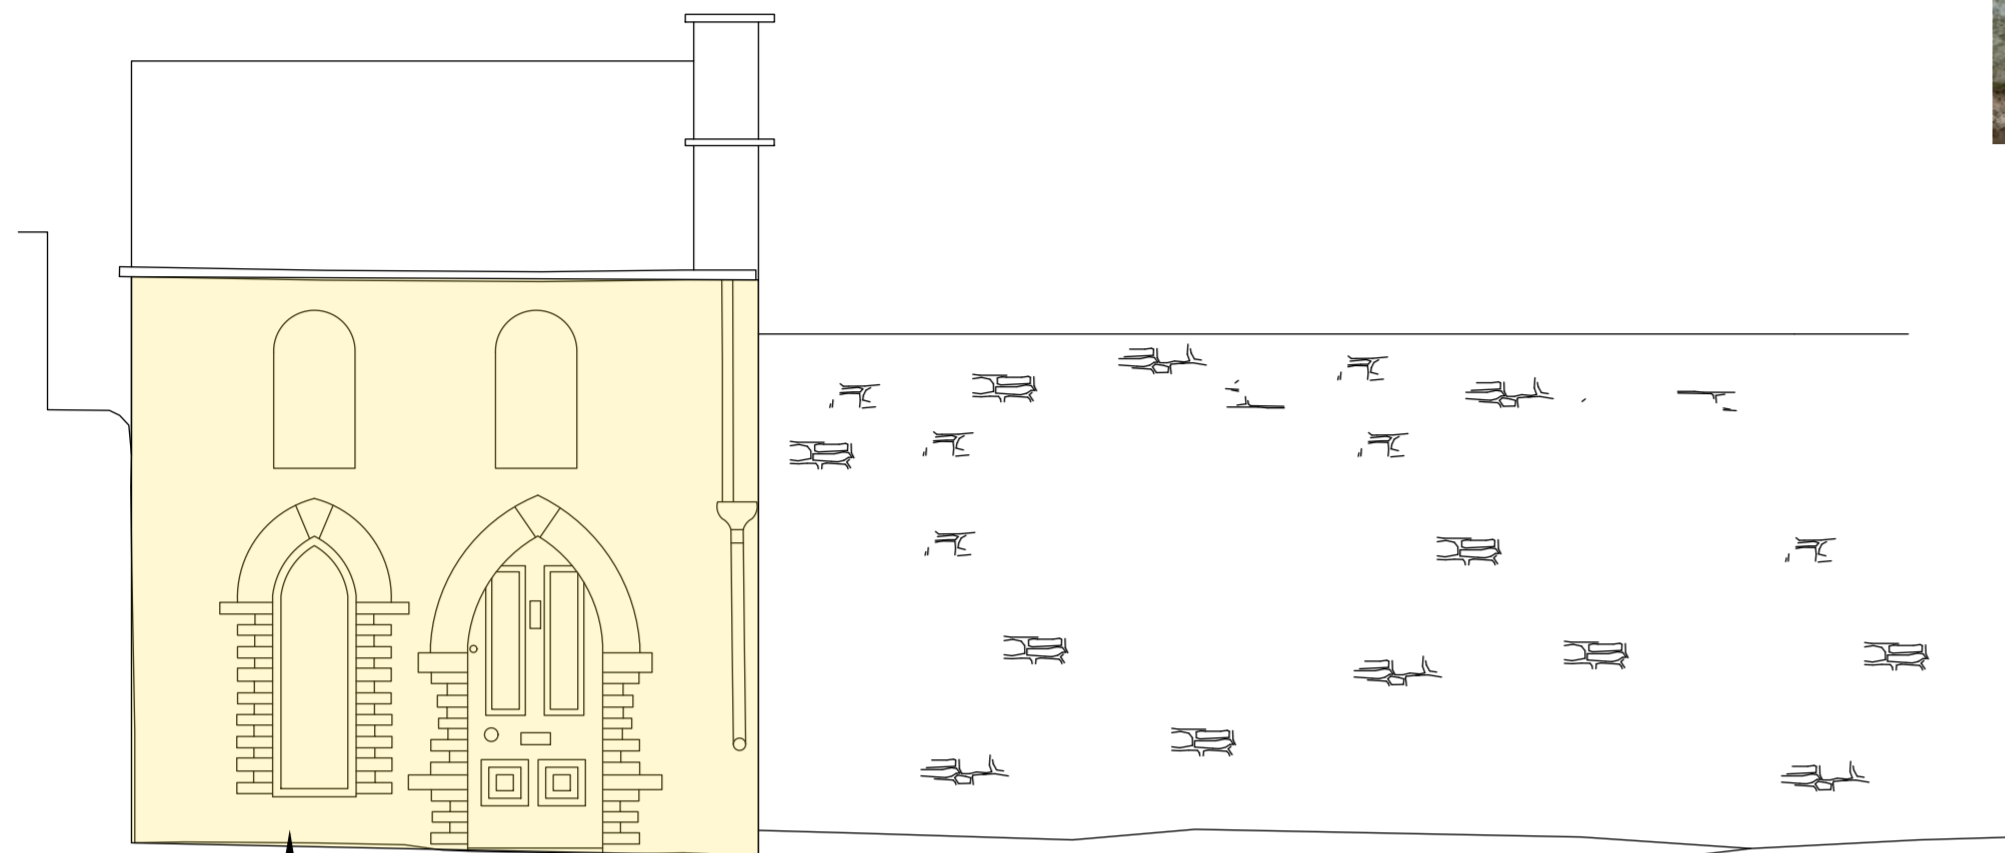
• Highlight area to be repointed

CLM 26 Coarse Putty Lime Mortar - Cornish Lime Company

Existing mortar to be removed using hand tools and raked clean.
 Joints to be moistened and a the ready mixed mortar putty applied.
 Joints to be rubbed out when dry.
