project  
 CO-OP SUPERMARKET  
 FRONT STREET  
 SEDGEMFIELD  
 STOCKTON ON TEES  
 TS21 3AT  
 PROPOSED PLAN

scale 1:50, 100 @A1 drg no. 3878:11

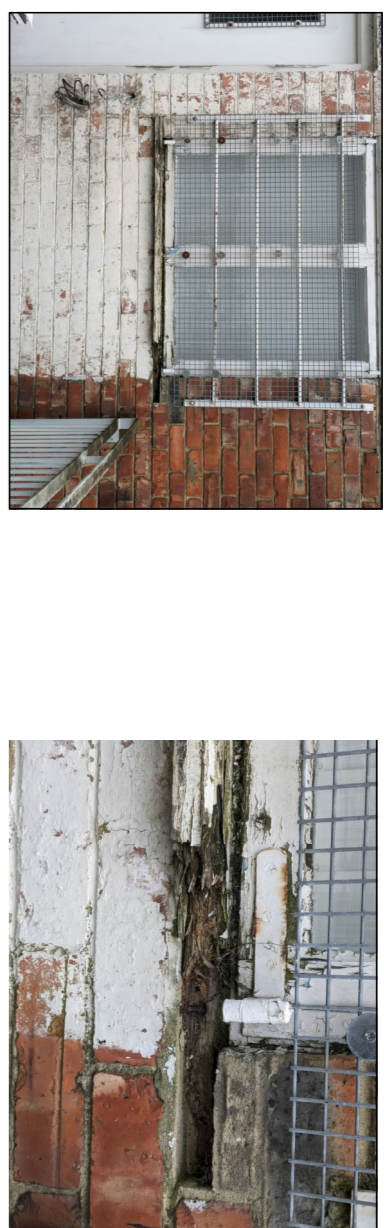
TYPICAL CONDITION OF WINDOWS

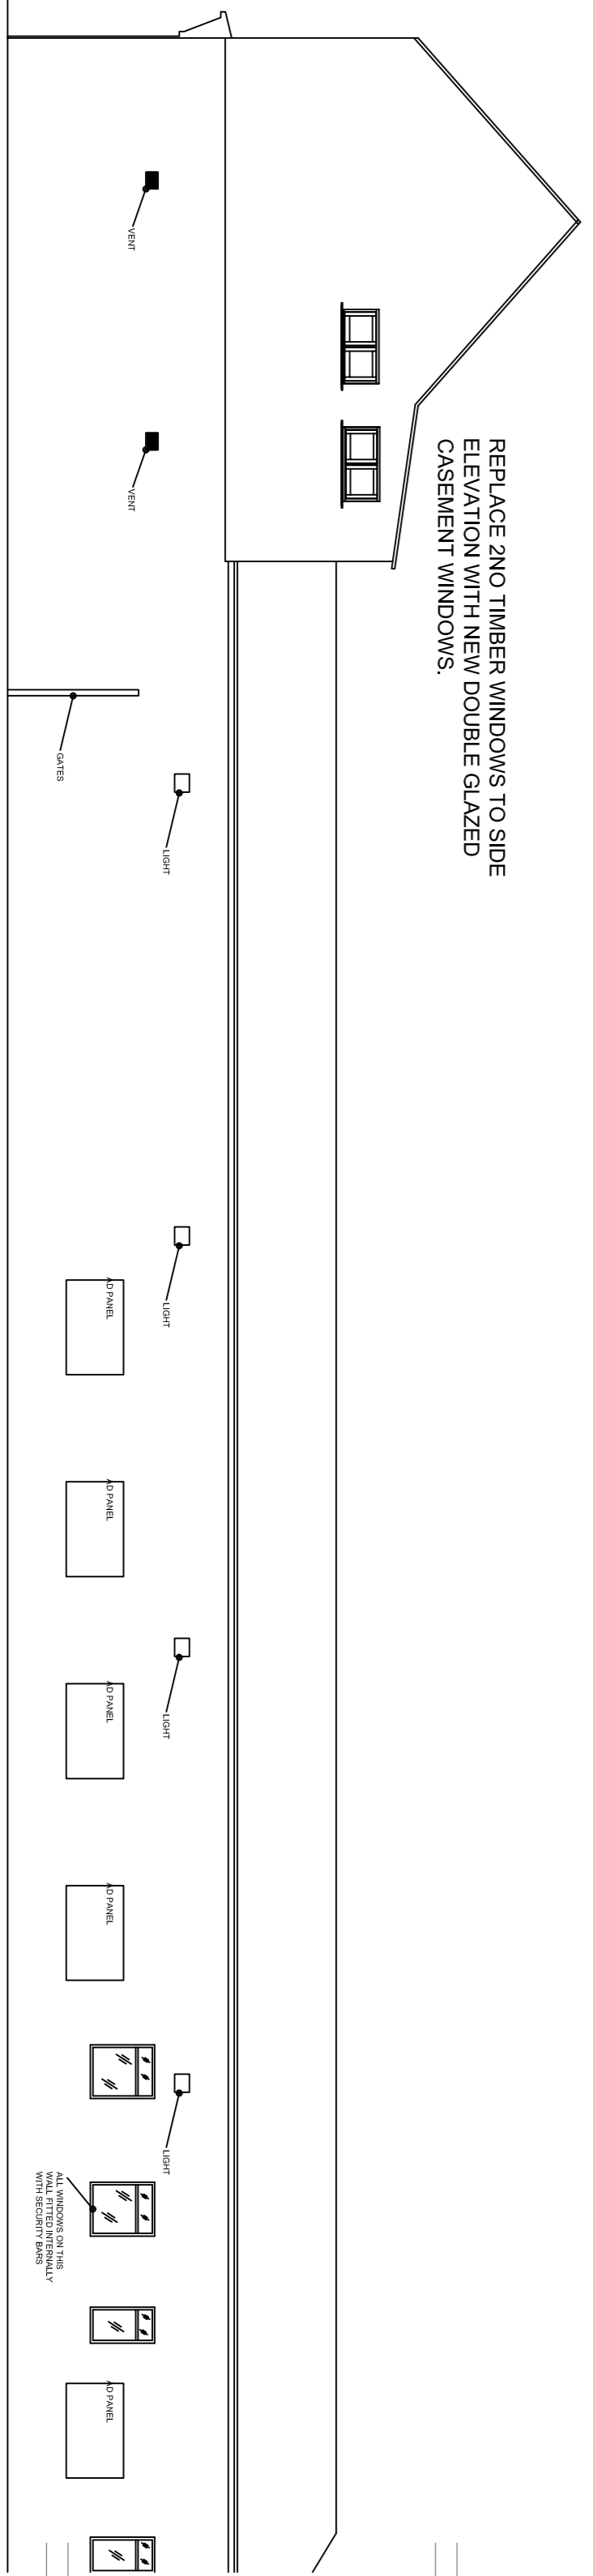
SIDE ELEVATION 1:100

REPLACE 2NO TIMBER WINDOWS TO SIDE ELEVATION WITH NEW DOUBLE GLAZED CASEMENT WINDOWS.

- DESCRIPTION OF WORKS**
- EXISTING DAMAGED WINDOWS TO BE REPLACED WITH THE SAME CONFIGURATION WITH NEW DOUBLE GLAZED WINDOWS.
  - WINDOWS TO BE PAINTED WHITE EXTERNALLY TO MATCH THE EXISTING WINDOWS BEING REPLACED.
  - 6NO WINDOWS TO THE FRONT ELEVATION
  - 3NO TO THE REAR ELEVATION INCLUDING THE DOOR
  - 2NO TO THE SIDE ELEVATION
