# DESIGN AND ACCESS STATEMENT

Planning Portal Ref: PP-12727379

Full Planning Consent: Full demolition of existing two storey extension & part existing single story living accommodation to form new Oak framed two storey & single storey alterations with new sash windows to replace existing UPVC to the farmhouse providing improved living accommodation at Grange Farm.

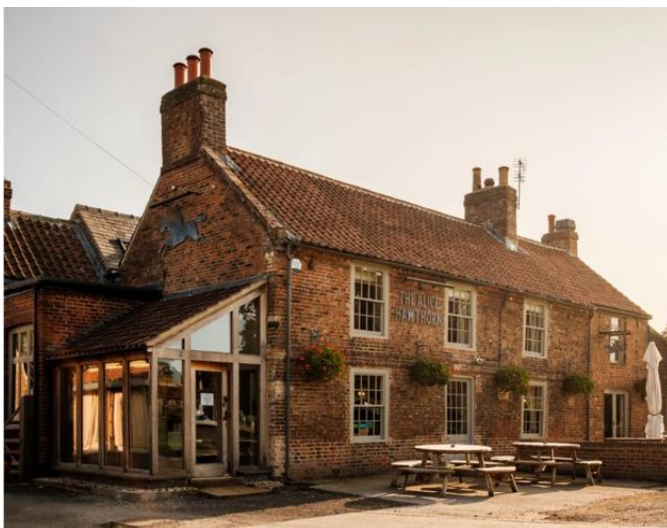
The form and massing will resemble the oak framework at the Alice Hawthorn Public House near York, and detailing will be similar to the existing cart door entrance on the north side of the Threshing Barn.

Image - The Alice Hawthorn Public house

Materials and detailing will match that of the existing property. The pitched roofs will be clad in clay pantiles, (see Alice Hawthorn illustration), and the small area of flat roof will be finished in a single ply membrane (coloured grey to replicate a lead roof).

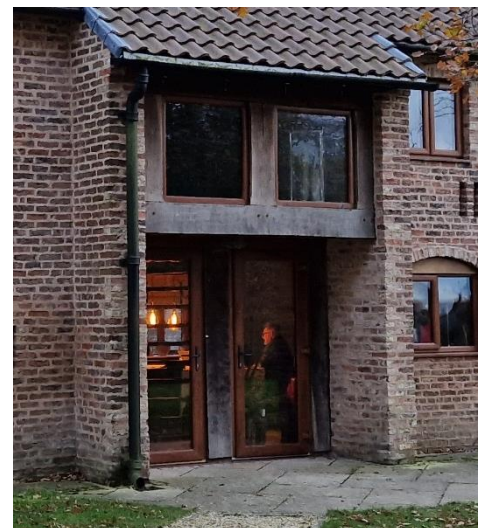
Image – Door to Threshing Barn
