Sketch Perspective from Ashcroft house

Conversion to a dwelling Project Address Ashcroft Barn, Skelton Client York Property Solutions Planning Drawing Title Sketch Perspectives Drawing Date November 2023

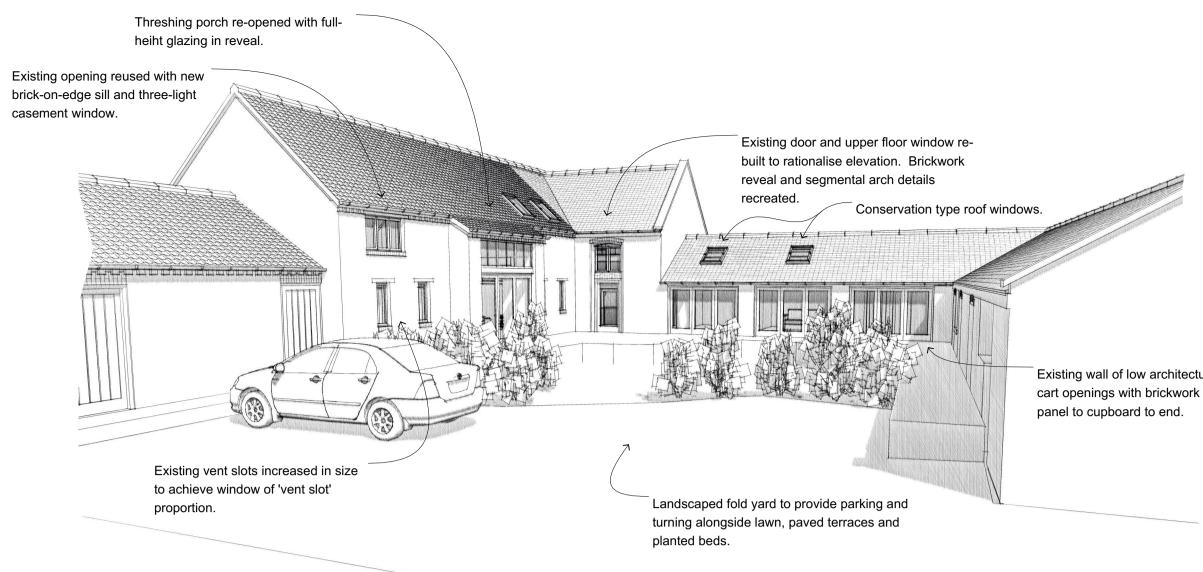
Existing wall of low architectural quality re-built as a series of cart openings with brickwork piers. Fully glaze with boarded

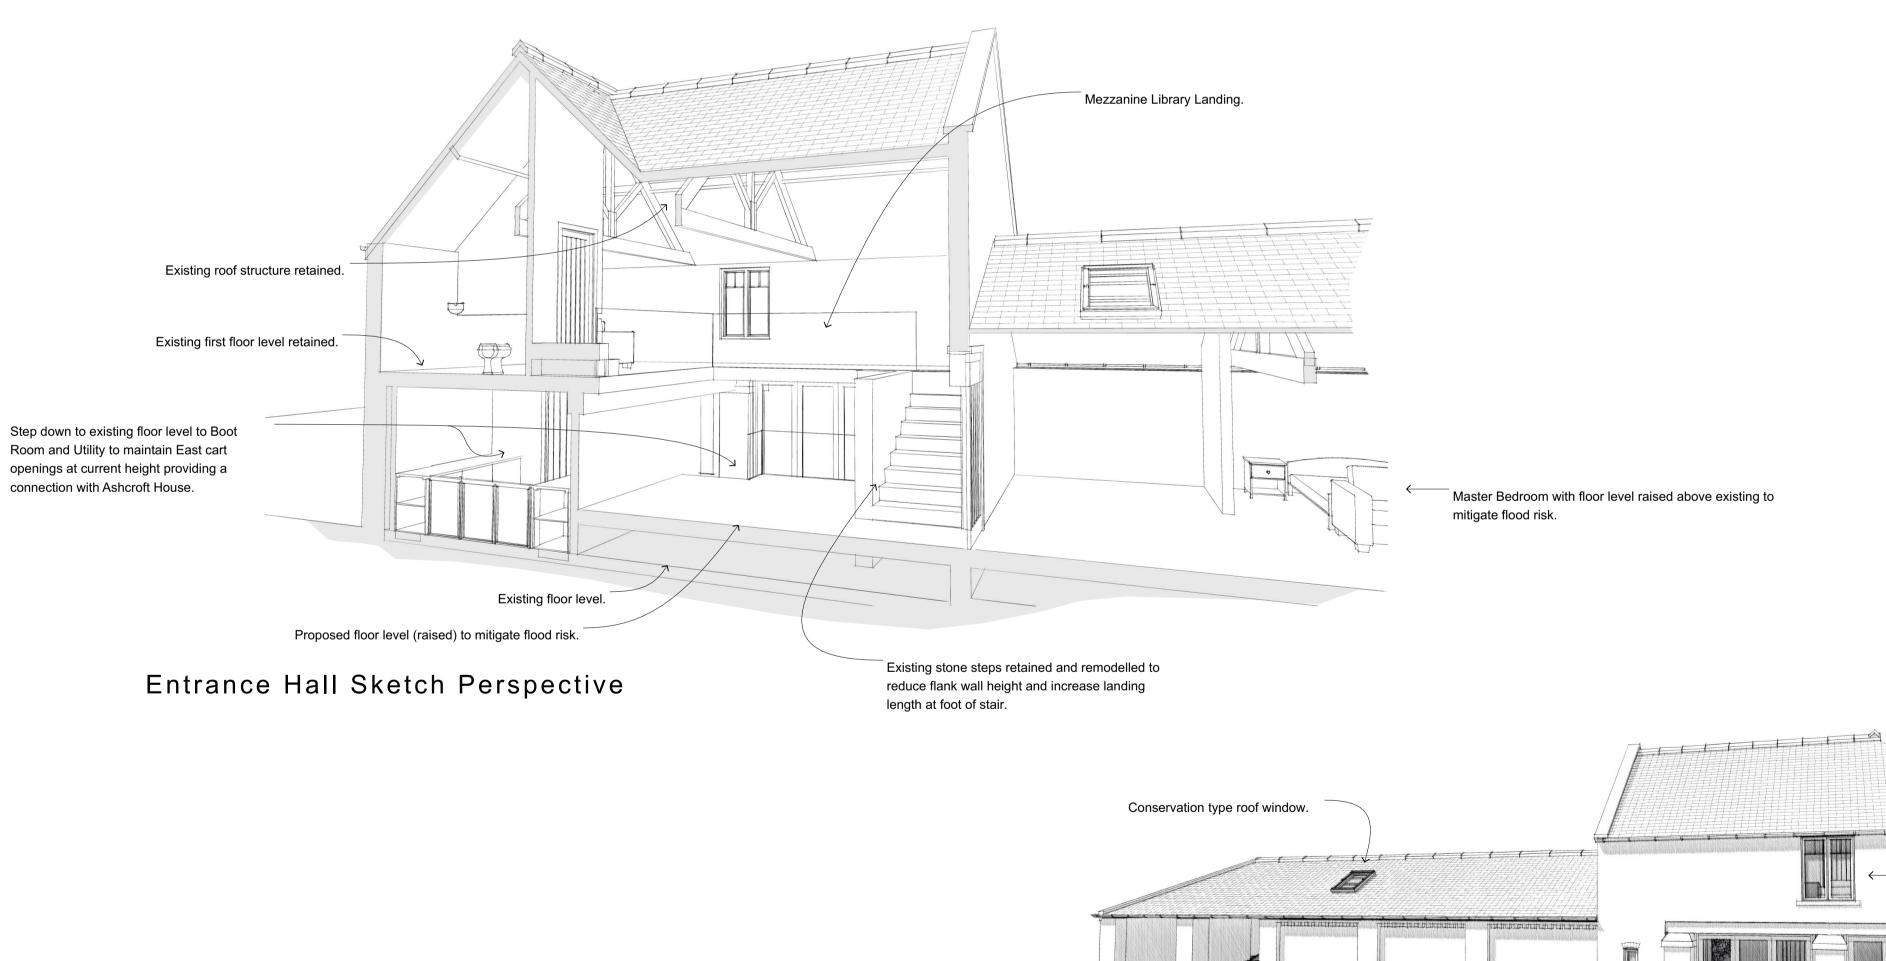
Cart openings fully glazed with 'back door' towards Ashcroft House.
