PROJECT
Alterations Barns at Home Farm, Bagendon

DRAWING TITLE
Proposed Roof Plan

DRAWING NUMBER
HFS 50.005

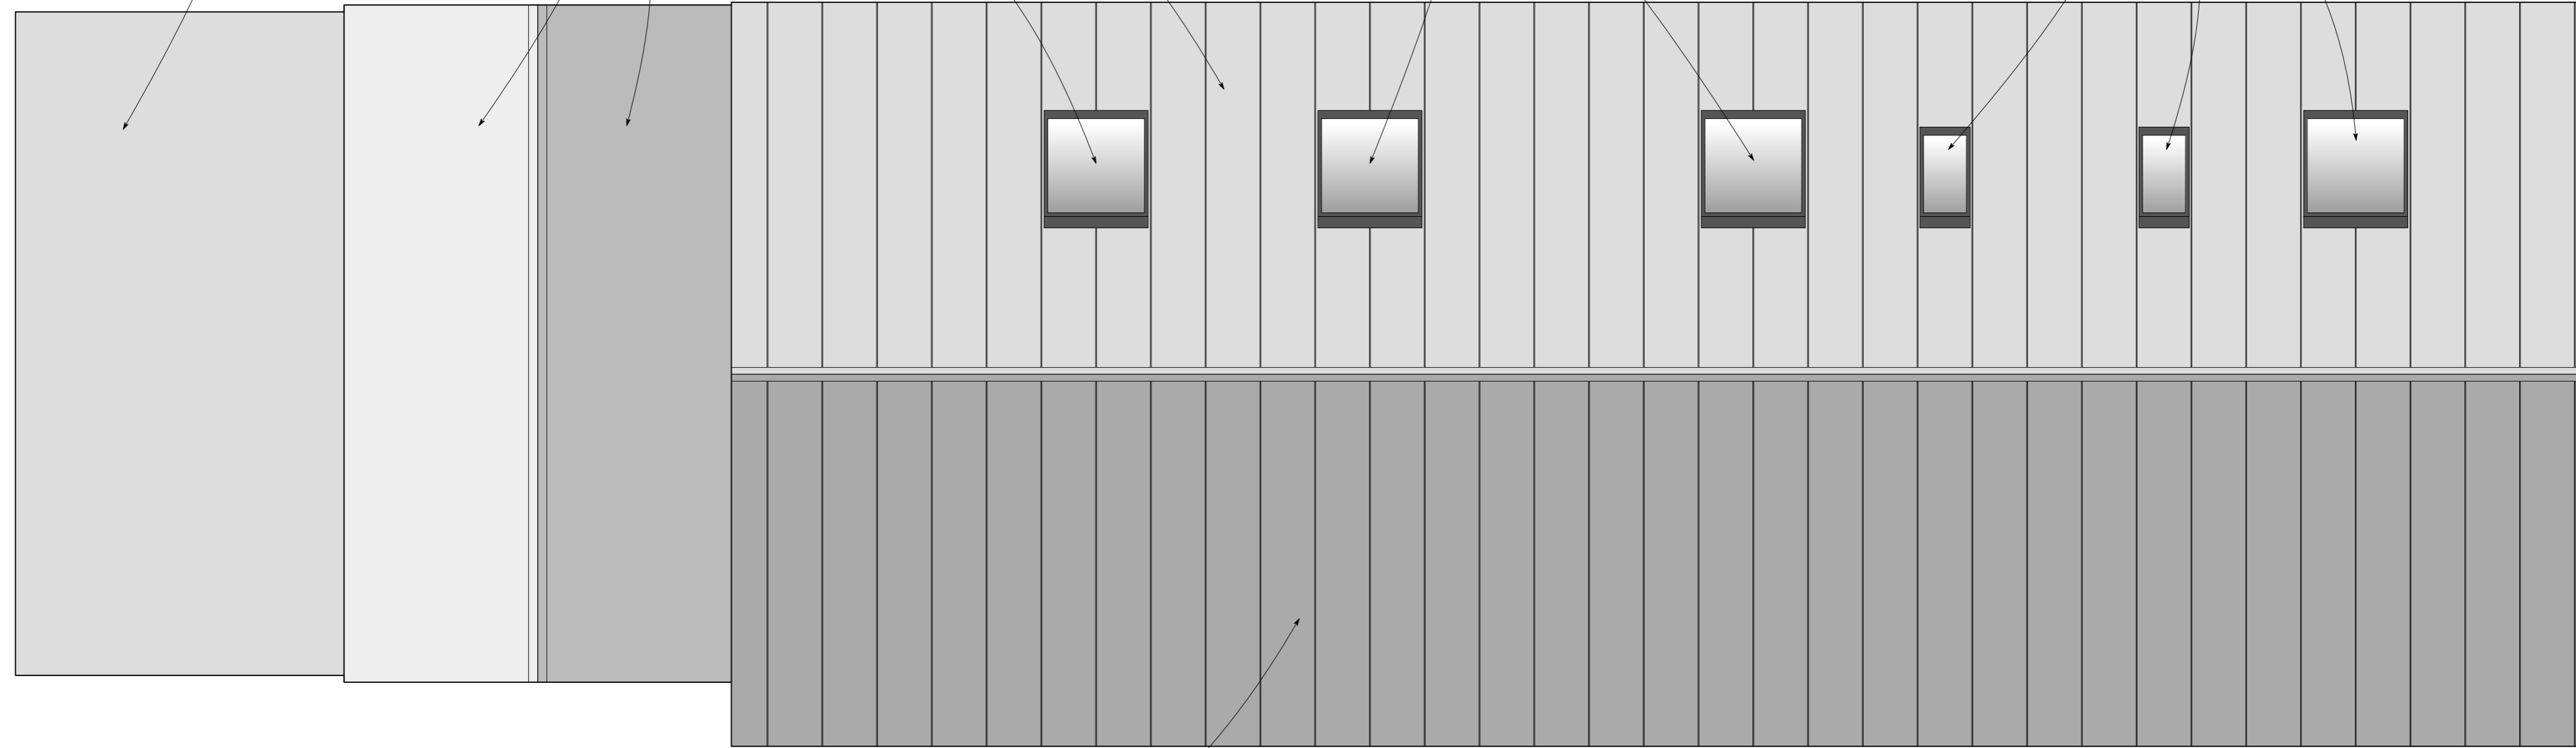
Roof faced with zinc clad panels with standing seam junctions

Corrugated cement sheet roof replaced with Cardinal reproduction Cotswold roof slates

Roof light

Roof lights
