CORPORATE REAL ESTATE HSBC OXFORD CORNMARKET 65 CORNMARKET STREET OX1 3HY

PUBLIC Proposed External Machine Details AS NOTED 21035 193 PA 23 RAWN BY / OFFICE: SP / LONDON

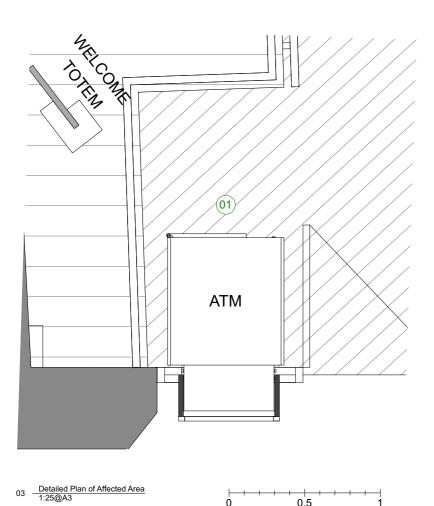
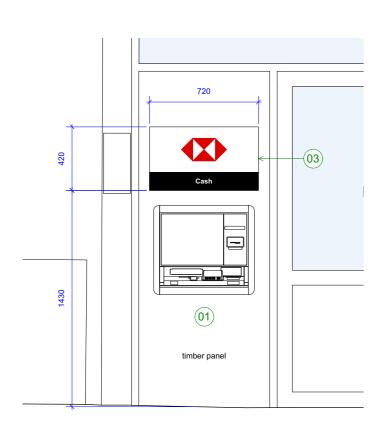
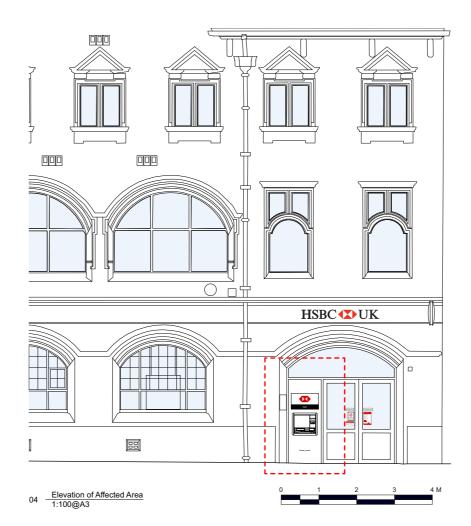
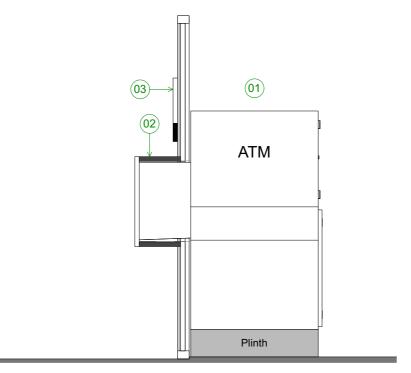
06 Detailed Section of Affected Area 1:25@A3

(01) New external ATM to replace existing. Reuse existing aperture.

ATM to be positioned in same location as existing but in a forward position to allow better reach for wheelchair users and to allow for ATM door and cassettes to be serviceable internally. Install scotia type weather collar powder coat black to match ATM.

(03) Existing non-illuminated ATM header sign replaced with new.

Non-illuminated ATM Header Sign Glass fronted with recycled plastics as base Size: 720mm(w) x 420mm(h) Thickness/projection: 30mm(d)
