HEAVY 3
A ROOF FOR LIFE

HEAVY 3

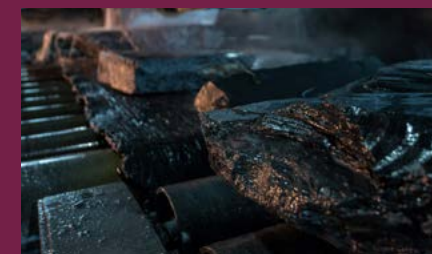
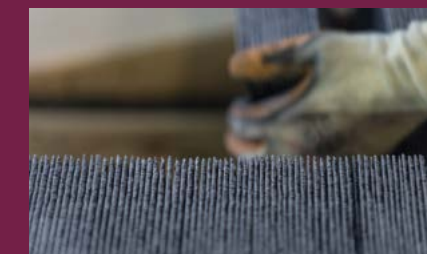
2. SLATE EXTRACTION

Explosives are rarely used today in the extraction of slate; instead diamond-tipped wire saws are used to remove large blocks of rock. To do this, two holes are drilled at right angles, through which the saw blade is threaded. Water is used throughout the cutting process, both as a coolant and in order to remove waste; this water is cleaned and reused. The blocks extracted from the quarry are then transported by truck to the processing sheds.
