Appendix A Collection of Flood Maps and Figures

(Part 1 of 2)

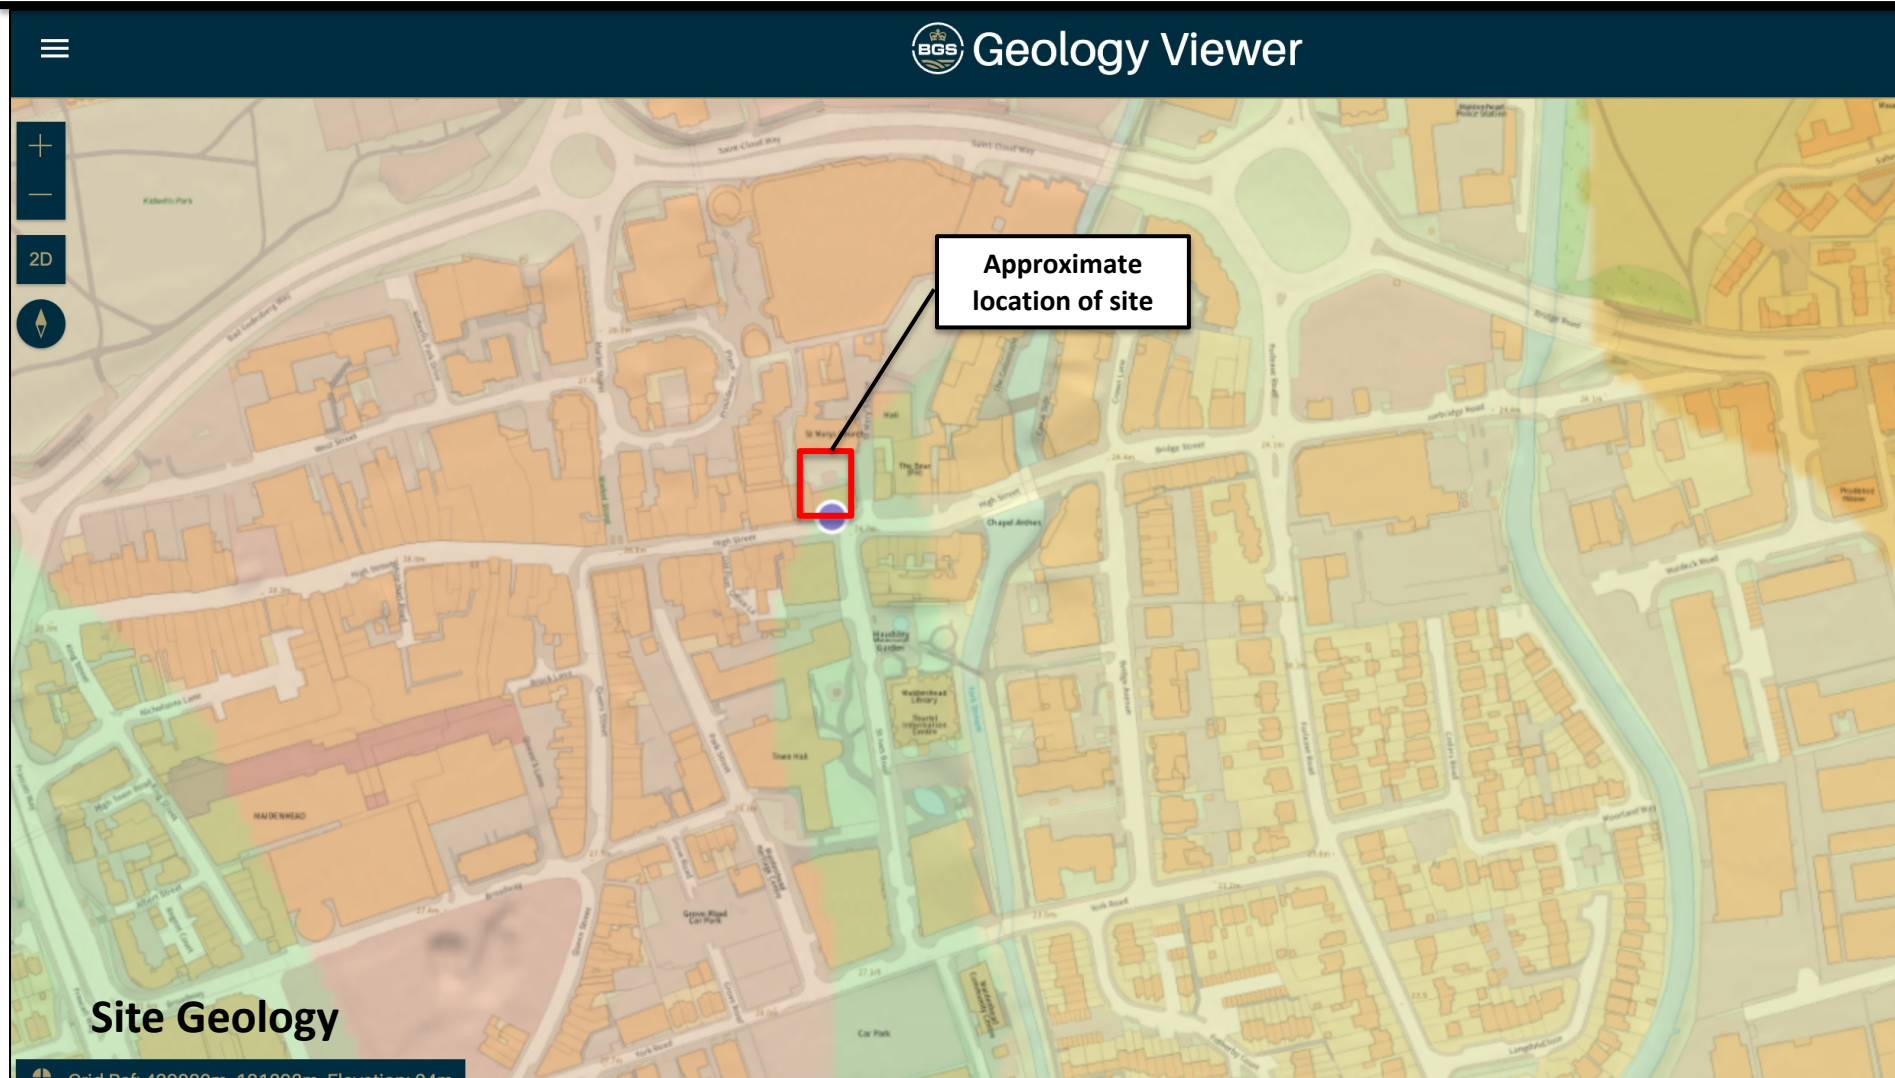
Figure 3 Geological Map of the Site
(Source: British Geological Survey Geological Britain Viewer)

Bedrock geology description: Seaford Chalk Formation and Newhaven Chalk Formation - Chalk. Sedimentary bedrock formed between 89.8 and 72.1 million years ago during the Cretaceous period.

Superficial deposits description: Taplow Gravel Member - Sand and gravel. Sedimentary superficial deposit formed between 362 and 126 thousand years ago during the Quaternary period.

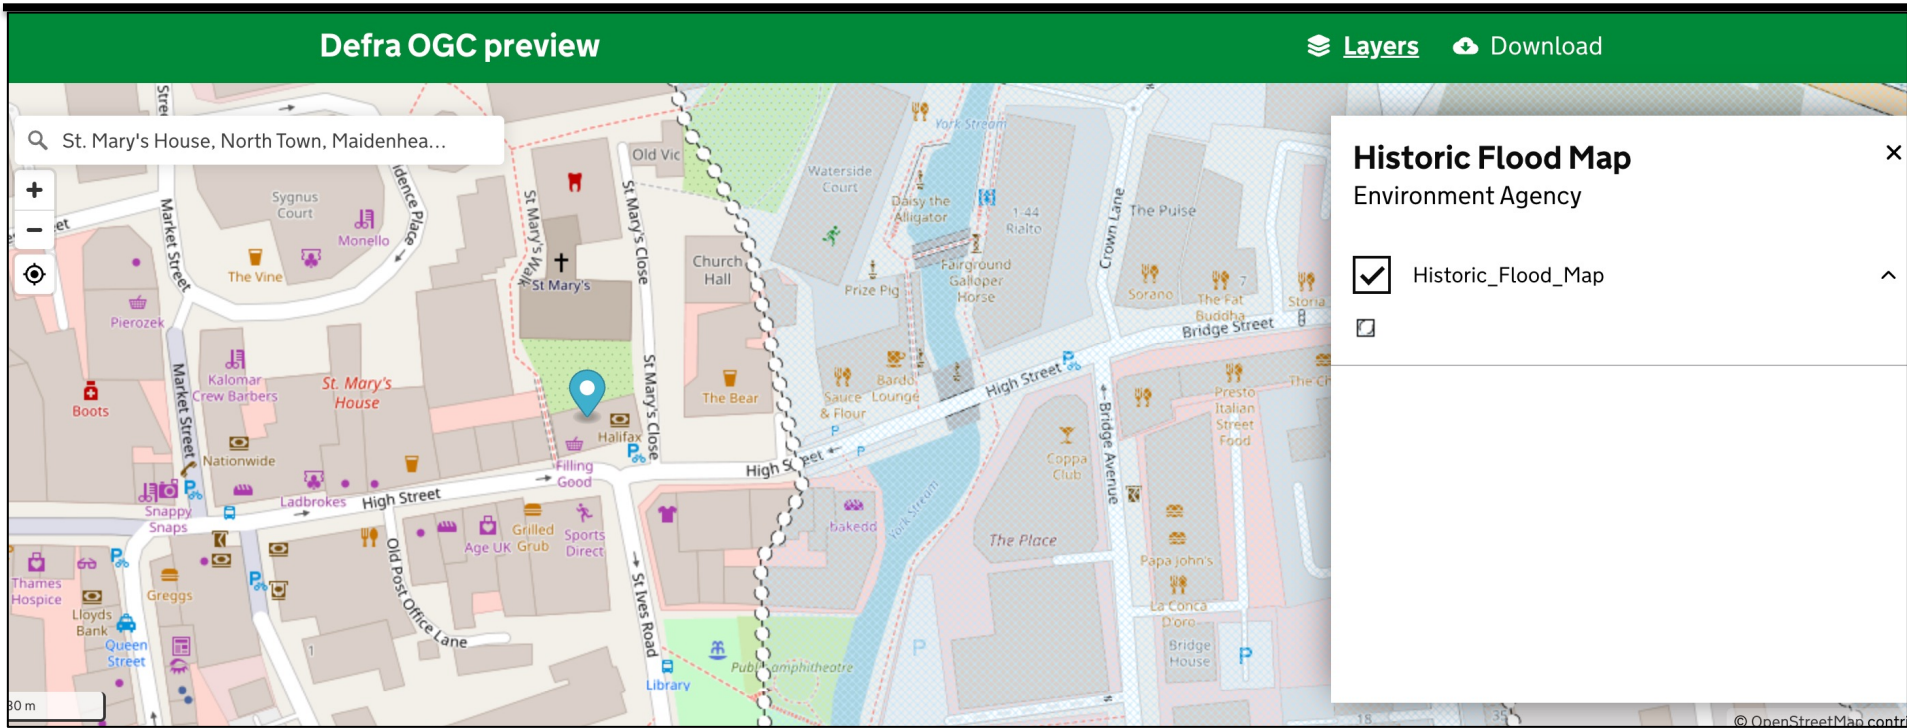
Figure 4 Environment Agency's Historic Flood Map

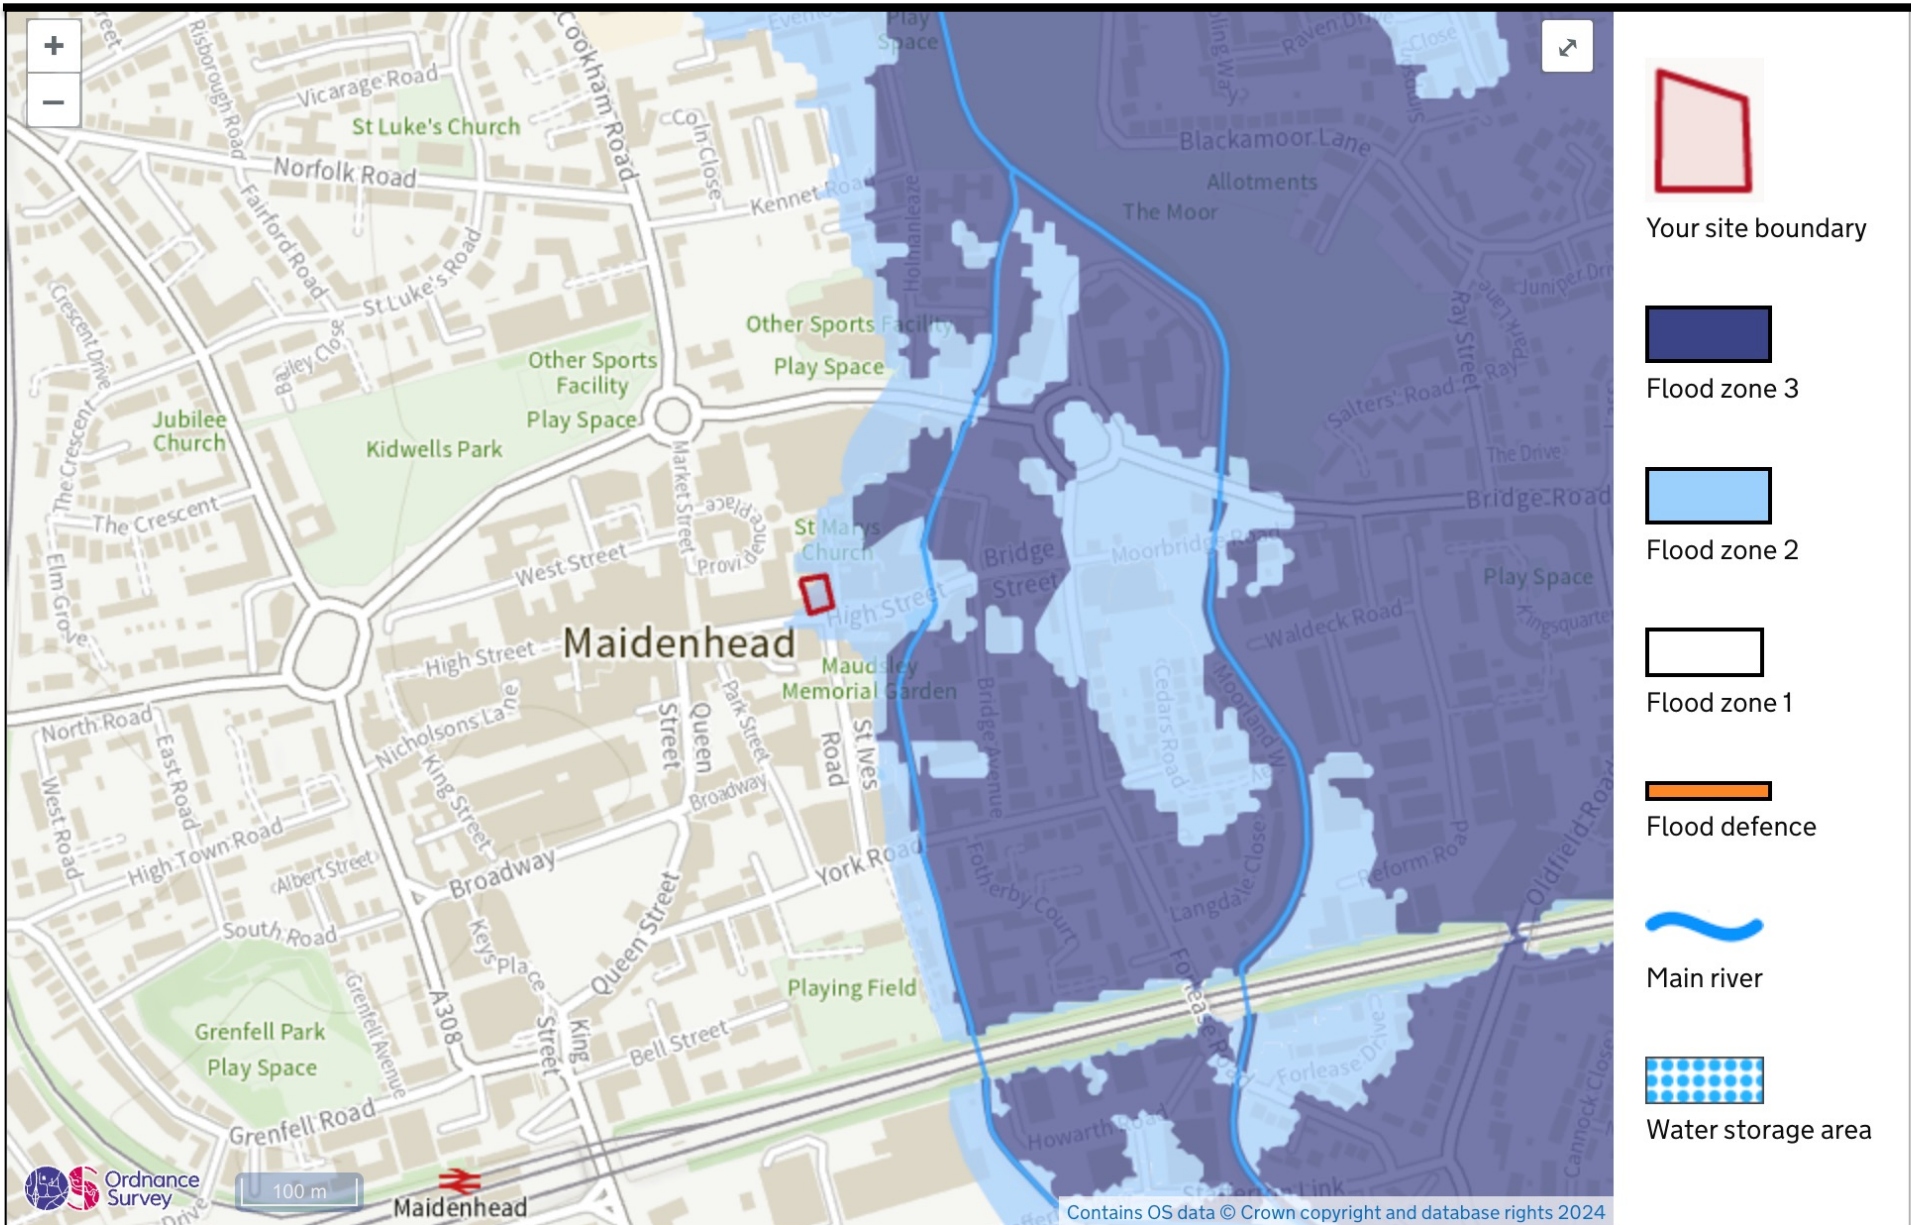
Figure 5 Environment Agency's Flood Map
