Project: Will Thorne Pavilion
 Client: Newham Council
 Drawing: Existing Ground Floor Plan
 Rev: 2306-3-010
 Status: Planning
 Date: 14/02/2024
 Scale: 1:100@A1

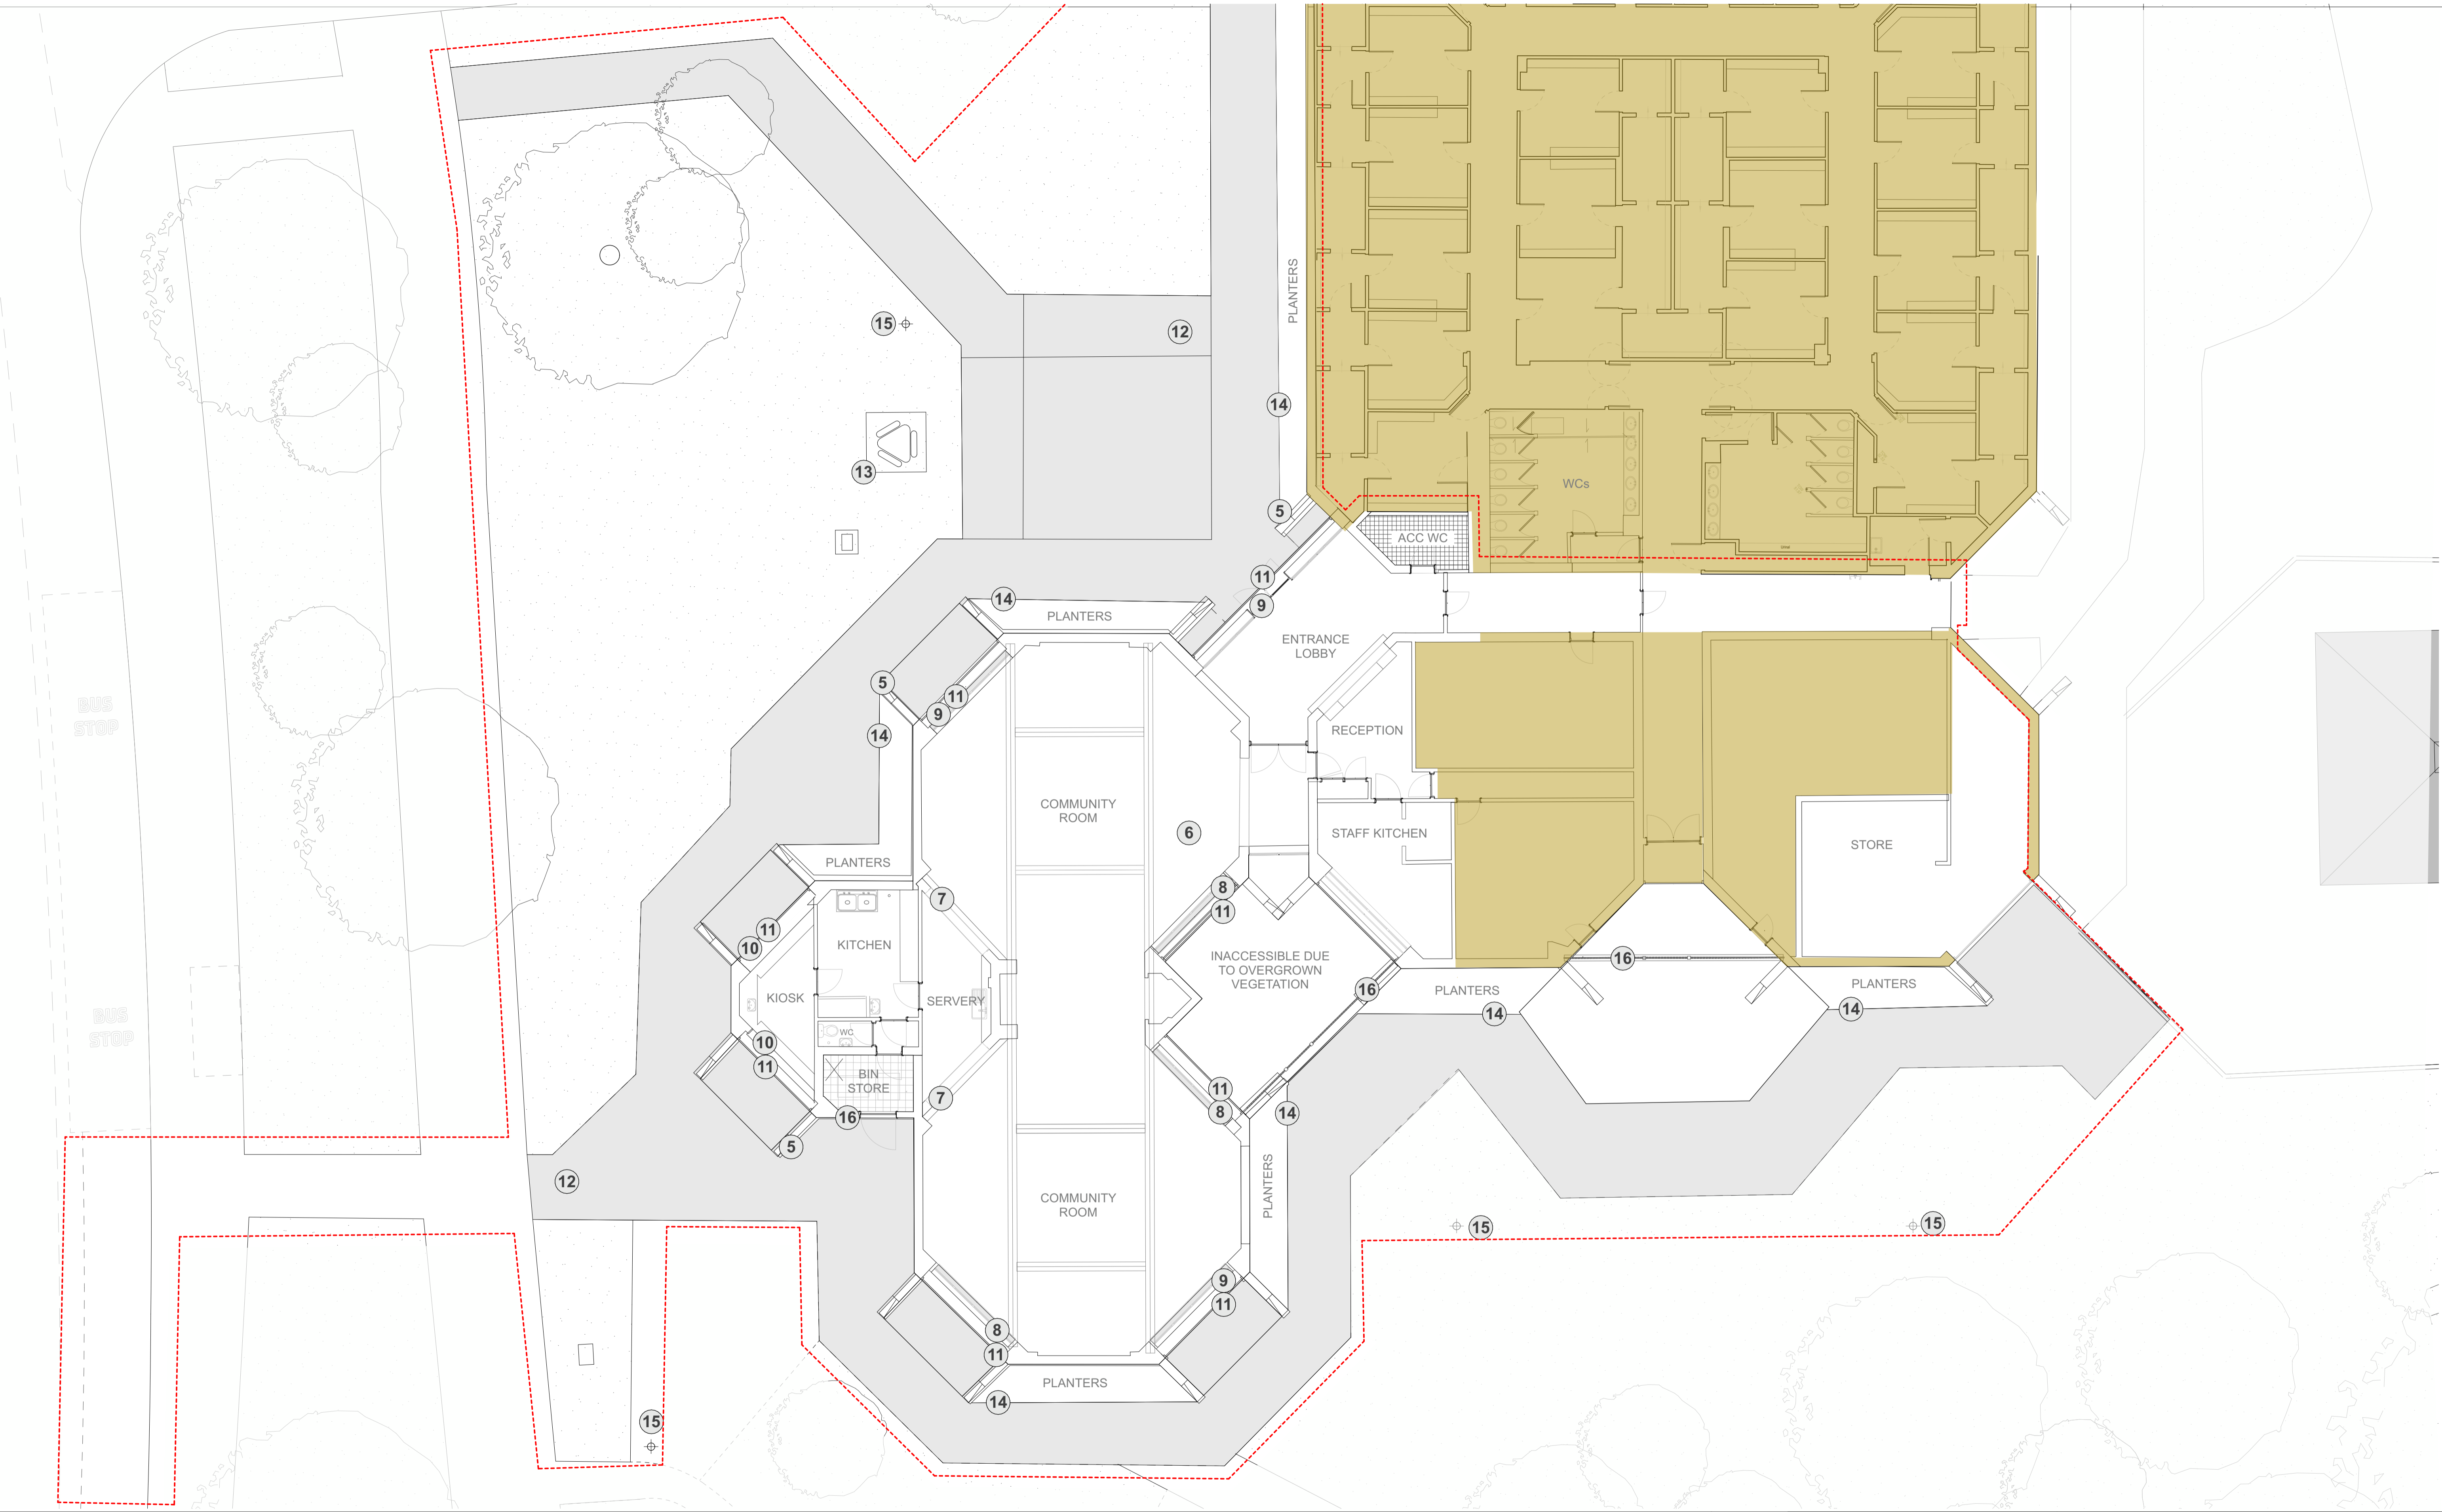
- KEY**
- Site Boundary
 - Existing
 - Areas not affected by the proposed works
- Existing Building Condition**
- Roof**
- 1 - Pitched pyramid roof with concrete tiles
 - 2 - Flat concrete roof with bitumen waterproof covering
 - 3 - Metal louvred roof cap to pyramid tops
 - 4 - Louvred ventilation riser
 - 5 - Brick buttress
- Internal**
- 6 - Linoleum tiles with asbestos adhesive
 - 7 - Kitchen servery hatch and worktop
- Openings**
- 8 - Full height single glazed timber windows
 - 9 - Single glazed timber double doors
 - 10 - Full height opening to kiosk
 - 11 - Galvanised or painted metal security shutters with timber cladding to head box
- External**
- 12 - Concrete paving slabs with uneven edges
 - 13 - Existing bench with table on paved surface
 - 14 - Overgrown planters
 - 15 - Existing lamp posts out of service
 - 16 - Existing painted metal fencing and gate
