Arboricultural Impact Assessment Method Statement & Tree Protection Plan (to BS:5837 2012)

37 Orchard Grove, New Milton
BH25 6NZ

Ref: TH 4249

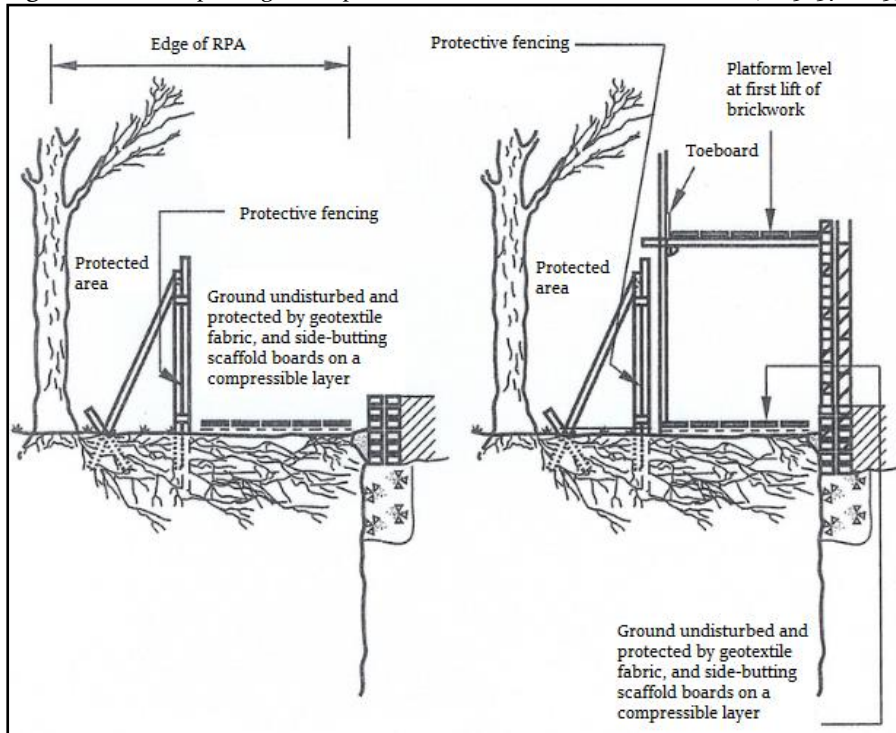
Figure 1: An example of ground protection on work areas within a RPA (BS 5837:2005).

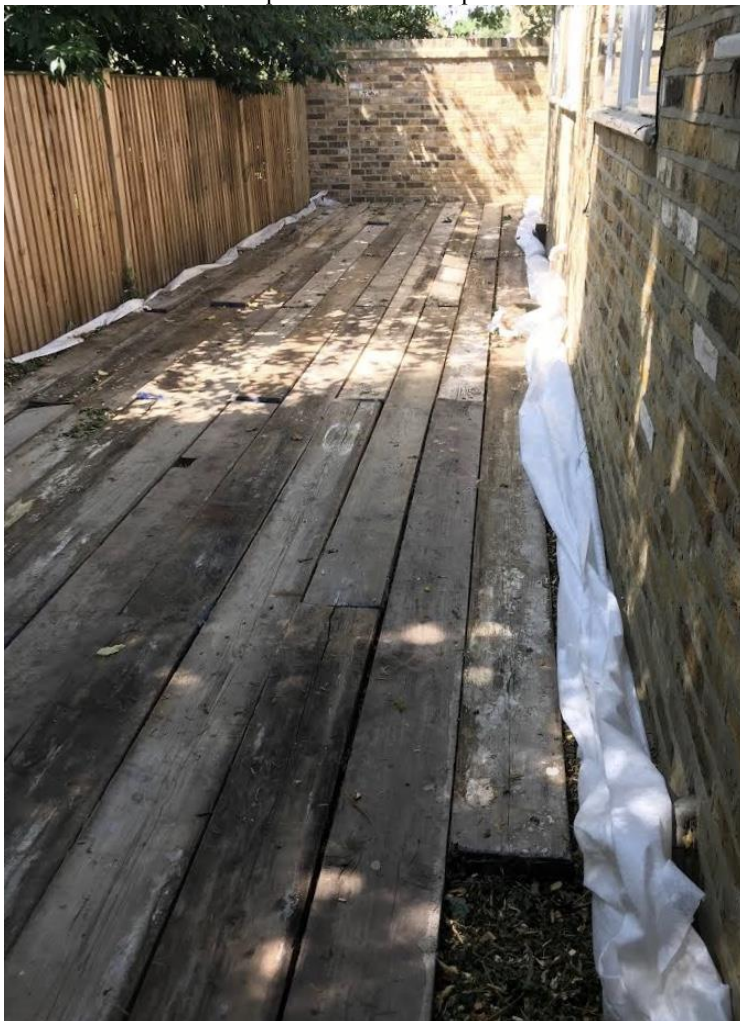
Photo 1. Scaffold boards placed on woodchip

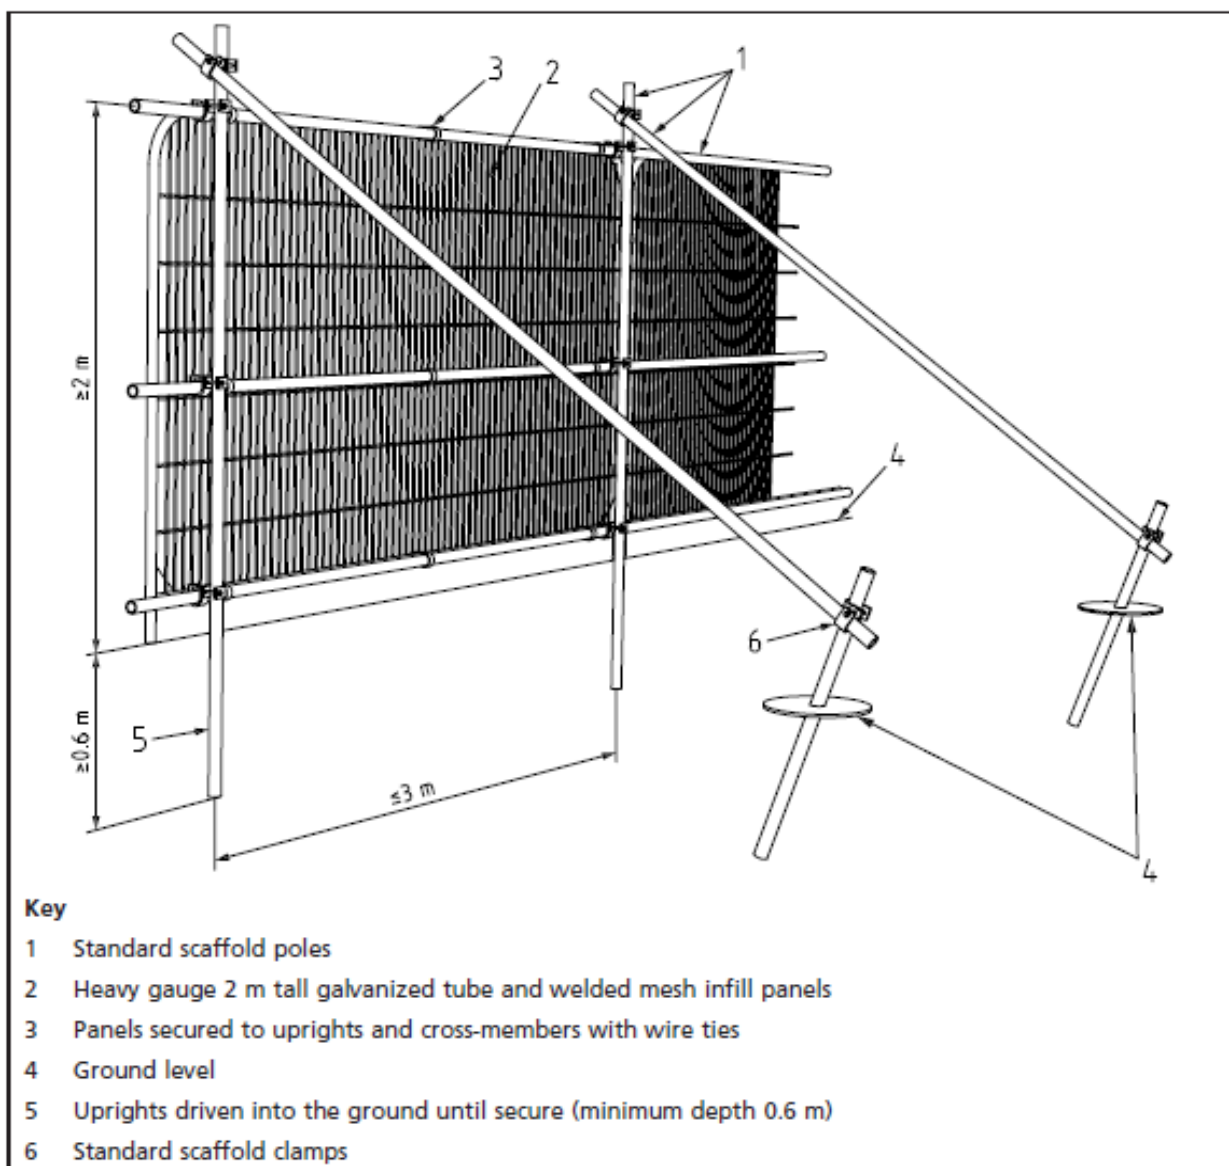
Figure 2: Default specification for protective barrier (BS 5837:2012)

The framework support (shown in Figure 2 and photo 1) is the usual method of support for 'Heras' fencing. Some variations are possible if site conditions are appropriate; i.e. support by wooden posts (75mm x 75mm x 2.75m) dug or concreted into the ground (dry mix concrete contained within a plastic bag), or if there is no pressure for access, a lighter form of netting on stakes.

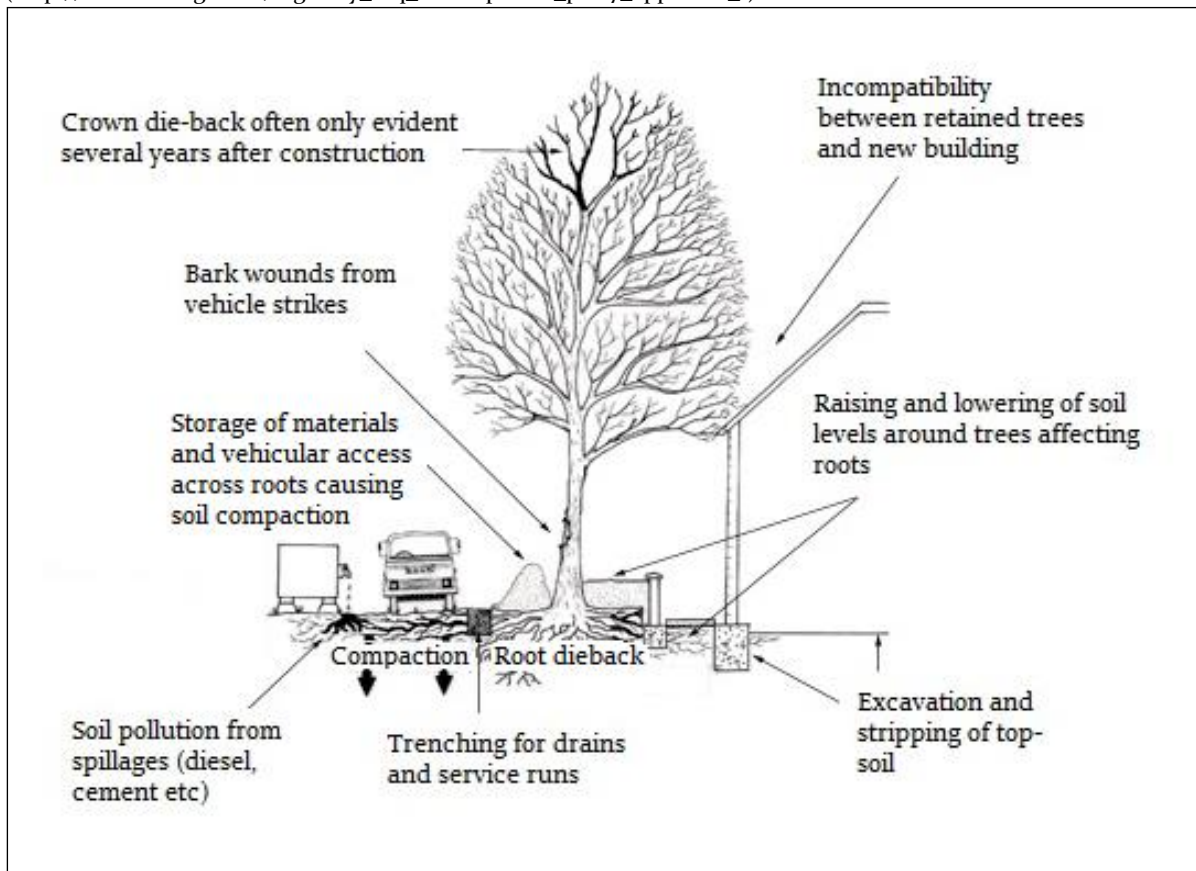
Figure 4: Common problems for trees on development sites
(http://www.leics.gov.uk/highway_req_development_part7_appendix_f)

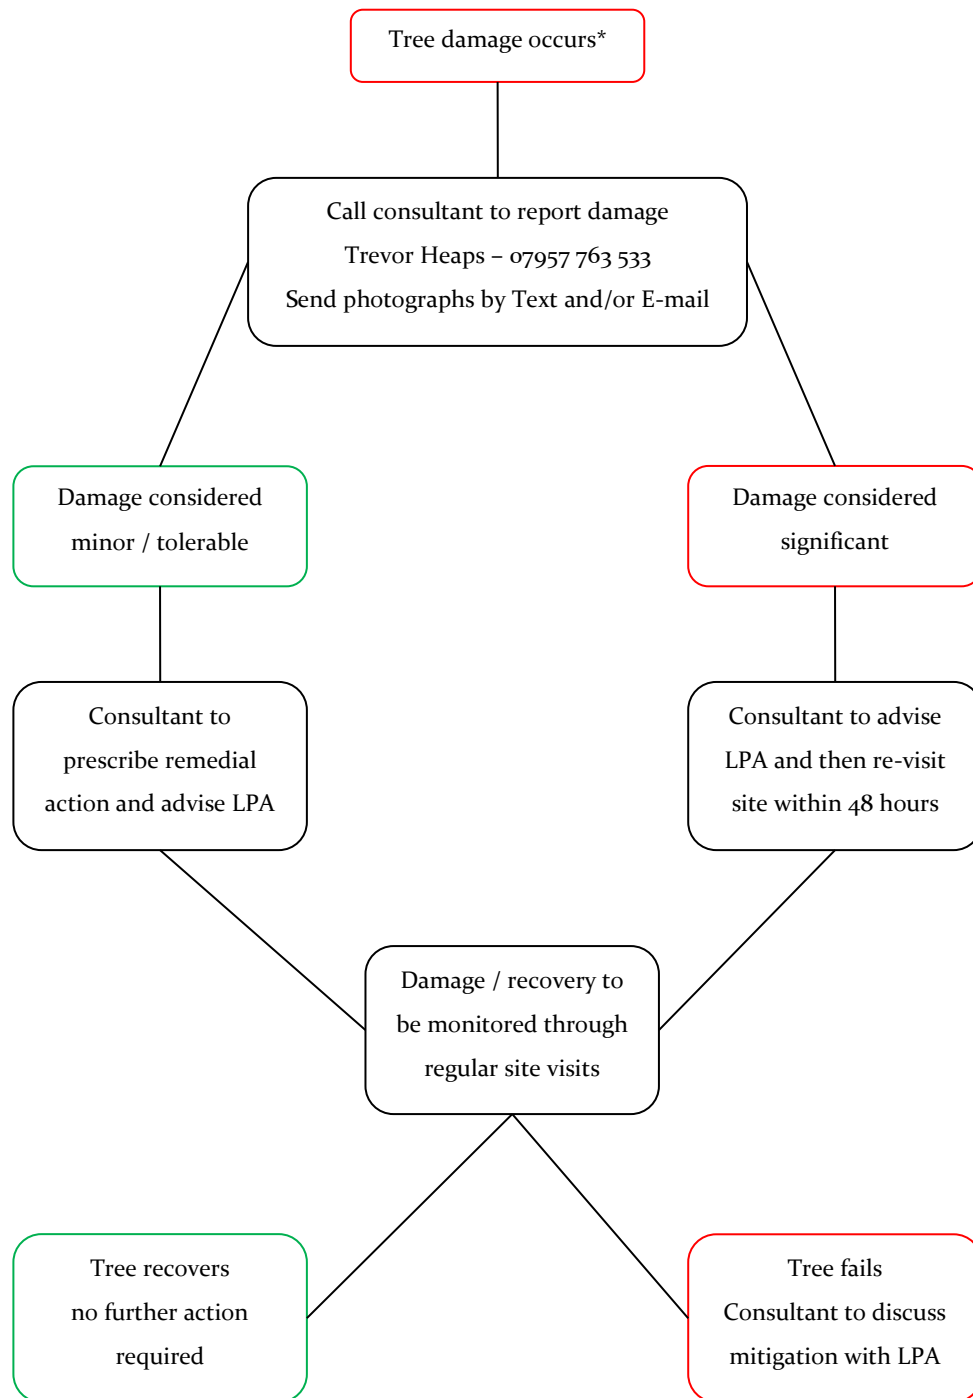
Appendix 6 - Procedure to follow in case of damage to retained trees

*Tree damage could include: unauthorised branch / root pruning; accidental damage to roots, stem, branches or crown; bark damage to vehicle / machinery strikes; and spillage of toxic materials within root protection areas (RPAs)

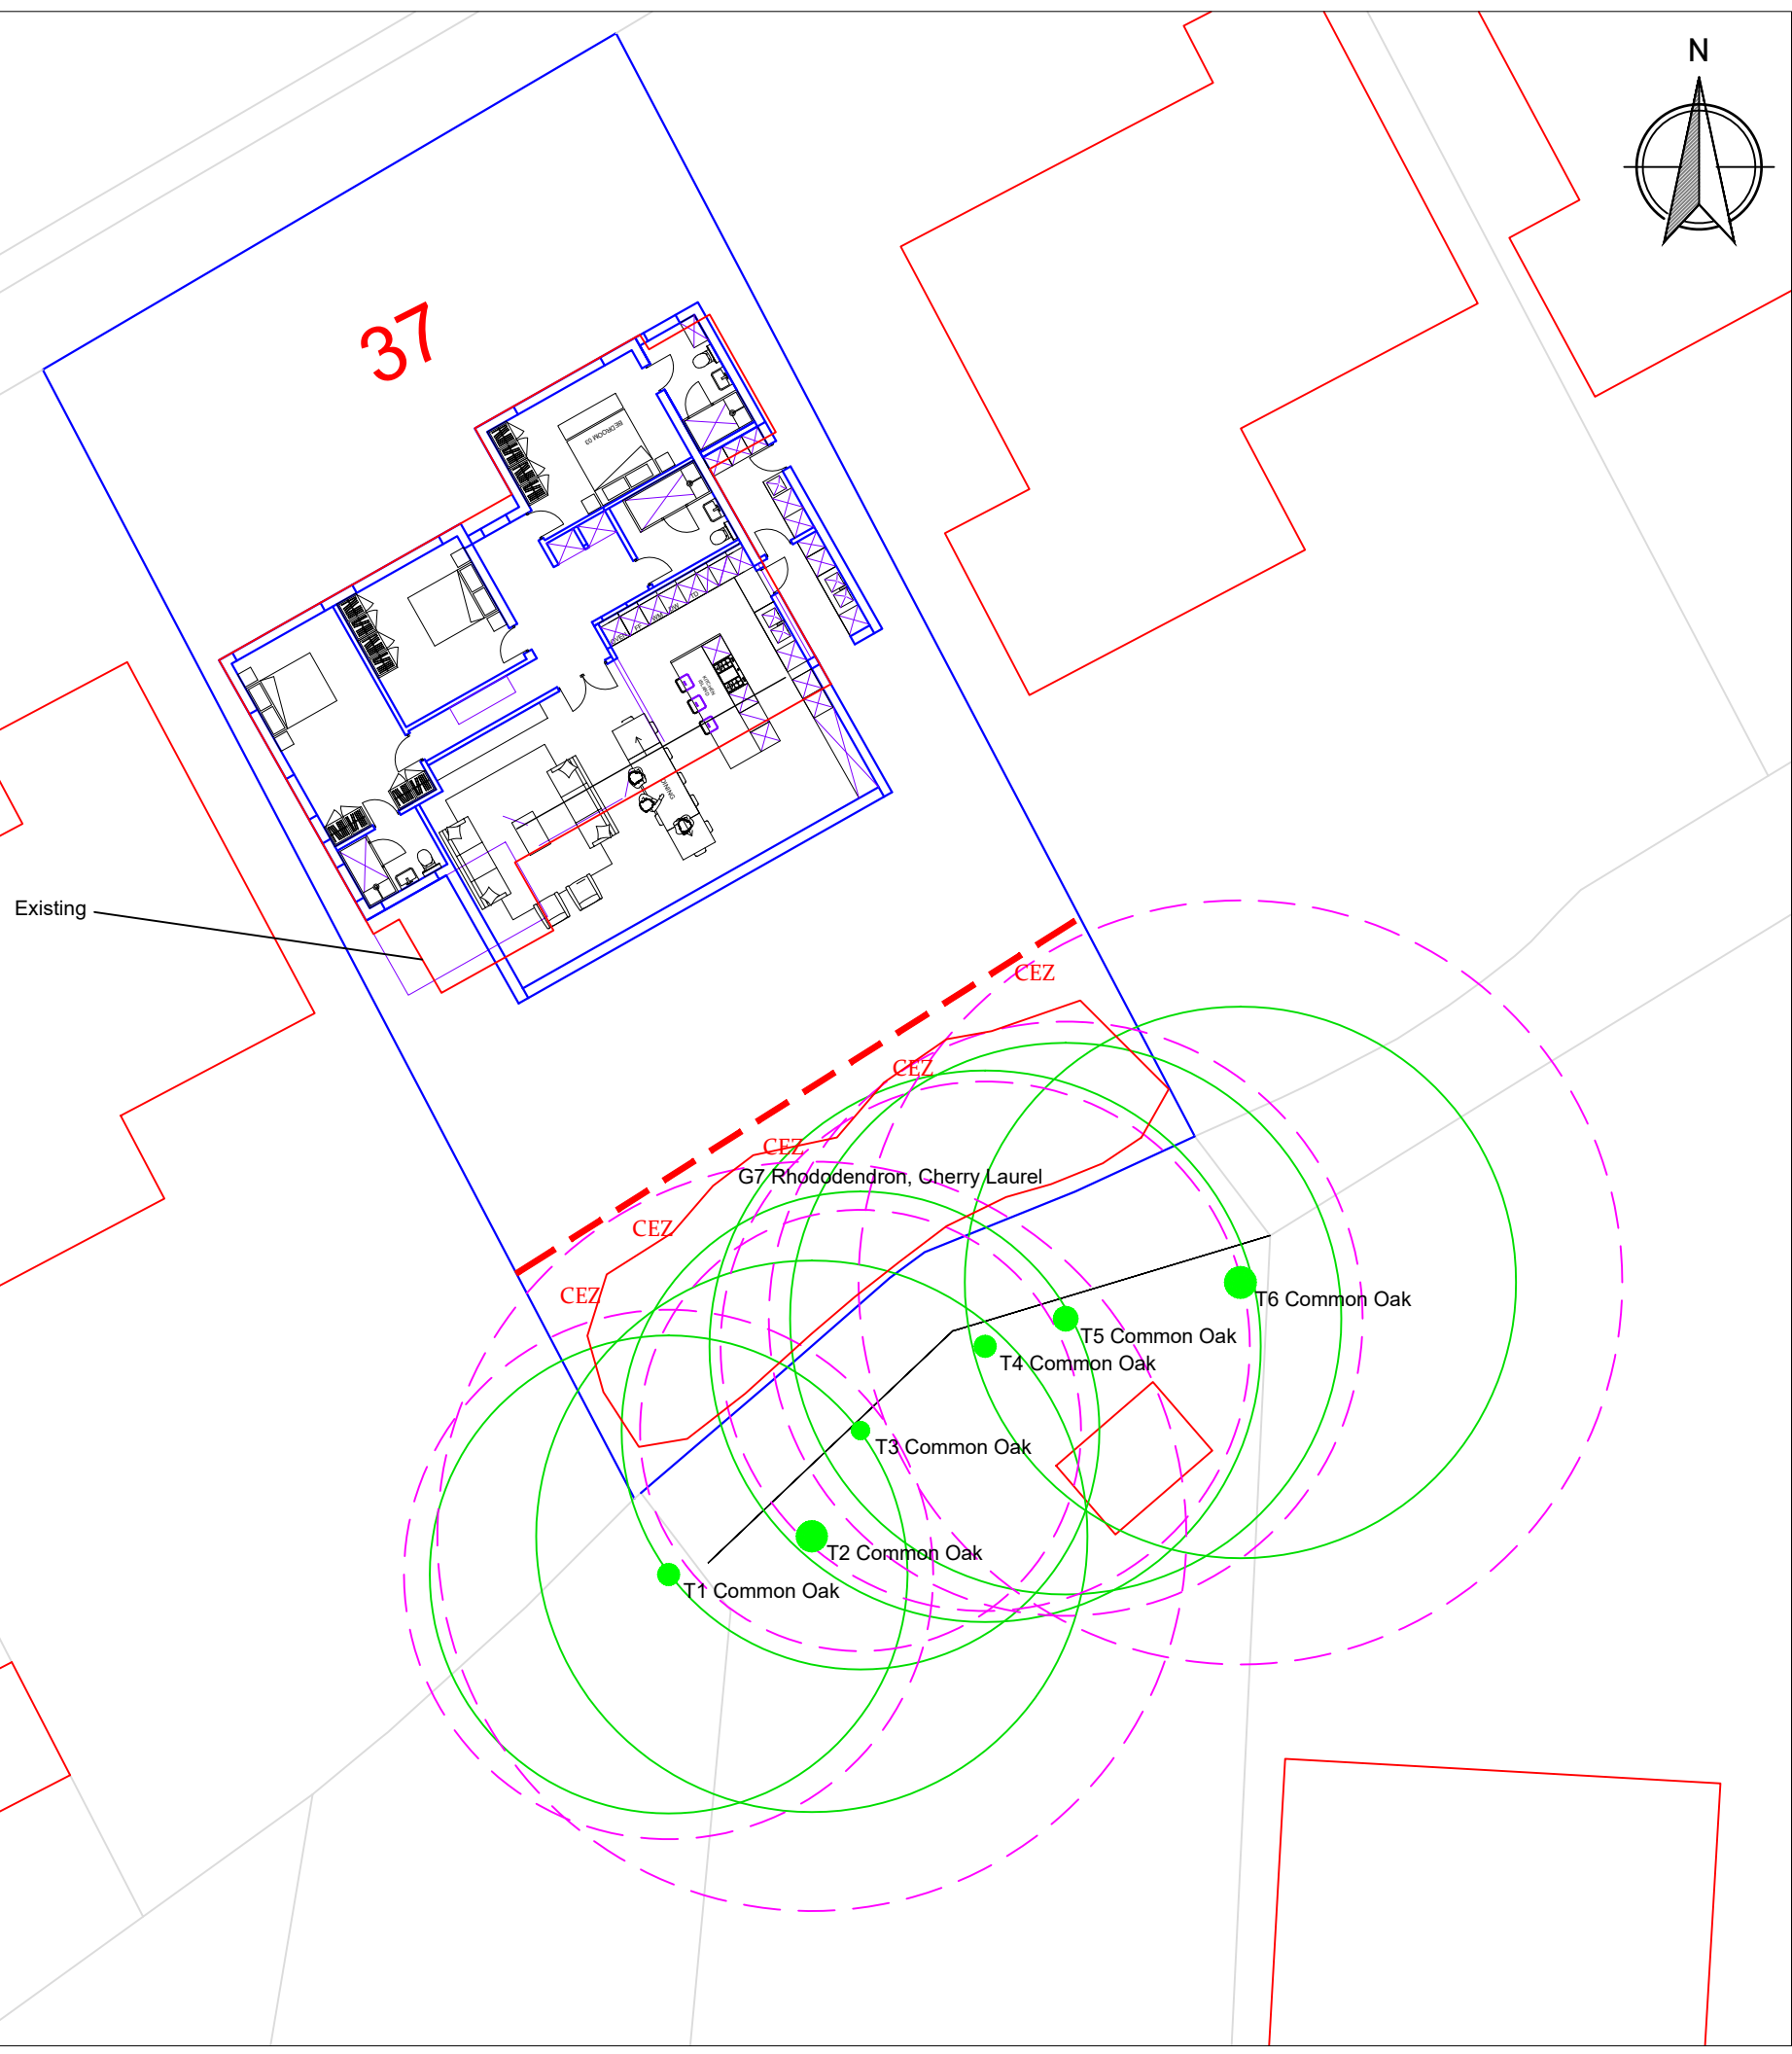
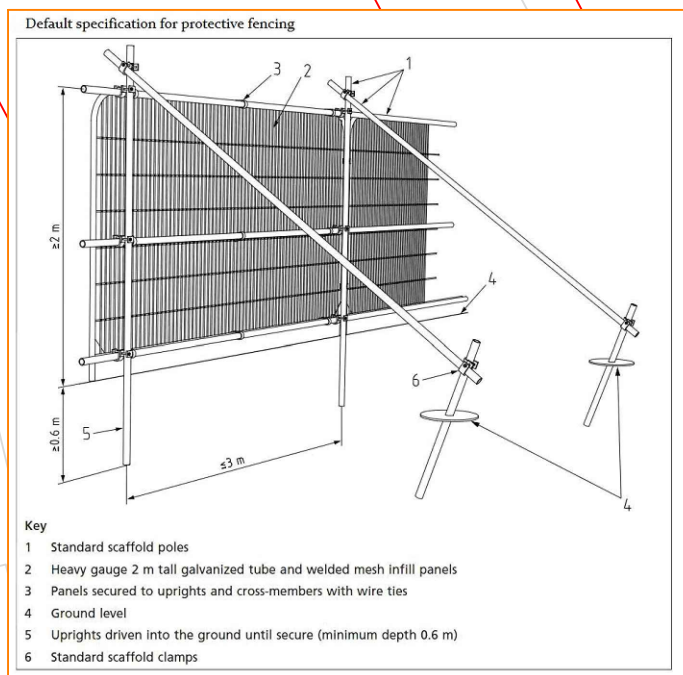
Scale: 1:200 @ A3

CEZ
Construction & storage exclusion zone

- At this site, operations are to occur in the following sequence:
1. Erect protective fencing along the position(s) shown by the dashed red line/s on the TPP.
 2. Provide a photographic record of all tree protection to arboricultural consultant - this will be forwarded to and approved by the Council's Arboricultural Officer and must demonstrate that all aspects of tree and ground protection measures have been implemented in accordance with this Arboricultural Report. The tree protection measures shall be retained until completion of all works hereby permitted.
 3. Commence construction.
 4. Remove tree protection when all construction activity has ended.
 5. Carry out landscaping works.

NOTE: It might be possible to move the protective fencing slightly to provide more working / storage / office space, but this will need to be confirmed with the arboricultural consultant first. IF agreeable, suitable ground protection (details provided in the appendices) will need to be laid over the exposed RPAs.

1. Erect protective fencing along the position(s) shown by the dashed red line/s on the TPP.
2. Provide a photographic record of all tree protection to arboricultural consultant – this will be forwarded to and approved by the Council’s Arboricultural Officer and must demonstrate that all aspects of tree and ground protection measures have been implemented in accordance with this Arboricultural Report. The tree protection measures shall be retained until completion of all works hereby permitted.
3. Commence construction.
4. Remove tree protection when all construction activity has ended.
5. Carry out landscaping works.
