# Heritage Statement

**Site :** Hall Bungalow

**Planning File Ref:** DC/23/4345/PREAPP

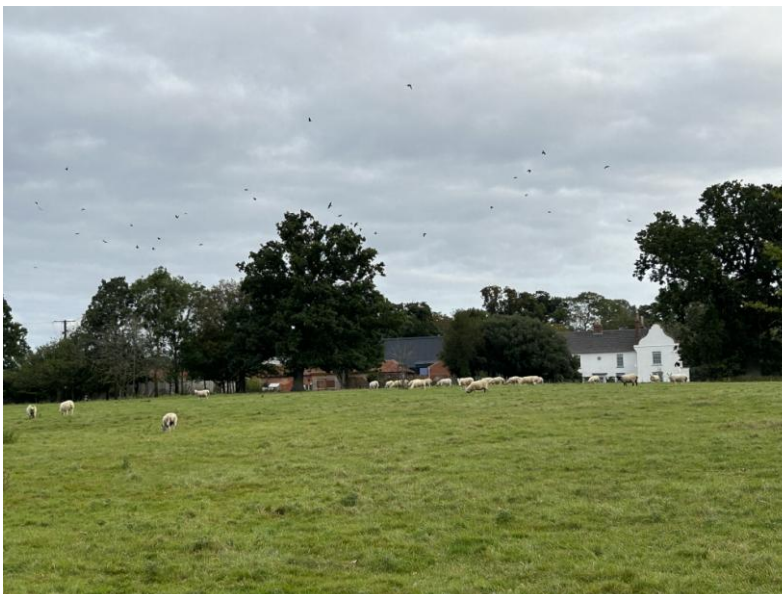
*View of the Hall and site of proposed new property from the South, with park land trees (to remain) obstructing any view to new property*

Any views from the Hall would not be altered by the renovation and extension of this property. The views of the Hall from around the overall landscape would not alter, as the Hall can mostly only be seen from the East or South.

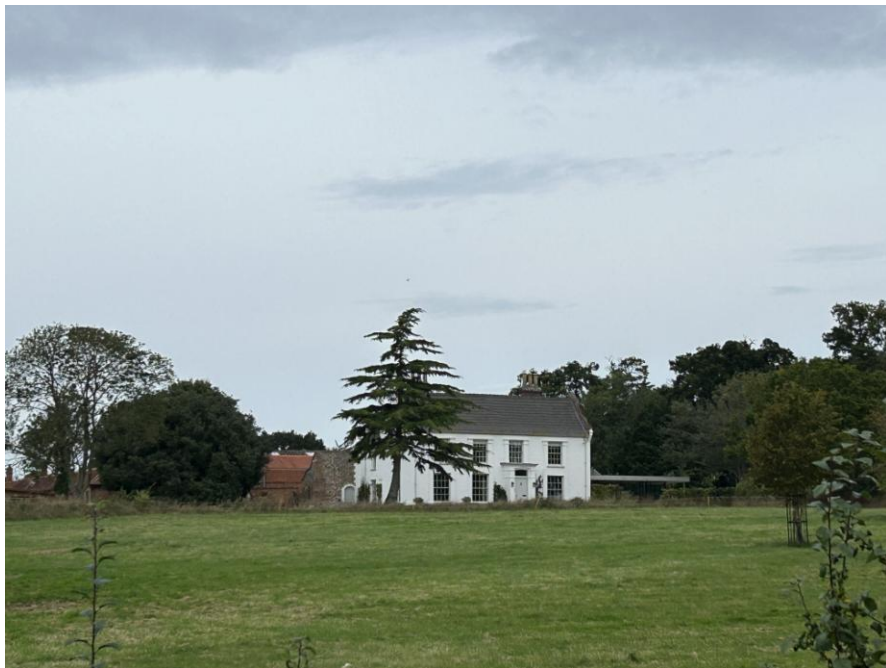
*View of the Hall from the South/East, also showing well established trees / vegetation screening farmyard buildings from the views of the main Hall*

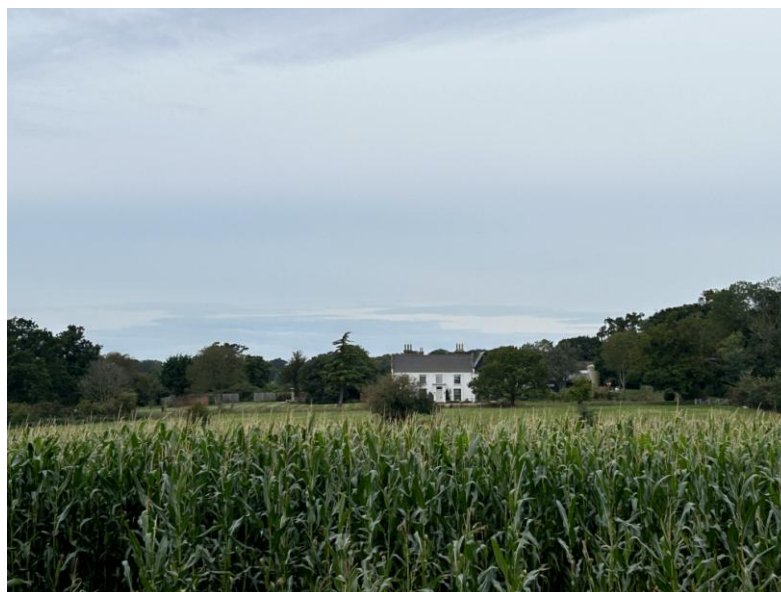
*Image of the main Hall from fields to the North, with no views of the farmyard building to the West*

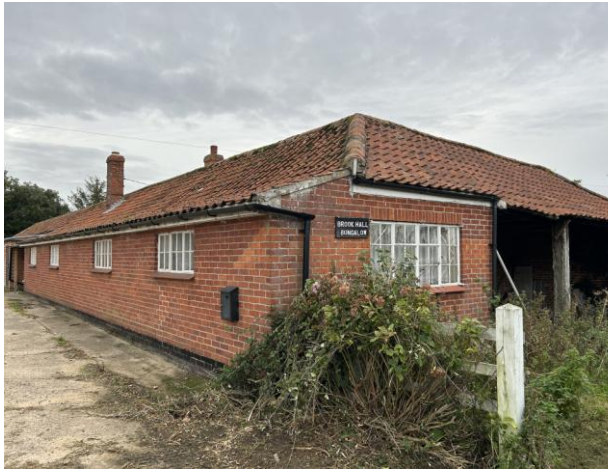
*Image of dilapidated building to be renovated and extended*

The farmyard setting, in which the newly renovated property will be positioned, will see managed change. The existing building has undersized ‘cittle’ style single glazed windows in the farmyard facing elevations. Some windows were altered in the workshop building further along the same elevation

during previous renovations, the windows in this property will be amended to match. The roof line on the farmyard side elevation has a ‘split pitch’. This is probably due to the way in which it has been converted for habitation and been amended over the years. The timber structure of the existing roof is rotten and suffers from insect infestation. This roof structure will have to be replaced and an offset truss system will be used. The actual roof covering on the farmyard facing elevation will re-use the existing tiles.

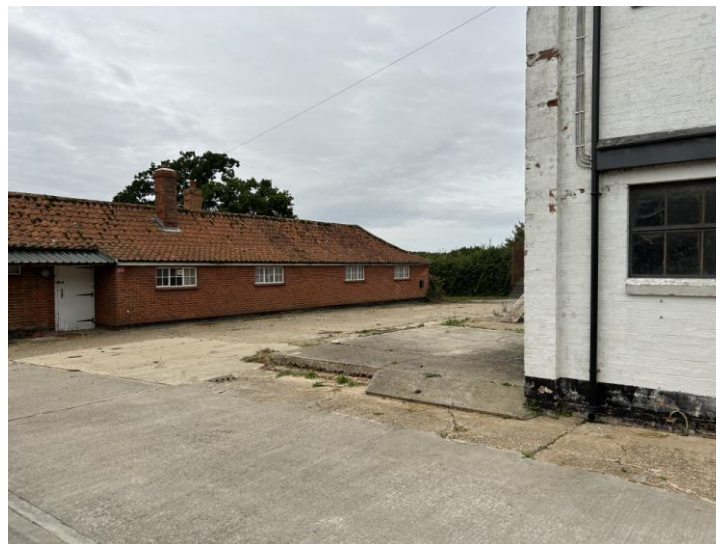
*Image of the building to be renovated and extended, showing the ‘farmyard’ area*

The property redevelopment has been designed to maintain the existing appearance on the farmyard side elevation. The extensions to be built to the South side of the property will not be in view, but will be built to blend in with the existing building. The extensions will also allow for the protection, renovation and use of the existing garden boundary wall that runs along the drive.
