## **HERITAGE, DESIGN AND ACCESS STATEMENT FOR PROPOSED REPAIRS & RESTORATION, OLD FORGE HOUSE, THORINGTON STREET, STOKE BY NAYLAND, CO6 4SN**

This heritage, design and access statement has been prepared in support of application (**PP-12871750**) for permission to repair Old Forge House. A scope of work has been prepared by Penny Clements RIBA AABC of Roger Balmer Design Ltd. The work will be undertaken by a reputable builder experienced in heritage building practices.

**Purpose of application:** we are seeking permission to repair and restore Old Forge House, addressing internal damp, external repairs to render, timbers and windows, replacement of rainwater goods and external decoration. A scope of works and photographic documentary evidence is provided as **Appendix A** and **Appendix B**.

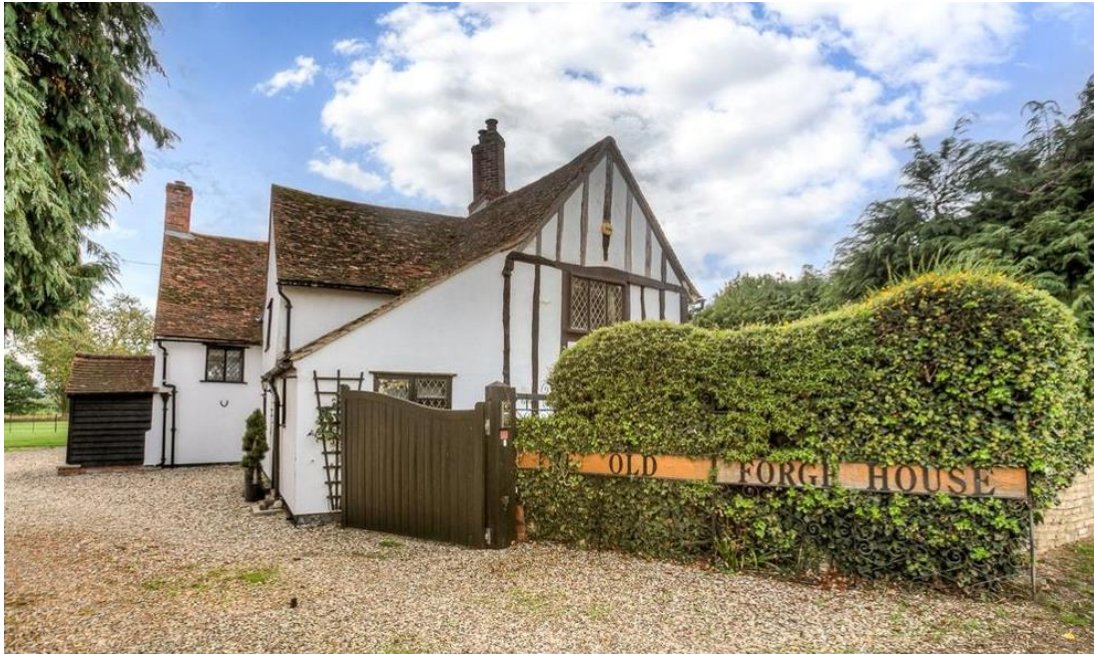
Picture 1: Old Forge House, viewed from front entrance on B1068

The Listing of Old Forge House points to the exposed timber-framing of the west front and north end as being of significance, as well as the lattice leaded lights in the casement windows. A review of documented histories of Old Forge House reveals little of significance about the southern end of the property, or the extended and historically refurbished (1980's) southeast wing. The garage and shed buildings are both non-listed, modern constructions.

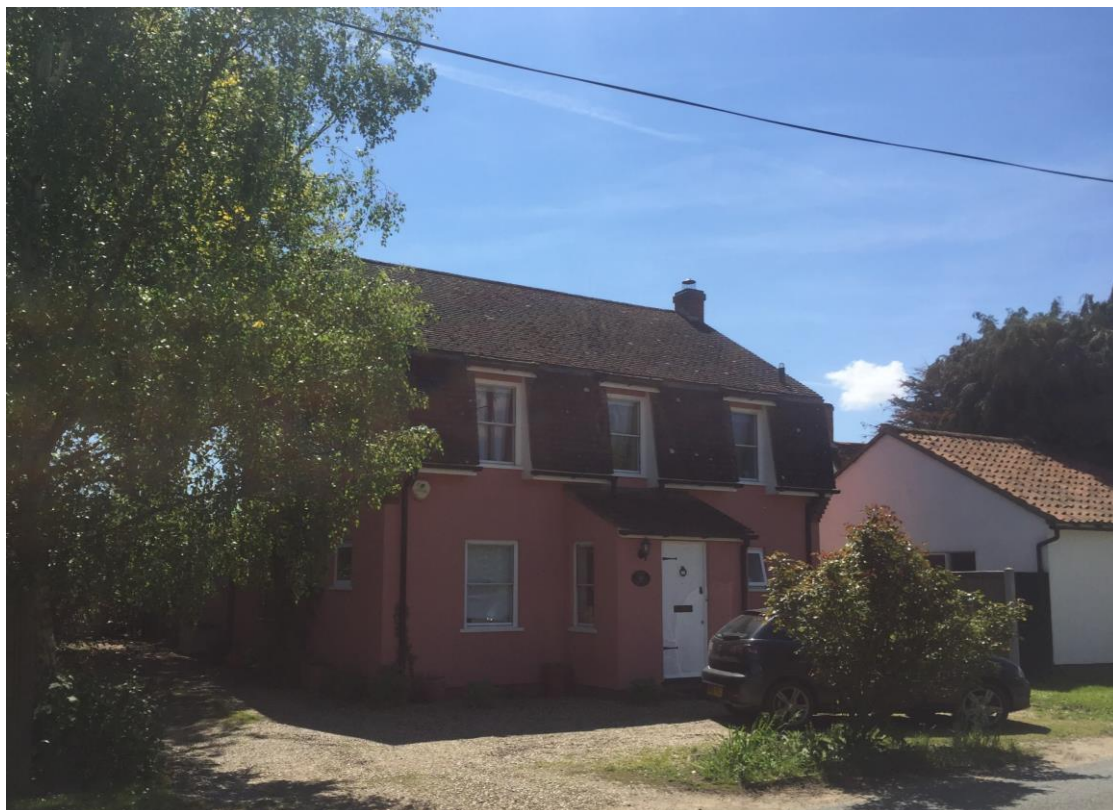
Picture 2: 'Rose Cottage'

To the immediate left of Old Forge House there is a relatively new build house (approx 1980) called “Rose Cottage”. This incorporates a render finish and Dutch style roof. See picture 2 below:

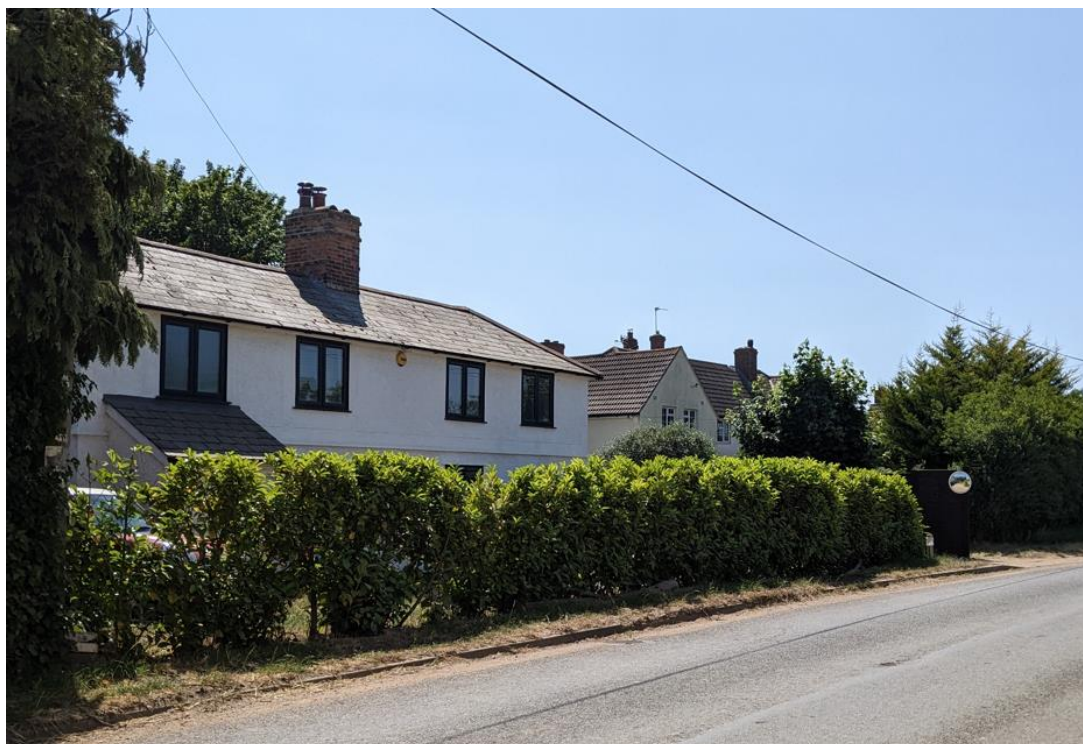
Picture 3: 'The Cottage'

To the right is a recently refurbished cottage-style building with a render finish and tiled roof. This house is called "The Cottage", picture 3 below:

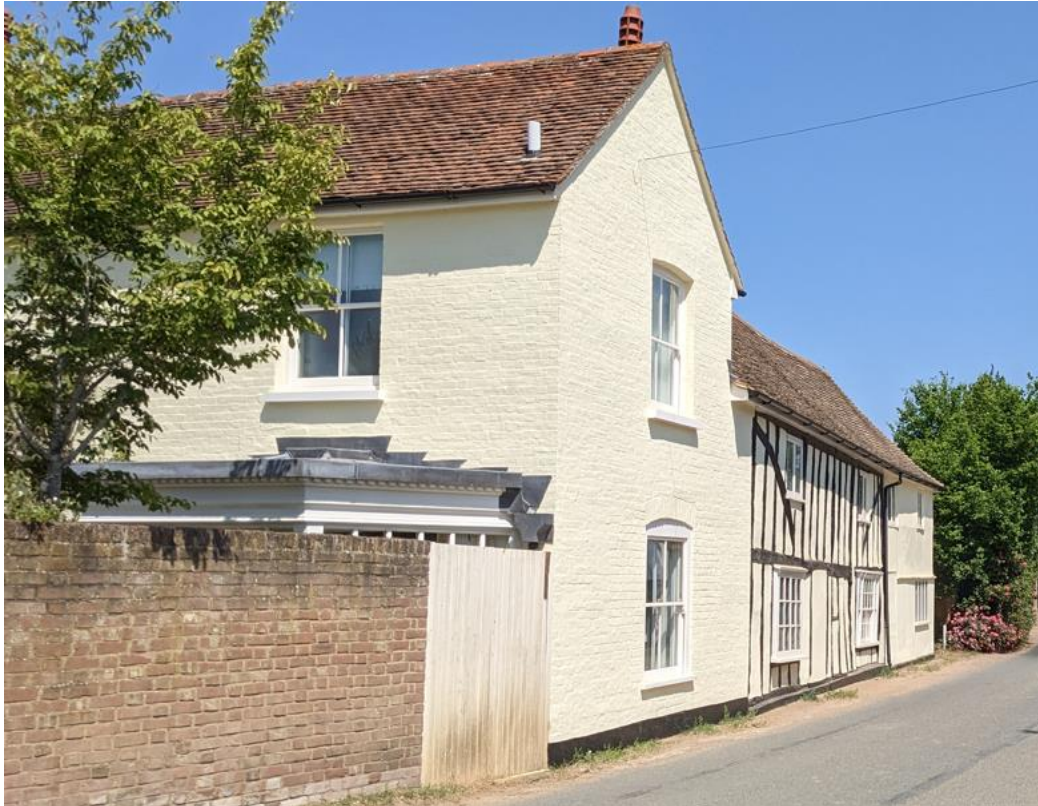
Picture 4: ‘Old Rose Inn’

Directly opposite the Old Forge House is a recently renovated Grade II listed former public house called “The Old Rose Inn”. This is of a similar age to the Old Forge House and shares similar features including exposed timber framing to one side and a tiled roof. See picture 4 below:
