Needham Market Veterinary Centre

Former Co-op, King William St, Needham Market, IP6 8AE

Proposed Signage Scheme

DRG NO.	SCALE	REV
23-036-05	As Shown	P1
DRAWN	AUTH	DATE
DM	DM	14.03.2024

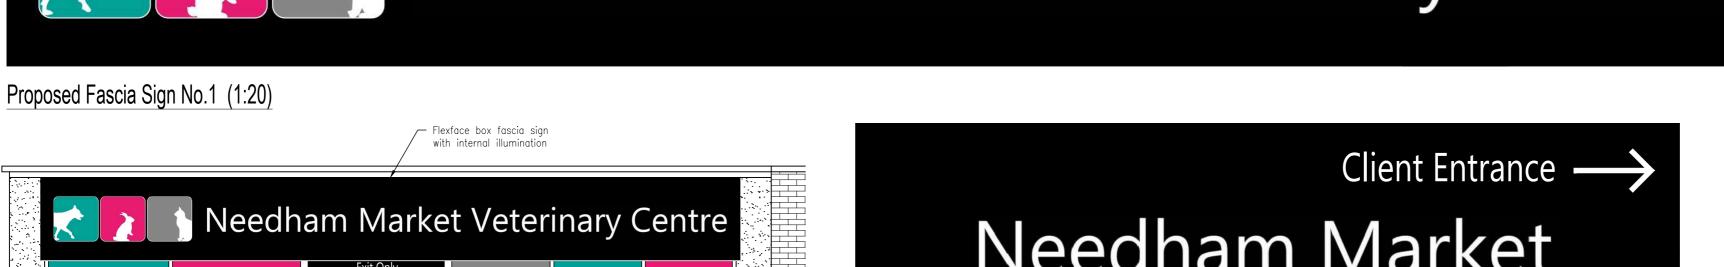
Proposed Rear Elevation (1:50)

Parking

at Rear

Showing Hoarding / Signage

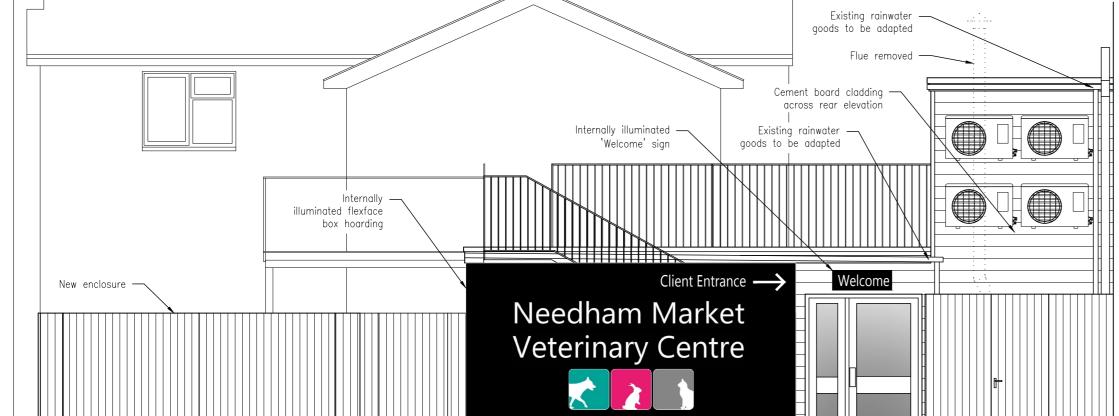
Proposed Fascia Sign No.2 (1:20)

Fascia Sign No.2 to comprise folded aluminium panels with internal illumination at 160 cd/m.

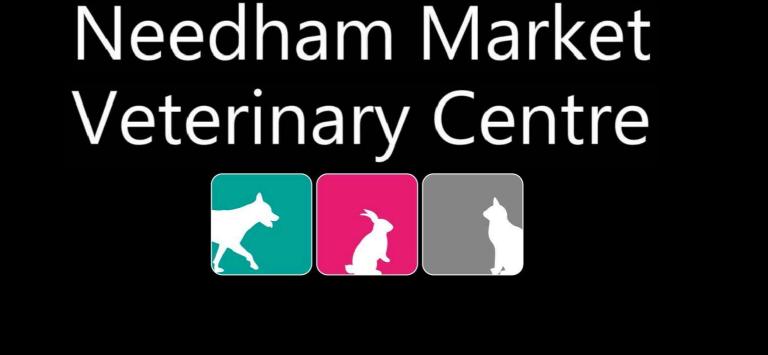
Typical Section through Flexface Box (1:10)

ascia Sign No.1 and Hoarding Sign to comprise flexface box with nternal LED illumination at 160 cd/m.
