PROPOSED SIDE 2 ELEVATION - SECTION C-C

5 BENNINGTON DRIVE - WD6 4QN

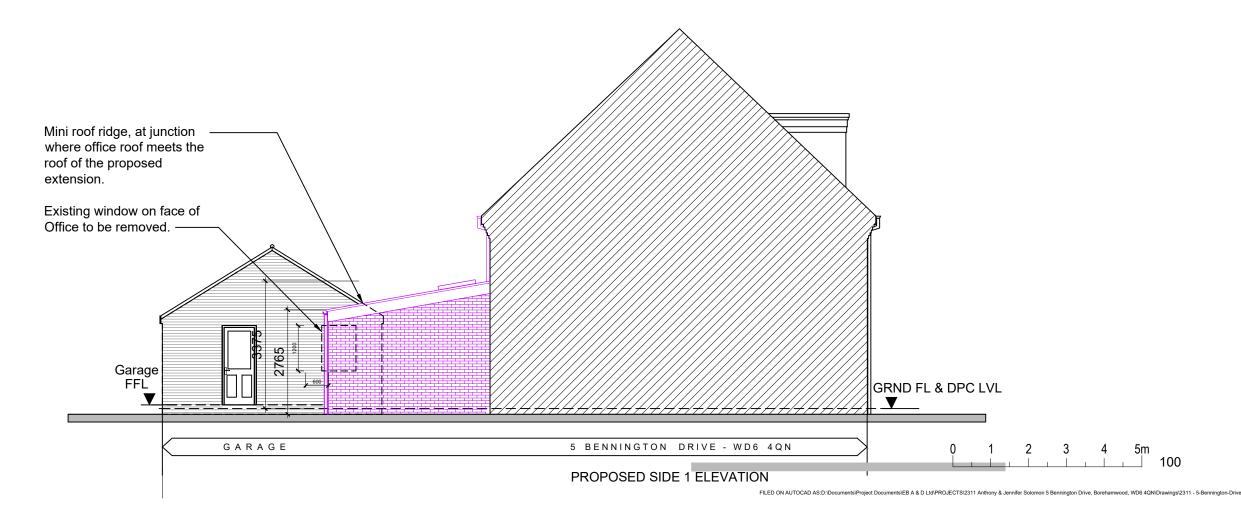
New rainwater pipe Roof light U/S CLNG \blacksquare Proposed extension as seen from behind the existing 1.8m high closeboarded timber fence and existing garages at street level. U/S CLNG Existing window to be removed from Office wall. 1ST FL

NOTE: Office finished floor level is higher than the main house, therefore a Building Regulation compliant step is to be formed at the point indicated on this drawing.
