Temporary Ground Protection Specification

PROJECT
**Bentworth Hall West,
Holt End Lane, Bentworth,
Alton, GU34 5LA**

TITLE
Tree Protection Plan (TPP)

Tree Protection Specification

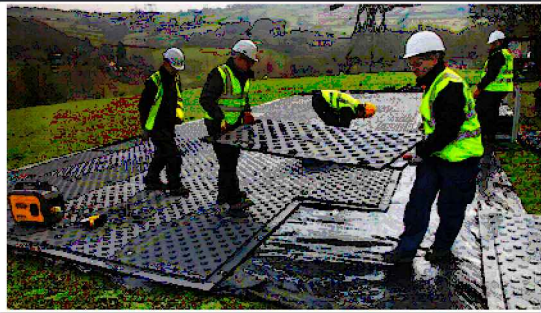
Temporary Ground Protection Specification

To be installed prior to any on site activity (demolition or construction)

- Retain existing on site hard standing if present for as long as possible.
- If indicated new temporary ground protection should be installed as part of the tree protection measures prior to work starting on site.
- For exposed unmade ground within Root Protection Area.
- To be laid on non-permeable membrane
- We recommend 300 x 300 x 20mm mats manufactured from recycled HDPE plastic, with carrying handles and an engraved grid pattern with minimum 150mm overlap to join together.

To cover all exposed unmade ground for tree Root Protection Area outside of Tree Protective Fencing
