DESIGN AND ACCESS STATEMENT

PROPOSED FRONT ENTRANCE PORCH EXTENSION, REPLACEMENT WINDOWS AND
NEW FRENCH DOORS TO THE REAR

61 BOTYL ROAD, BOTOLPH CLAYDON, BUCKINGHAMSHIRE, MK18 2LR

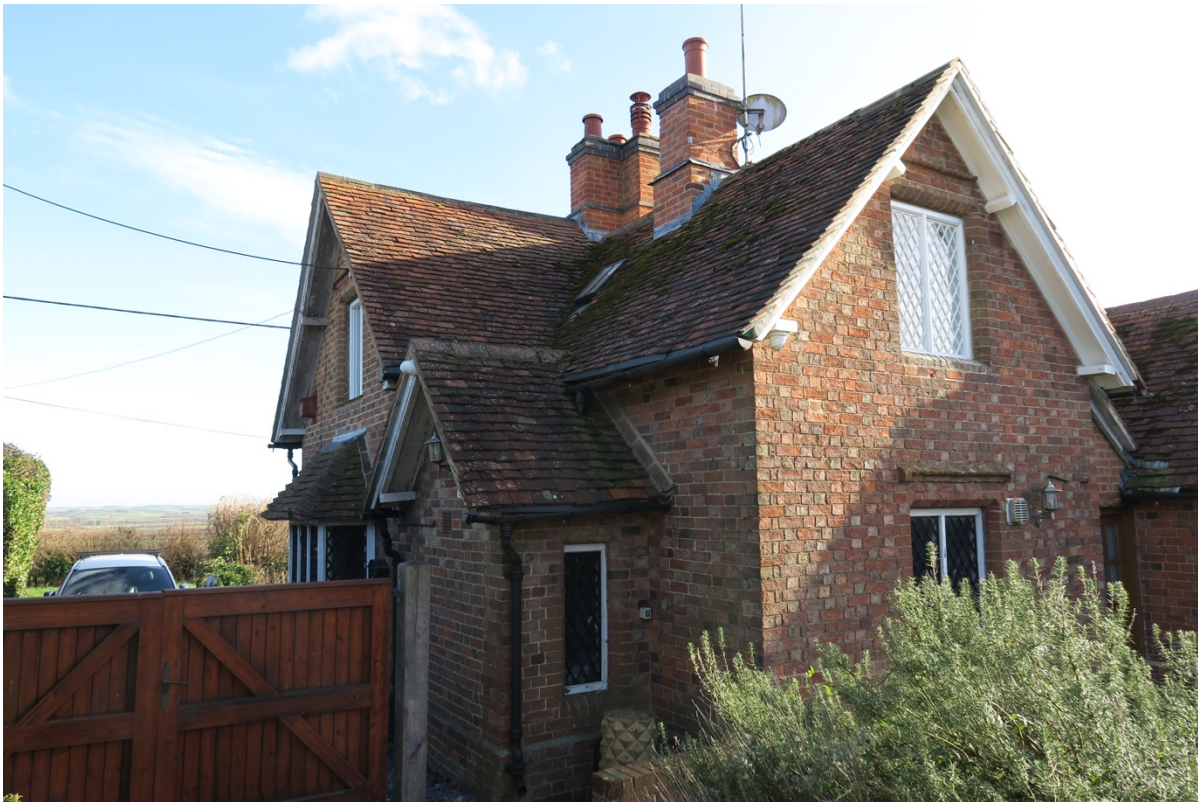
REAR PHOTOGRAPH

Northwest corner of the cottage showing plain clay tiles
