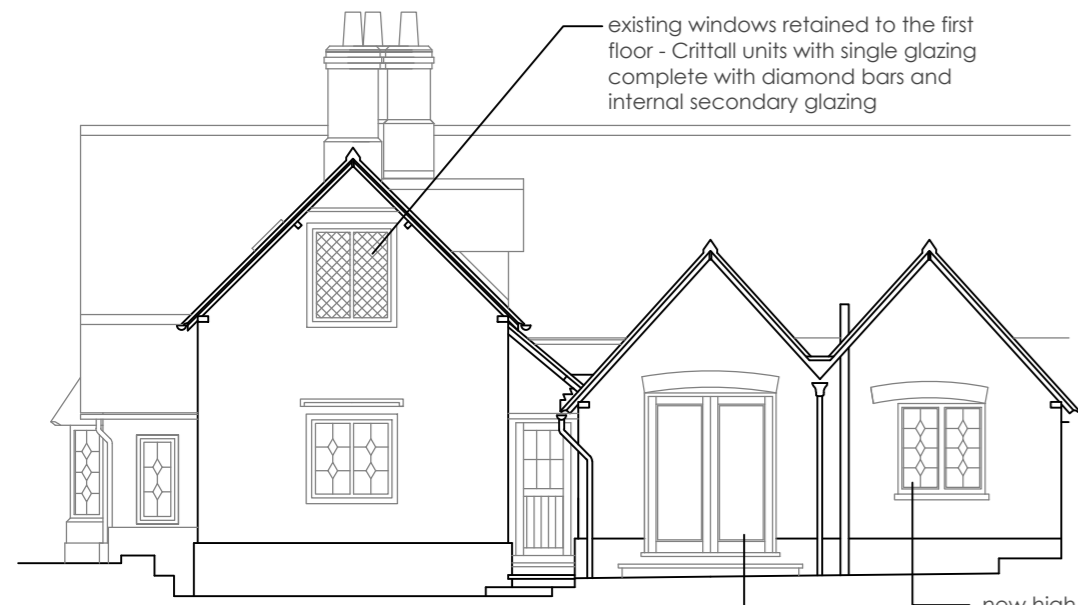
north west elevation

existing windows retained to the first floor - Crittall units with single glazing complete with diamond bars and internal secondary glazing

new high performance double glazed (slim heritage double glazing) flush casement hardwood framed windows to the ground floor with diamond glazing bars - white painted

hardwood framed double glazed French doors

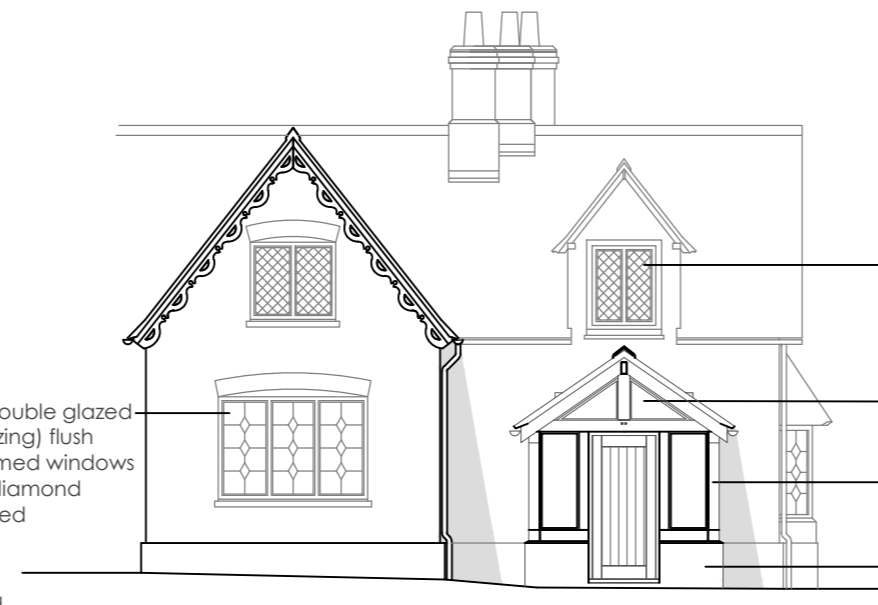
south east elevation

existing windows retained to the first floor - Crittall units with single glazing complete with diamond bars and internal secondary glazing

glazed apex

double glazed European oak frame

reclaimed or high quality handmade projecting brick plinth in traditional lime mortar - colour and detail close match to existing with snapped headers to replicate Flemish bond

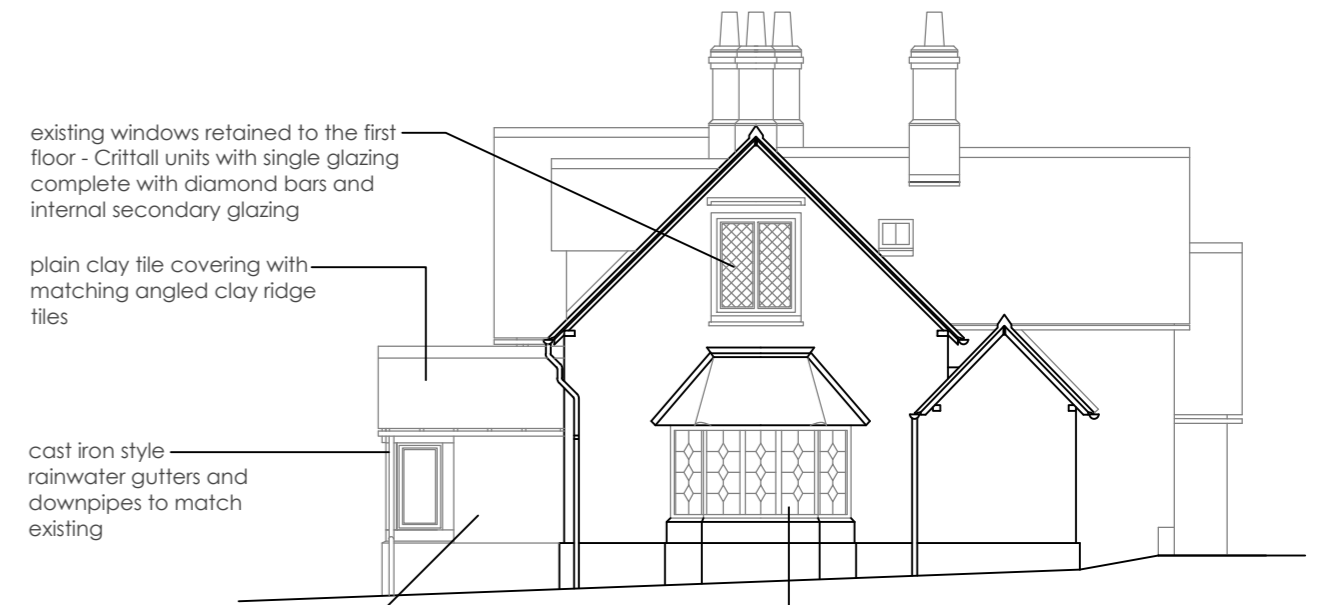
north east elevation

existing windows retained to the first floor - Crittall units with single glazing complete with diamond bars and internal secondary glazing

plain clay tile covering with matching angled clay ridge tiles

cast iron style rainwater gutters and downpipes to match existing

reclaimed or high quality handmade brick in traditional lime mortar - colour close match to existing with snapped headers to replicate Flemish bond

new high performance double glazed (slim heritage double glazing) flush casement hardwood framed windows to the ground floor with diamond glazing bars - white painted

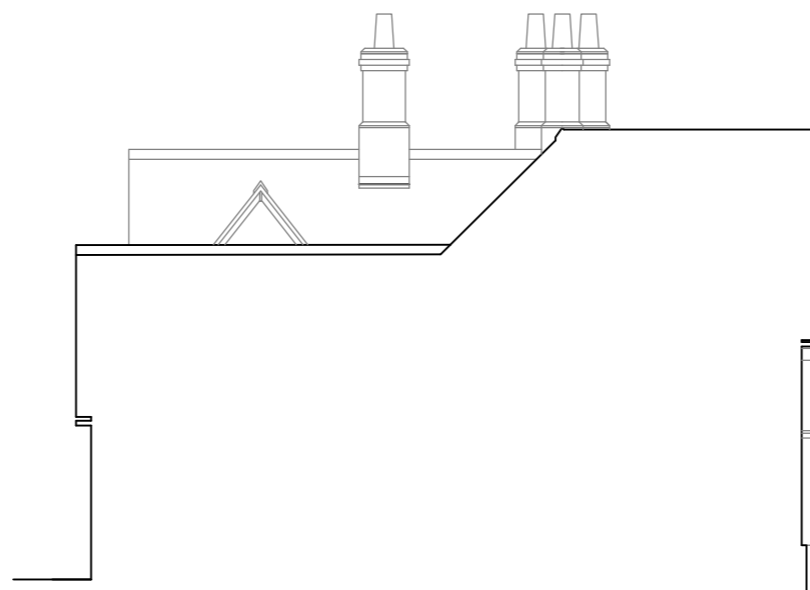
south west porch elevation / section through existing

plain clay tile covering with matching angled clay ridge tiles

cast iron style rainwater gutters and downpipes to match existing

reclaimed or high quality handmade brick in traditional lime mortar - colour close match to existing with snapped headers to replicate Flemish bond
