## **Structural Report**

## <u>Conversion & Extension of Redundant Agricultural Barn to</u> <u>From Dwelling House & Associated Works</u>

Great Treburrick Farm, Treburrick, St Eval, PL27 7UR

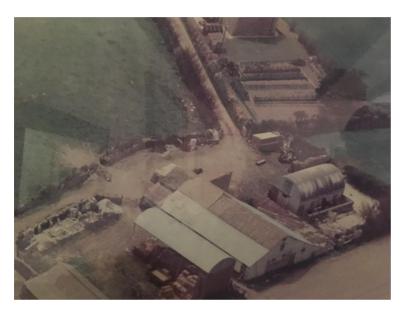
2.1 The site consists of principally one barn. A historical image identifies the block barn prior to the storm damage.

The barn to be converted is the western barn on the application site which is two story in nature and redundant.
