PROJECT:
Land at Wight Haven, Swains Lane, Bembridge

DRAWING TITLE:
Draft Tree Protection Plan

DRAWING NO: AS/ED/0324 DTPP	REV.
--------------------------------	------

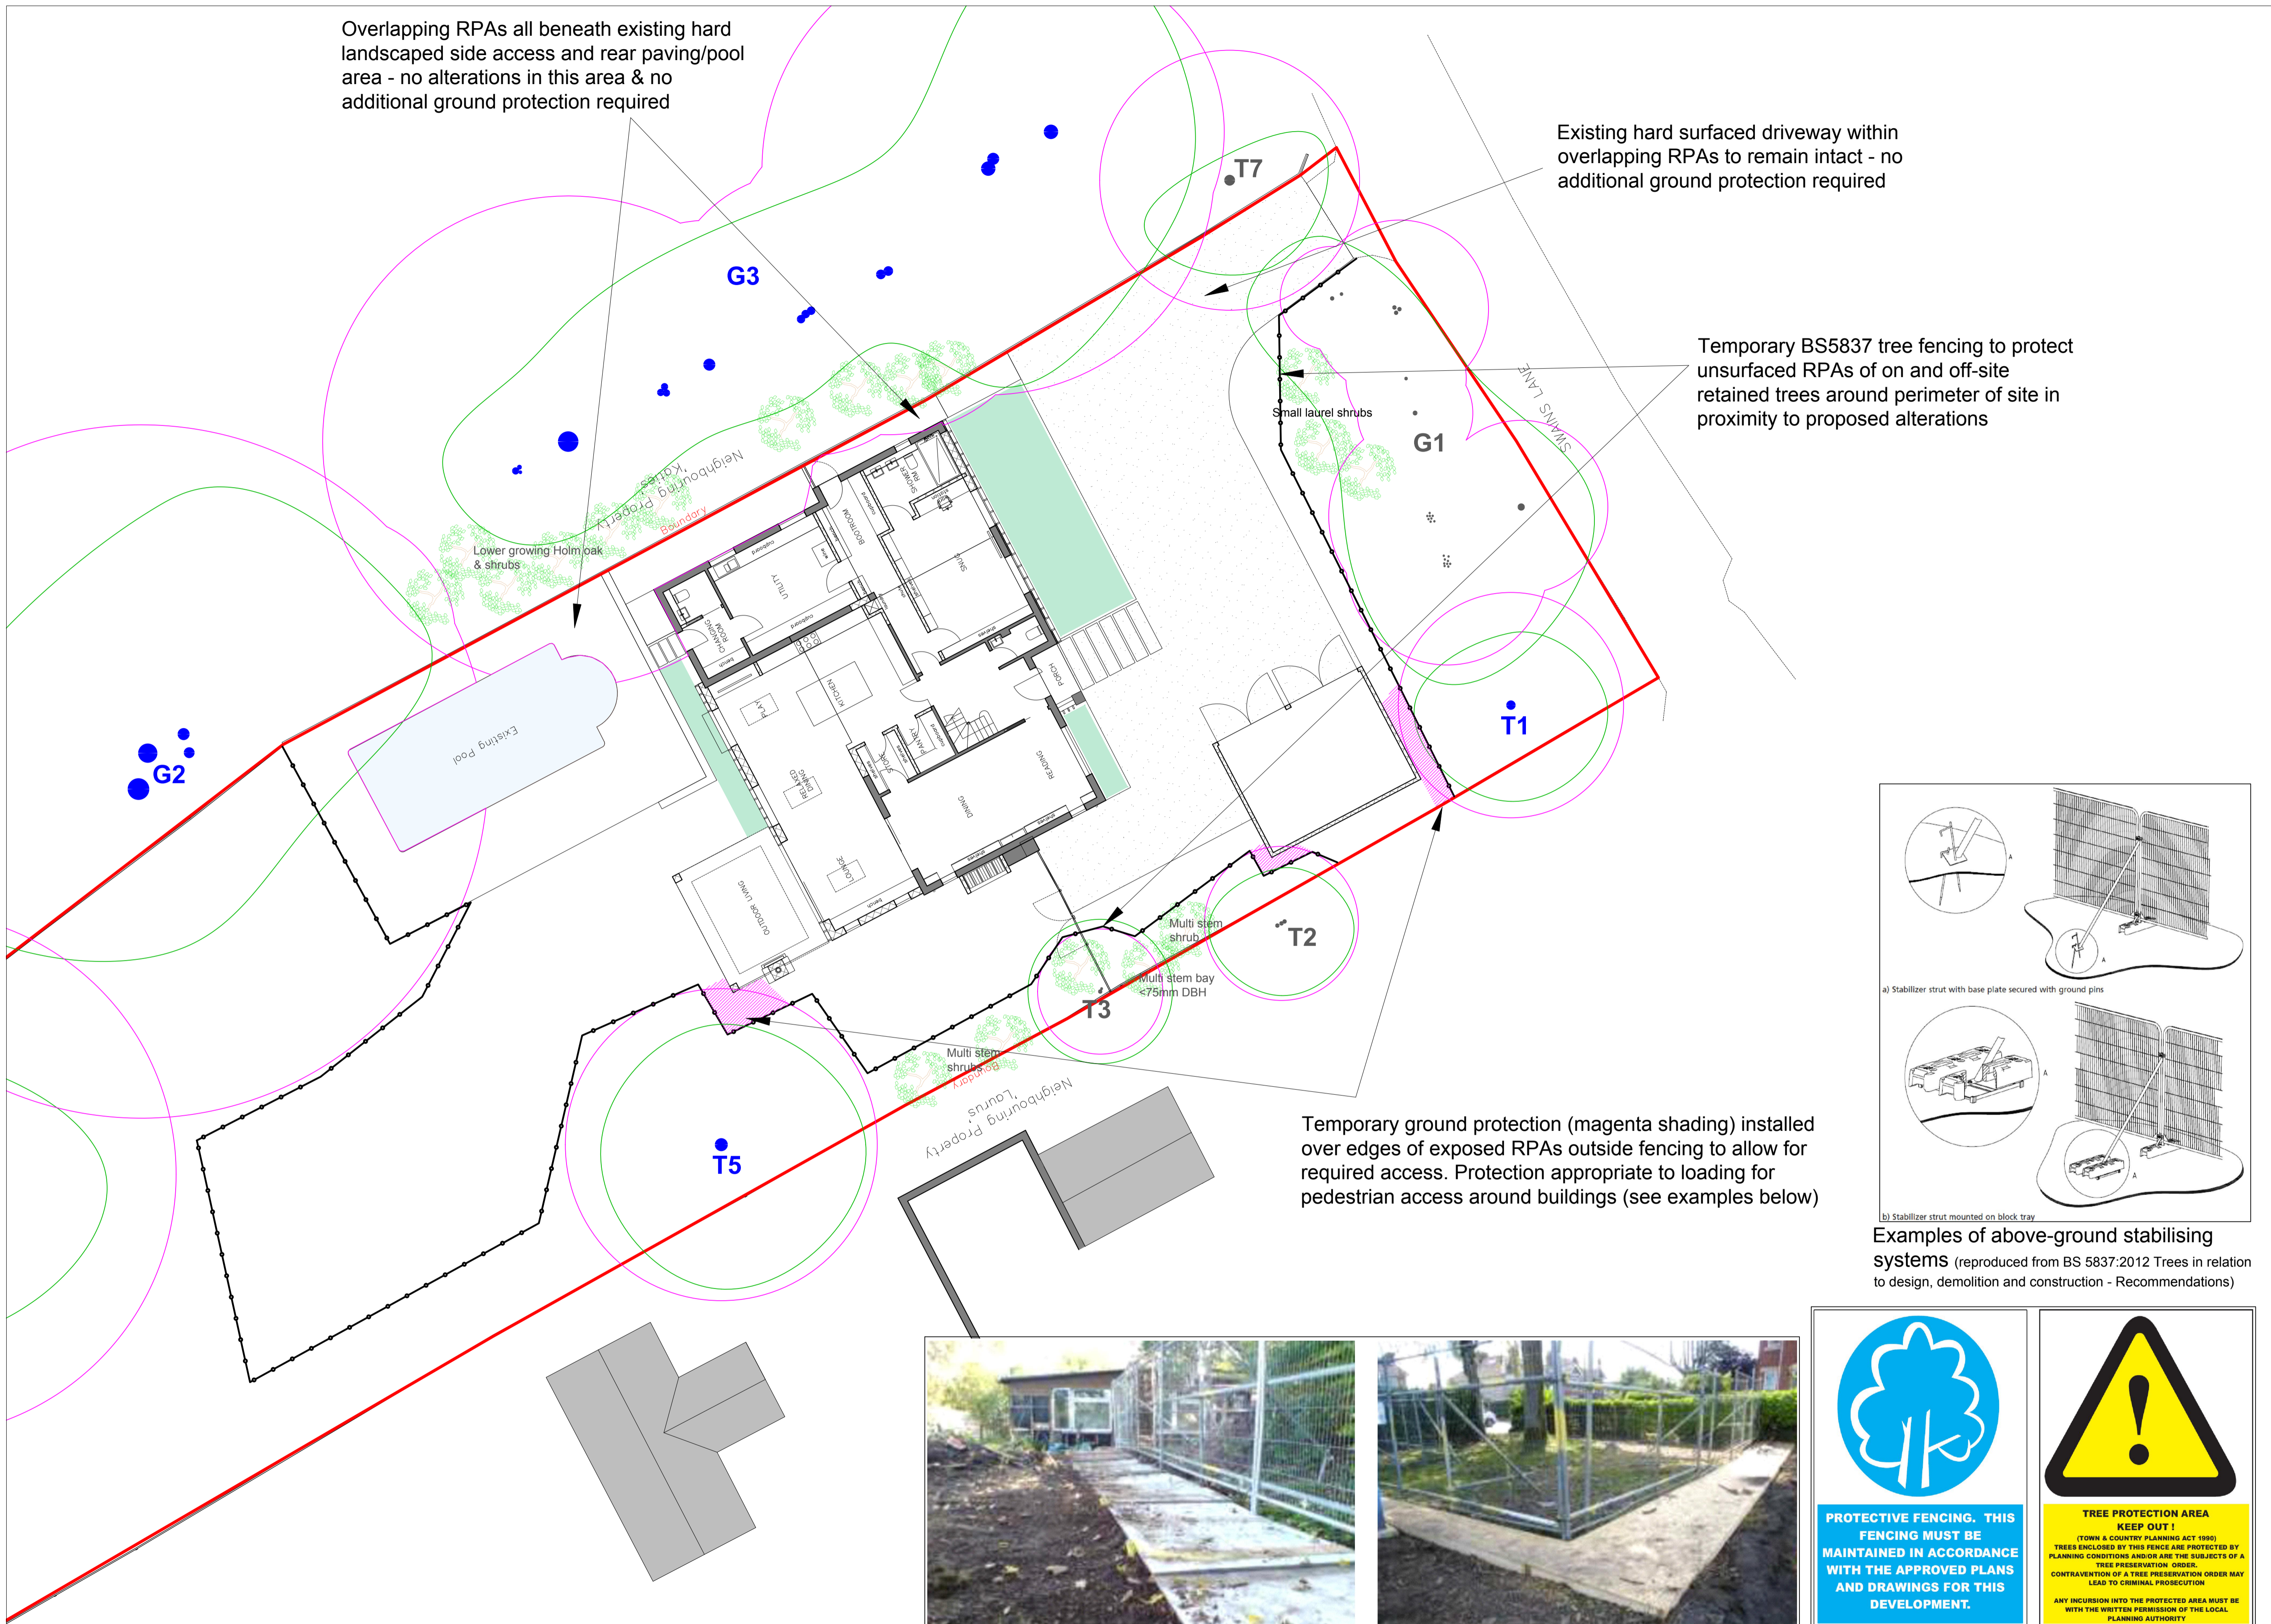
Overlapping RPAs all beneath existing hard landscaped side access and rear paving/pool area - no alterations in this area & no additional ground protection required

Existing hard surfaced driveway within overlapping RPAs to remain intact - no additional ground protection required

Temporary BS5837 tree fencing to protect unsurfaced RPAs of on and off-site retained trees around perimeter of site in proximity to proposed alterations

Temporary ground protection appropriate to loading within exposed RPAs (magenta shading) - refer to example specifications shown on this plan

Temporary ground protection (magenta shading) installed over edges of exposed RPAs outside fencing to allow for required access. Protection appropriate to loading for pedestrian access around buildings (see examples below)
