Project:
 Greenock Town Hall
 Reroofing & window replacement

Dwg No: AC(31)006	Rev: RevA
----------------------	--------------

Drawing Title:
 Window replacement
 Ventilators, electrical spurs

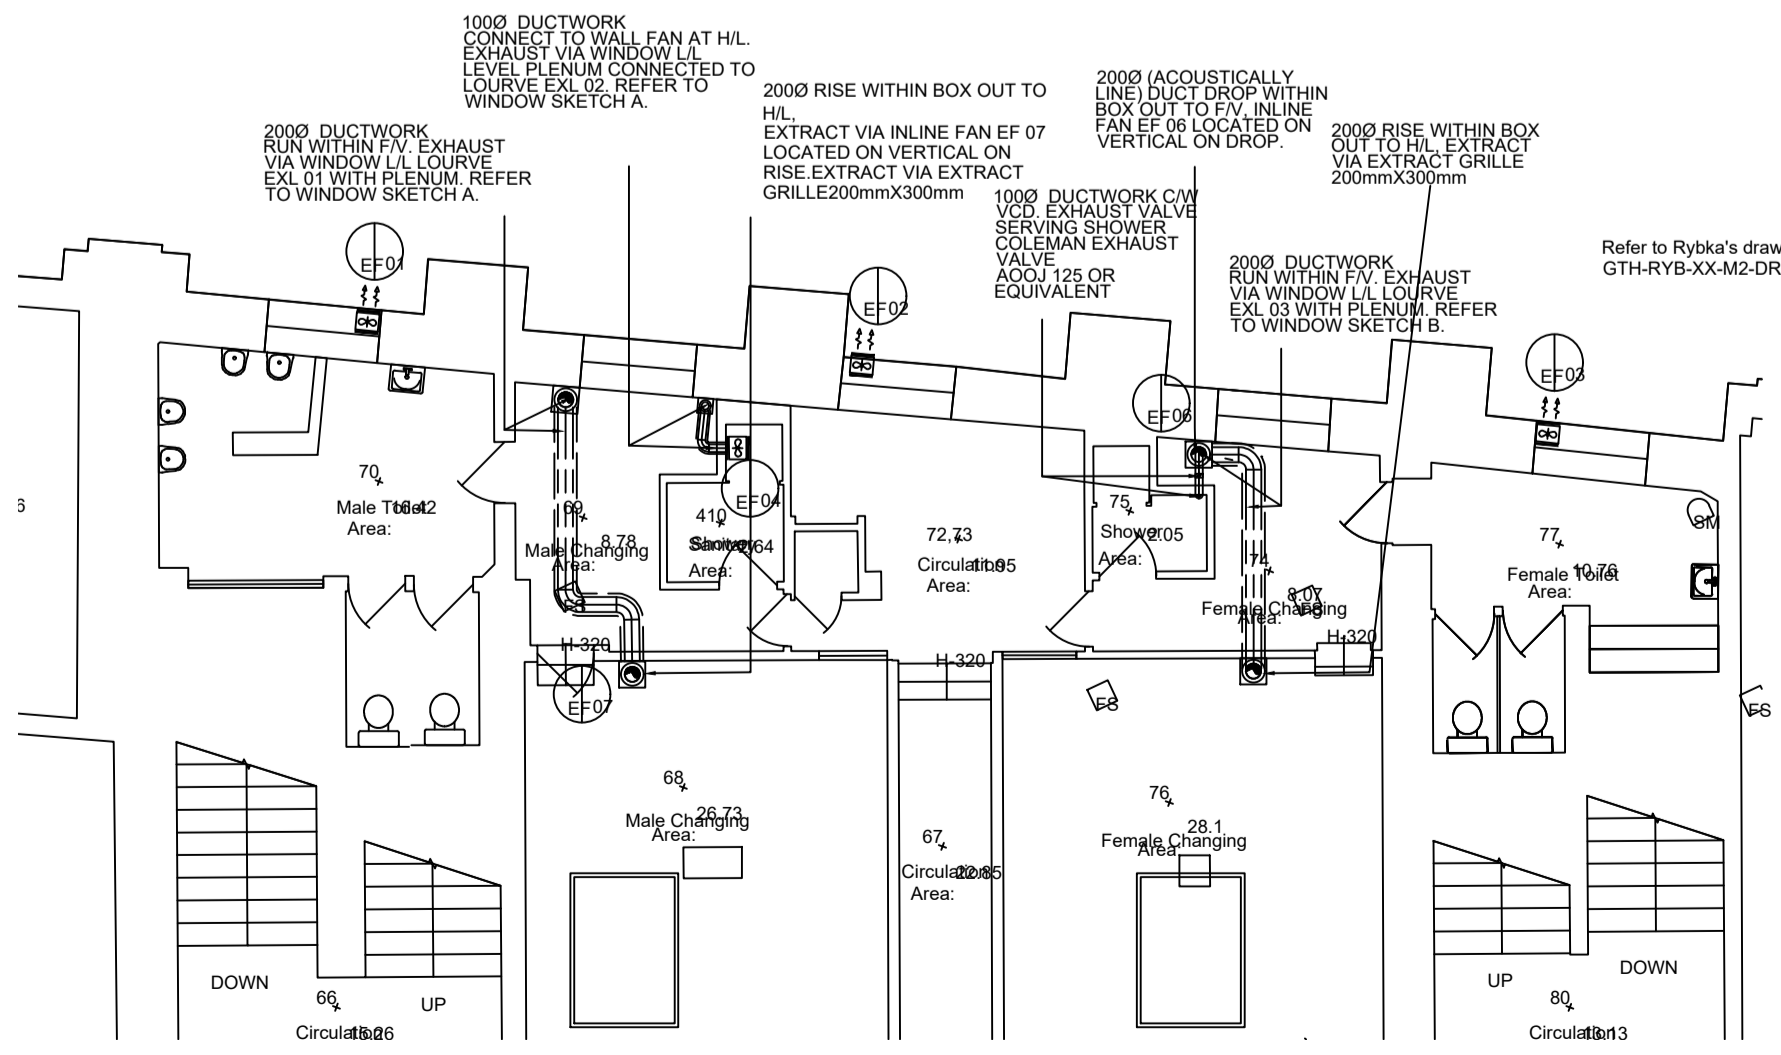
Proposed windows to changing room area below stage. 1:100

3 No. timber bulkheads formed to rear wall around changing room windows at the rear of the stage
 Contractor may carefully remove bulkhead to provide access for window replacement. Bulkhead to be reconstructed and repainted following window replacement.

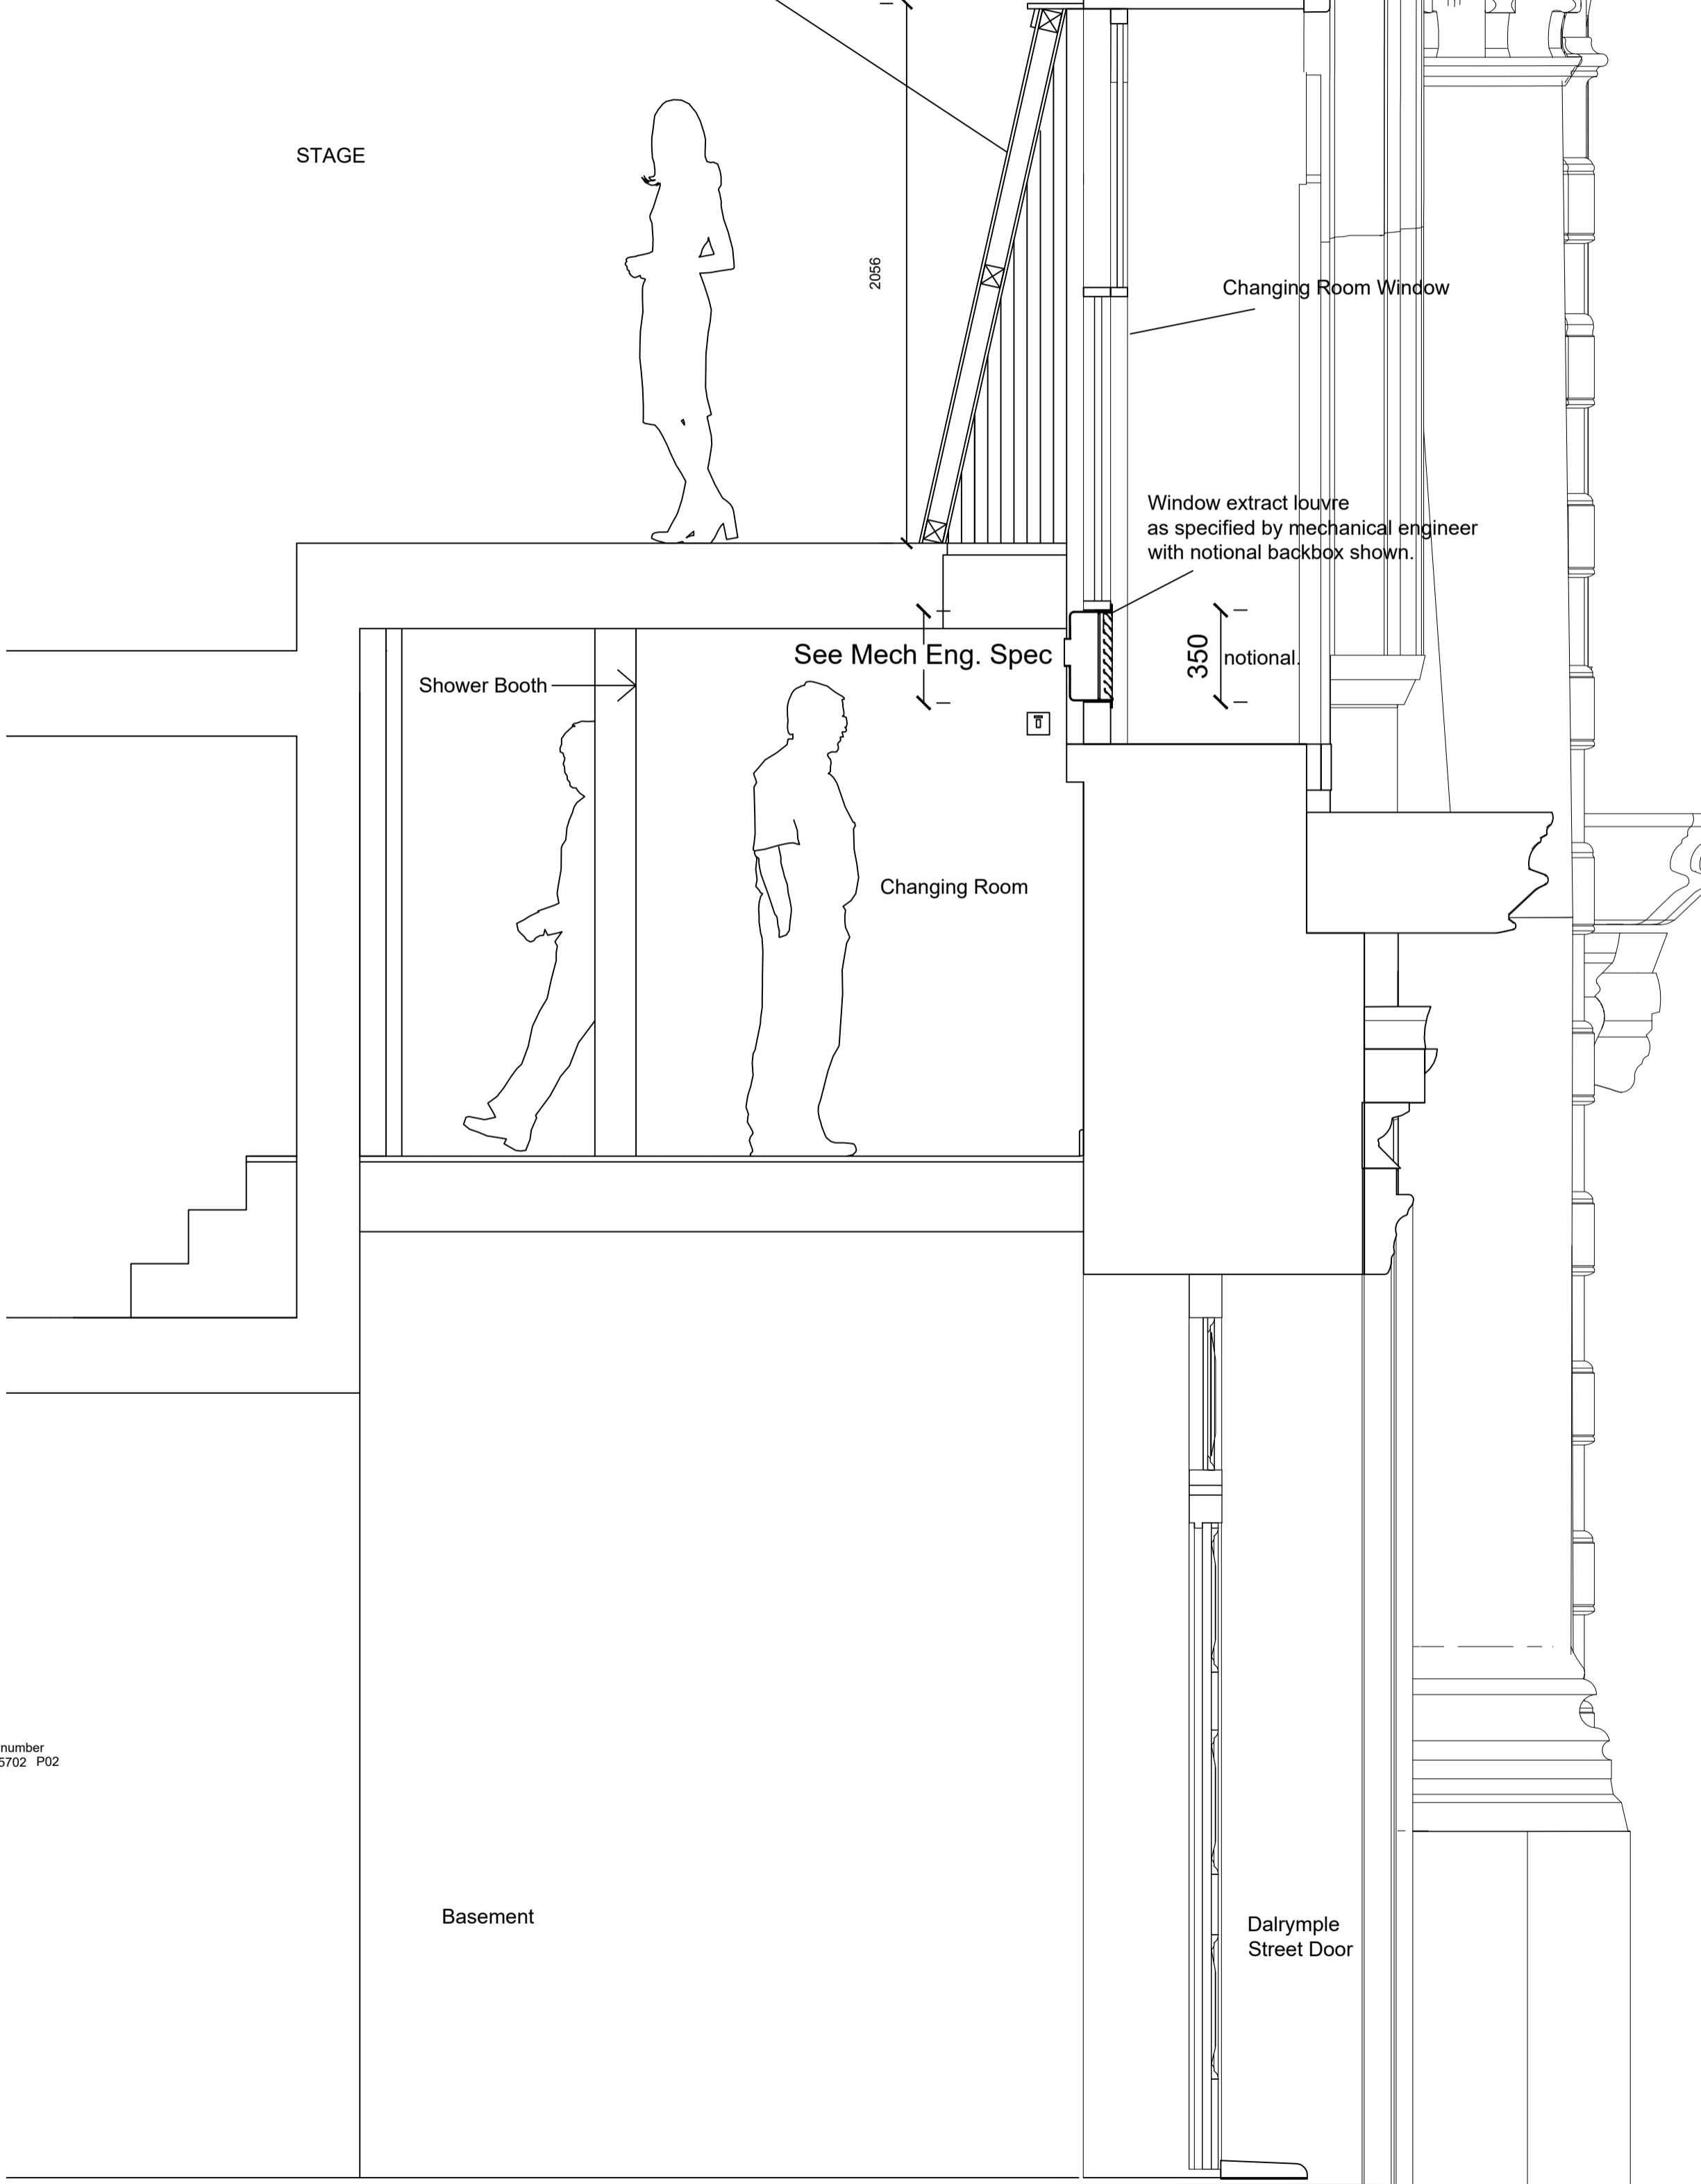
Section changing room window 1:20

3 No. timber bulkheads formed to rear wall around changing room windows at the rear of the stage

20 x 1800mm Cill board
 fillet
 20mm facing board
 12mmx 50mm timber cladding to stage and to changing room.

75mmx 75mm timber framing

New changing Room Window

Window extract louvre as specified by mechanical engineer with notional backbox shown. Louvre to be sized in accordance with Mechanical Engineers specification.

fused spur to fan
