BUILDING BAY
COLLAPSED

Revision
A West end bay collapsed. natural stone
gable wall rebuilt in new position
Stone buttresses added to north wall } Feb
2024

TYFHE FARM, GOPSHILL LANE,
GRETTON, GLOS. GL54 5ET
BUILDING 'B' GROUND FLOOR PLAN - PROPOSED.
21: 1935: 15 A (REDRAWN) FEB 2024 1:50
DENIS L RAYTON TEL 01242 620818

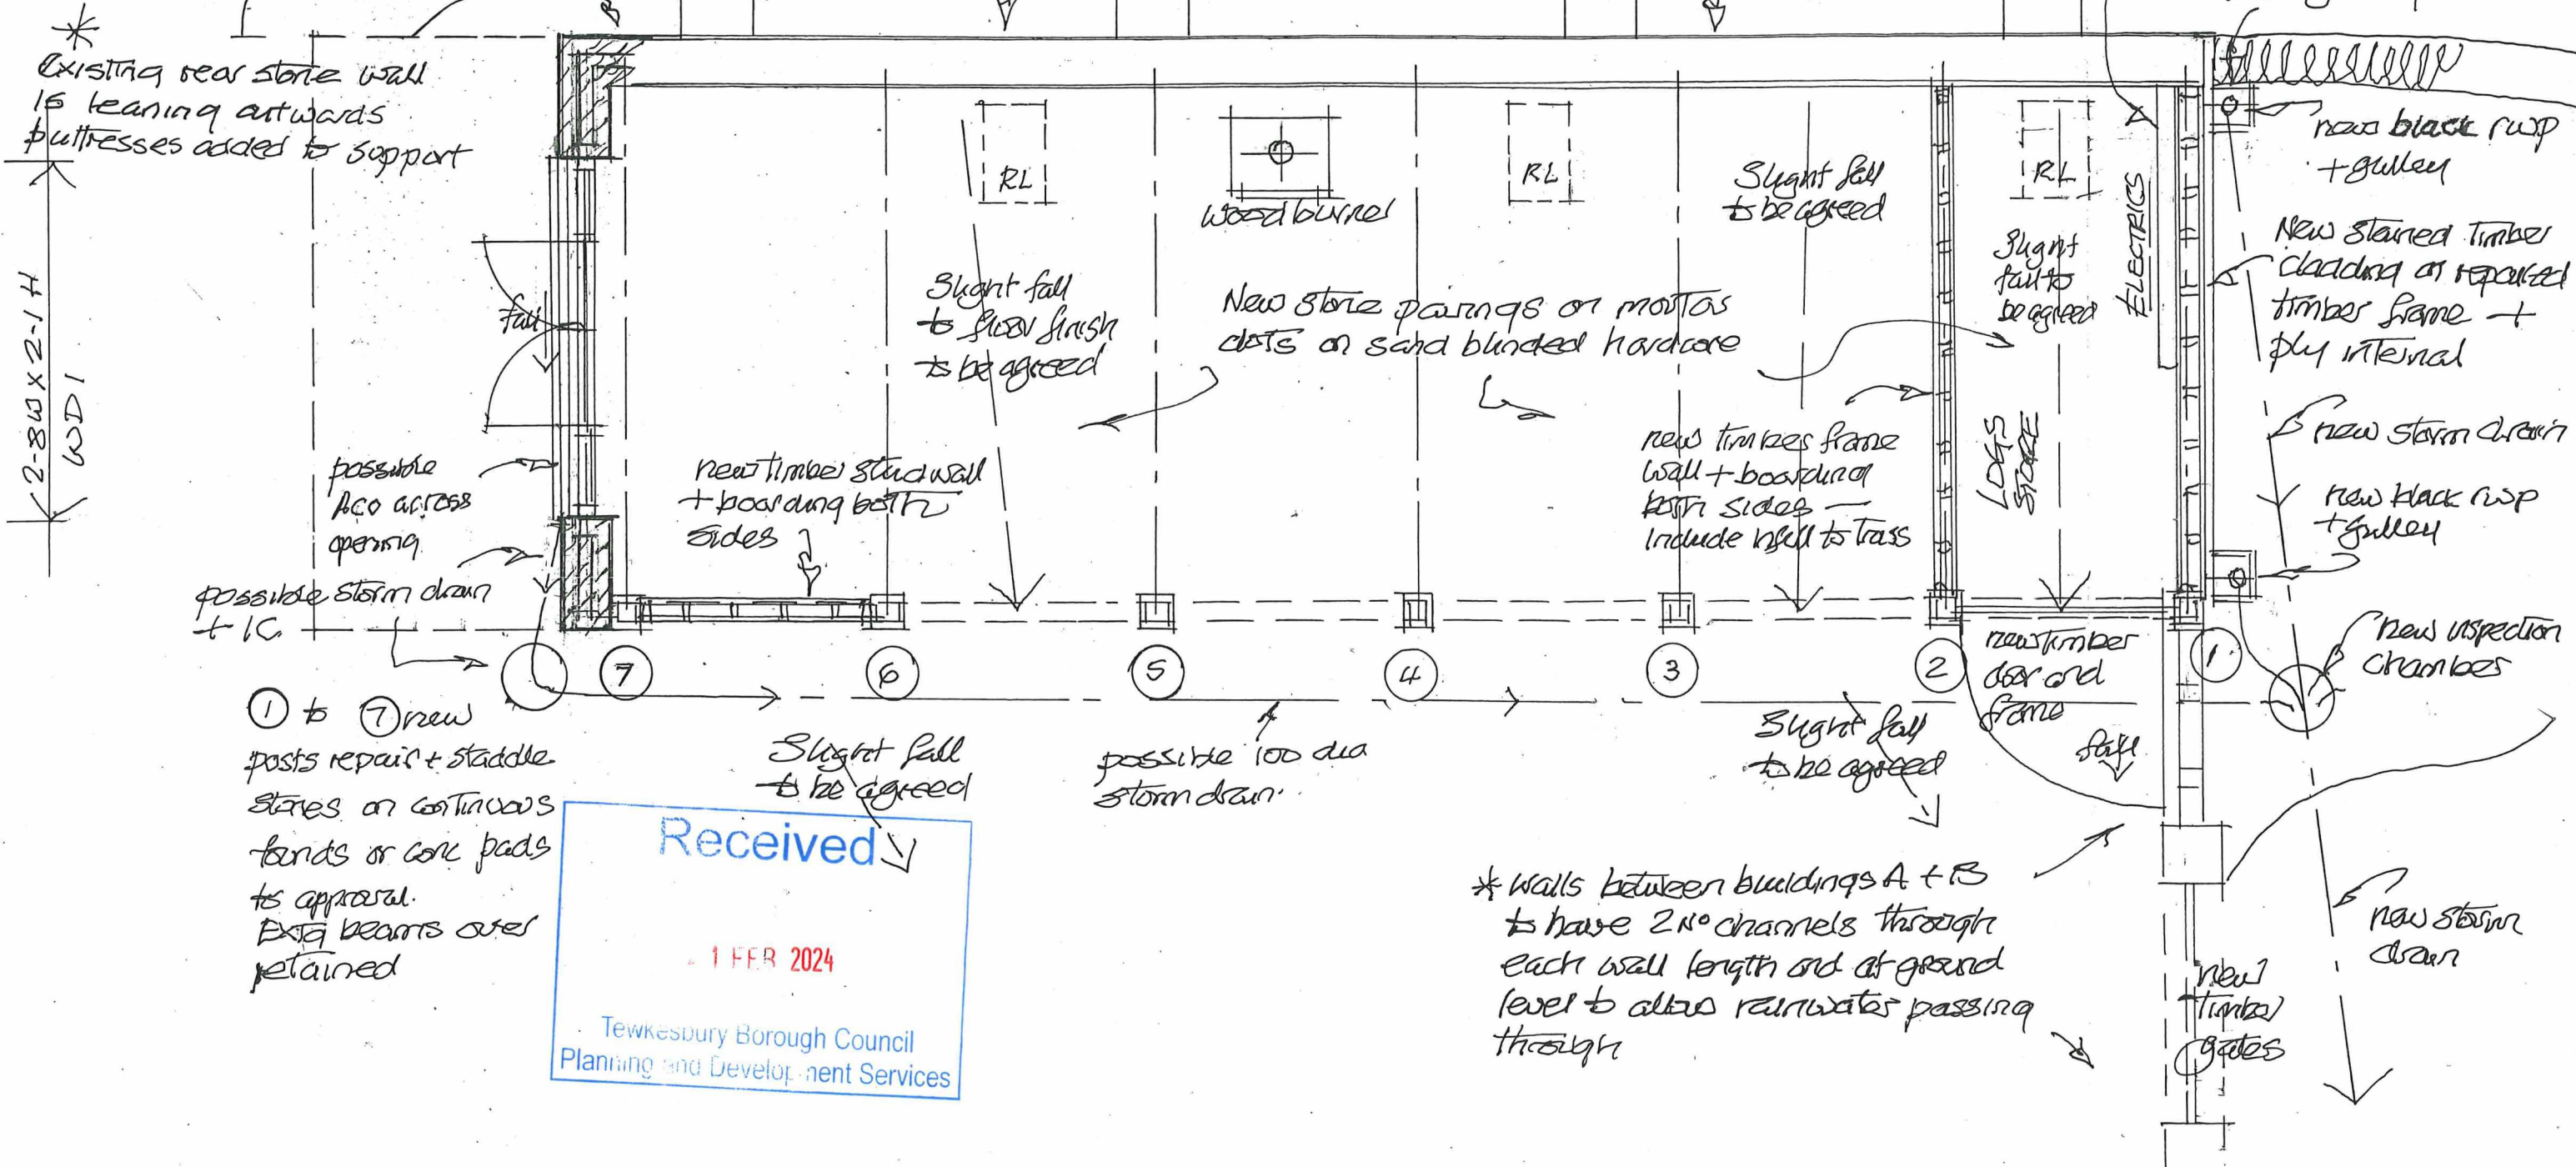
New rebuilt wall in natural stone
both sides of concrete block internal
core + stainless steel wall ties
boarding wall (also wall thickness)

Existing stone wall inspected, repaired, stitched
and repointed both sides.

new nat. stone
buttresses

new redoxide back
inlet gutter

* Existing rear stone wall
is leaning outwards
buttresses added to support

① to ⑦ new
posts repair + saddle
stones on continuous
benches or cork pads
to approval.
Extra beams over
retained

* Walls between buildings A + B
to have 2 no channels through
each wall length and at ground
level to allow rainwater passing
through
